Testing of Diamond-Like Carbon Coatings under Slip-Rolling Friction Monitored by Acoustic Emission

Manuel Löhner, Federal Institute for Materials Research and Testing (BAM), Berlin, Germany^{*)}

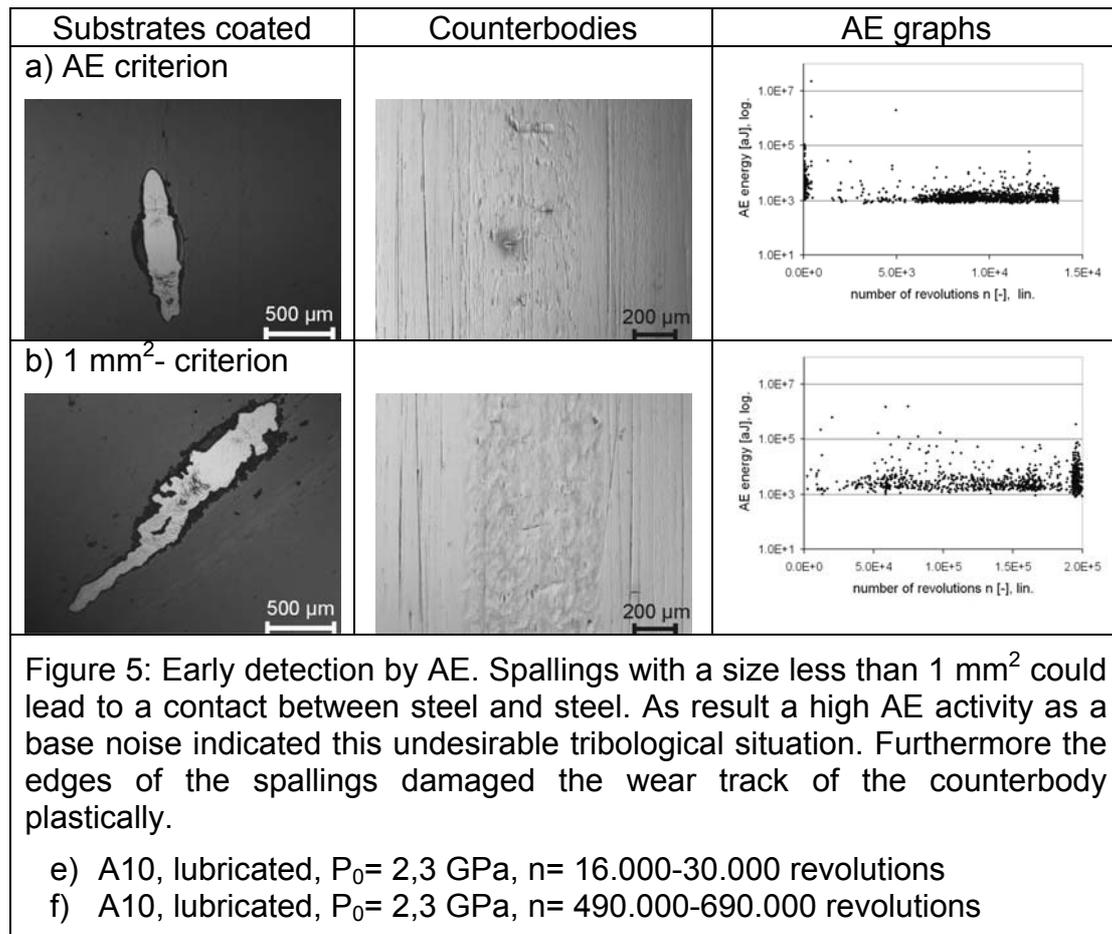
Spallings smaller than 1 mm² and damage events “subsurface” to the DLC coatings could lead to a high AE activity (AE criterion). In figure 5 the test sample with the code number A10 is shown. This test was terminated after a total number of 690.000 revolutions and a high AE activity was registered. This high AE activity occurred already after a total number of 23.000 revolutions, too. The base noise was caused mainly by the direct contact steel against steel. The small damage events in the wear track of the counterbody were mainly caused by the hard edges of the spalling in the coating. The damage events of the coating and of the counterbody were indicated by single AE hits. The AE energy of these hits was in most cases higher than the base noise.

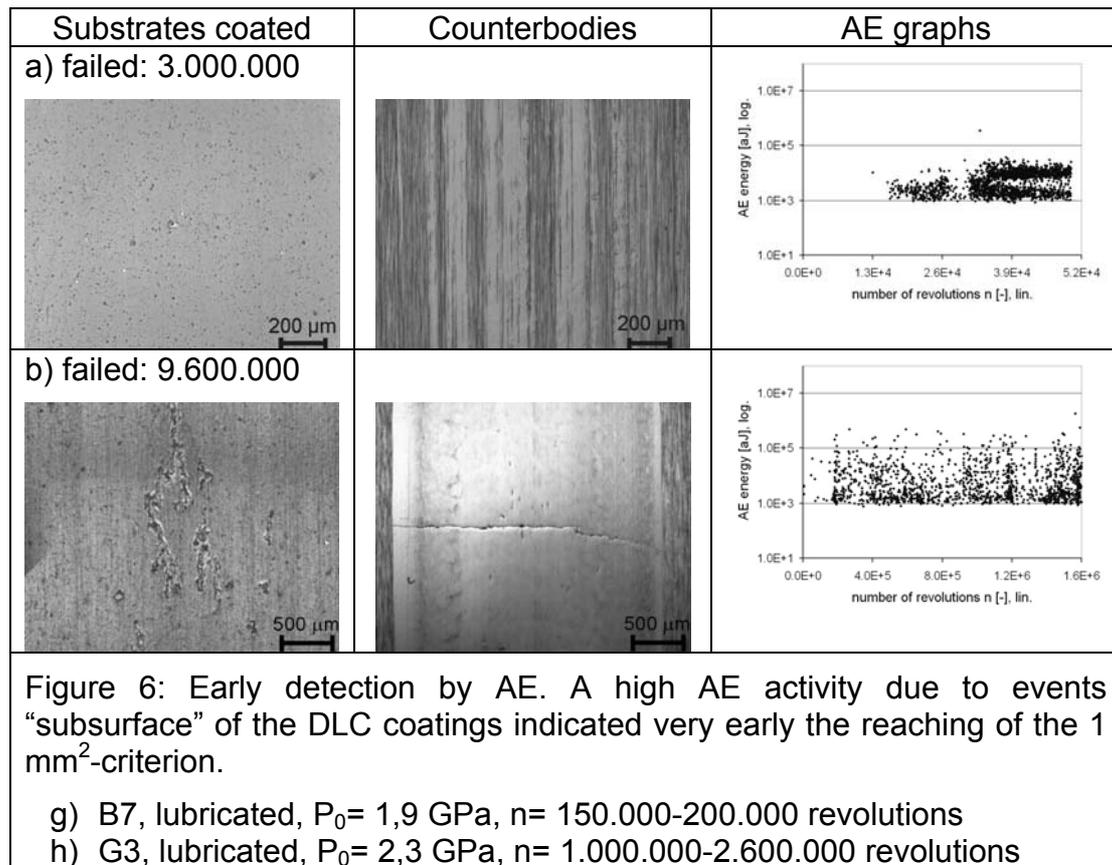
Damage events “subsurface” to the DLC coating were another reason of an early detection. These damage events indicated the oncoming termination of the test (1 mm²-criterion). Some samples, which per definition were called resistant to slip-rolling fatigue, were tested further to the 10.000.000 revolutions. The test samples B7, E3, F1 and G3 reached the 1 mm²-criterion after 1.000.000 revolutions. A high AE activity was recorded much earlier. Figure 6 shows the results of the test sample B7 and G3. The AE graphs show the AE in the test interval, in which the high AE activity began. The sources of AE had to be “subsurface” to the DLC coating like cracks and delaminations, because the amount of “visible” damage events were too small for the high AE activity observed.

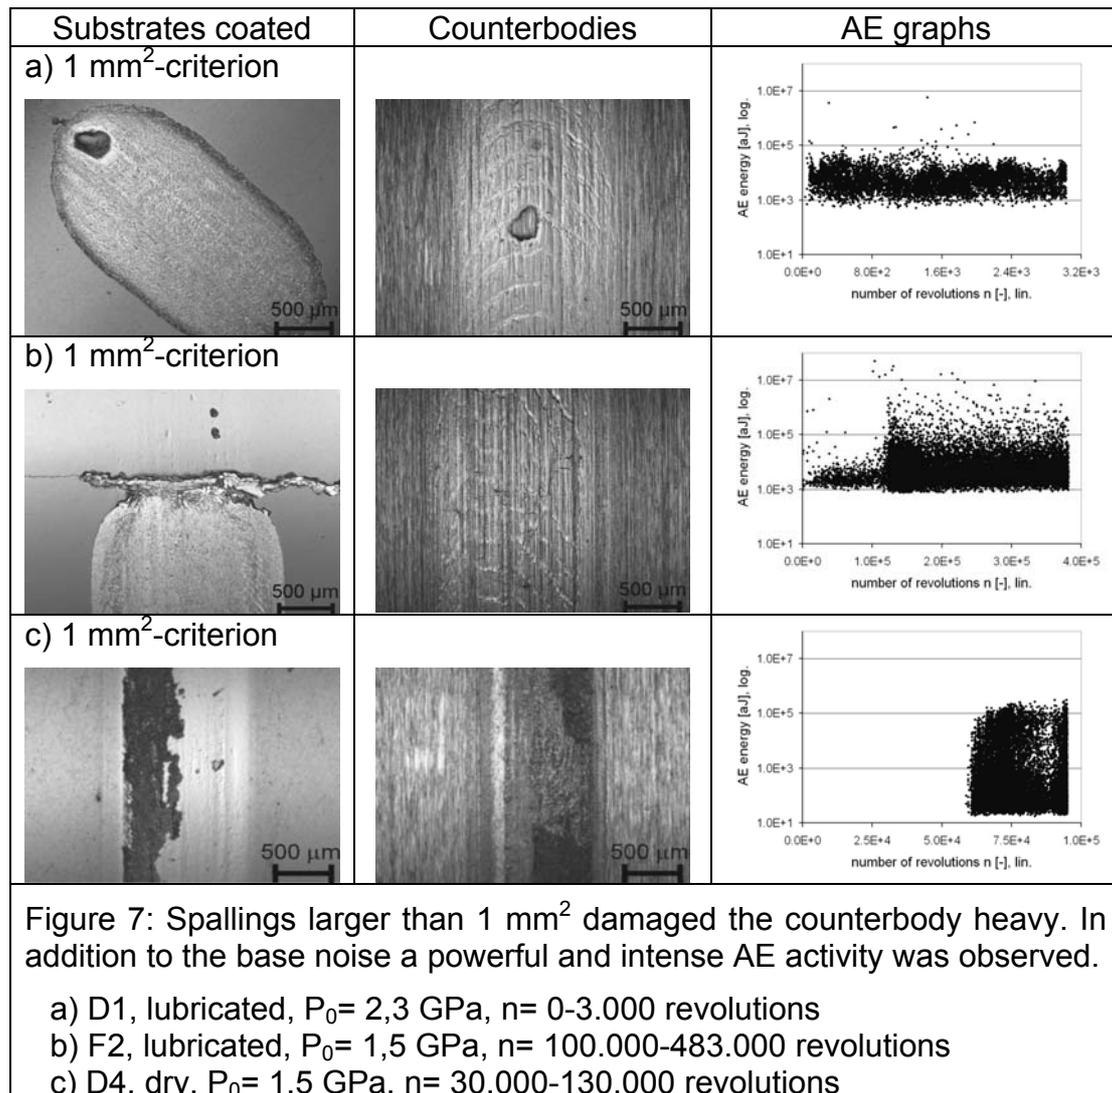
Fig. 7a) The edges of the large spalling in the coating had dramatically damaged the respective counterbody. The high AE activity, which was recorded immediately, was due to the direct contact of steel against steel and to the observed plastic deformations and spallings of the counterbody.

Fig. 7b) After a total number of 483.000 revolutions this sample reached the 1 mm²- criterion with a very large spalling. Most of the coating was removed suddenly inside the wear track. The counterbody showed plastic deformations. The AE graph showed the AE activity from a number of 100.000 to 483.000 revolutions. In this test interval the AE activity changed from a high AE activity to a very high AE activity. The very high AE activity was due to the contact of steel against steel and to the heavy damaging of the counterbody and the coating, both appeared suddenly. Probably the high AE activity occurred earlier due to crack events in the coating.

Fig. 7c) The DLC coating was partly rubbed out off the wear track. Parts of the coating covered the transfer layer in the wear track of the respective counterbody. The AE graphs shows the evolution of the damages which could be observed after the tests. The removal of the coating happened suddenly. Nearly no AE activity was registered before a very high activity level of AE was reached. The high AE activity was mainly caused by fretting events through the contact steel against steel and appeared suddenly at a total number of 90.000 revolutions. The AE hits showed an AE energy in a different range as under lubricated conditions due to the different threshold settings.

Spallings larger than 1 mm² could heavily damage the wear track of the counterbody. Under lubricated slip-rolling friction the counterbody showed plastic deformations and spallings. Under dry conditions a DLC coating, which was partly rubbed out off the wear track, could lead to fretting conditions between the steel surfaces. Such damage events led to a high AE activity in addition to the base noise. The base noise got more intense with increasing size of the spalling. Figure 7 shows three DLC coatings with a spalling larger than 1 mm². In all cases a very powerful and intensive AE activity was recorded:
