# EXPERIMENTAL APPLICATION OF 3-D TERRESTRIAL LASER SCANNING AND ACOUSTIC TECHNIQUES IN ASSESSING THE QUALITY OF STONES USED IN MONUMENTAL STRUCTURES

## Abstract

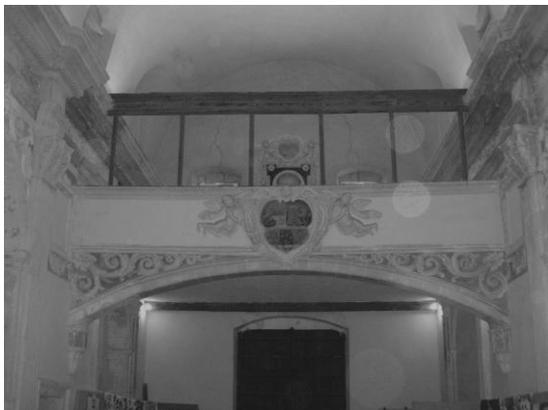
Figure 1 - Choir of the Santa Chiara Church

The study was carried out on the masonry structure of the choir (Figure 1) of the Santa Chiara ancient Church in the historical downtown of Cagliari (Italy).

The ultrasonic investigations on the choir (Fig. 1) of the surveyed Church were planned taking into account the aims of the work, the general conservation state of the materials and on the basis of the 3D TLS results.
