## **Induce stress of the cracks in the chassis structure of the mobile crane used in constructions on any type of terrain**

### **Abstract**

It was determined that at the mobile cranes used in constructions on any type of terrain (for instance, at Tadano Faun ATF 30-21 owned by SUT Carpati S.A.– Bucharest) there are some cracks in the structure of the 4x4x4 – type chassis with motor and driving wheels. The cracks in the welding seams as well as in its structure were determined for the first time during the oil changing in the gearing, in 2006; so they were mended by welding. After an year, in 2007, the chassis structure is presented here by photos and commentaries on the existing cracks. It is shown the mending solutions of the cracks made by SUT Carpati and those proposed by the manufacturer on the basis of the photos shot in 2006. The way they appear and the crack evolution in time are not known but it is quite sure they were done by the bad roads of the sites where the crane moves as well as by operating it by blocking the automatic control system of stress limiter which increases the induced efforts and stress value in the area and chassis structure as the crane operator doe

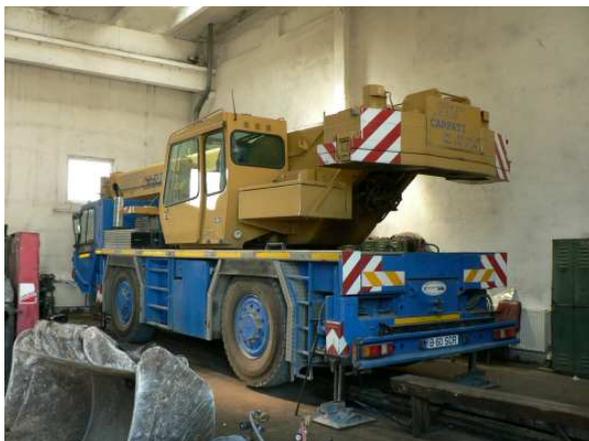
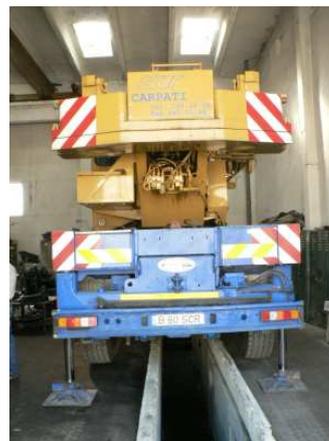
It is not known their evolution in time, but it is quite sure that they appeared because of the bad roads the cranes move as well as the blocking of their automatic control system of the stress limiter. Figure 1 and 2 show the ATF 30-21 crane that needs to have rebuilt the cracks in the chassis.

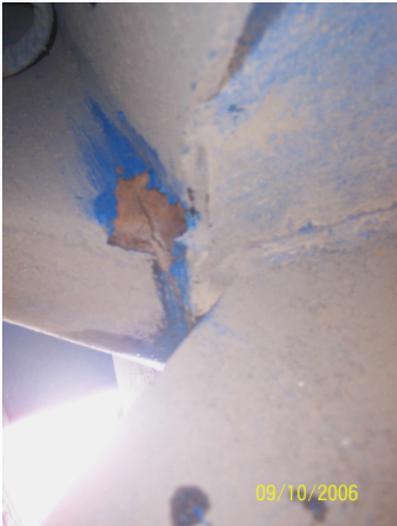
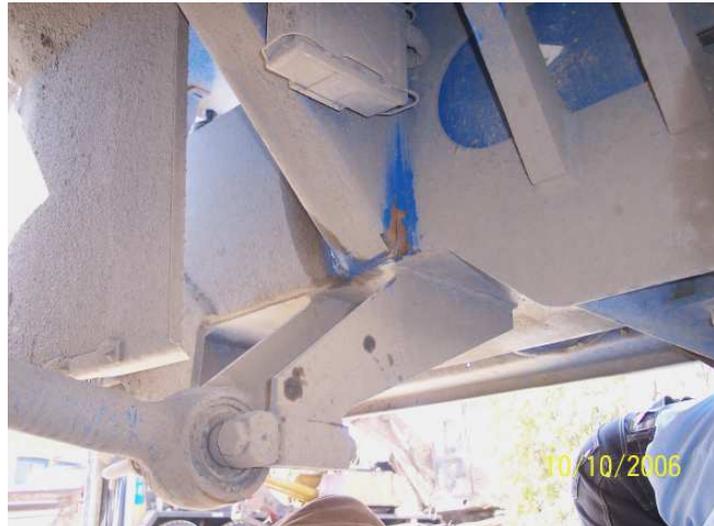
Figure 3

The chassis construction is made of two box spars, welded at the ends by the casing of the telescopic pressing on feet through gusset (Figure 3 and 4) on the back side of the crane, their cracked weldings being found in 2006.

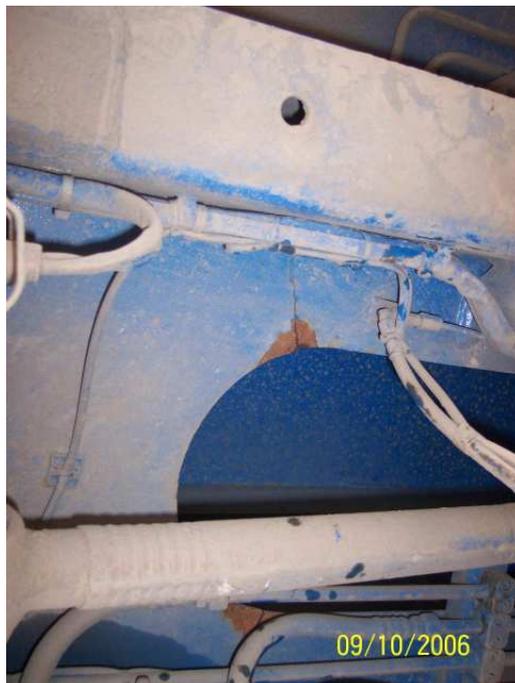
Figure 5 shows the crack in the stiffener of the box spar from the back of the setting, as it appeared in 2006.

On the top, between the box spare housings a square plate is welded; it is cut at the middle which links the setting casing with the rotation crown support (see photo in Fig 5, and the carding system of the back deck in Fig 9). At this plate there are now a series of cracks (see Fig 10 and 11) that are arranged along the longitudinal axis and crosswise in the 4 points along the plate diagonals.

The most stressed element where the cracks appeared, is the linked plate between the longerons built in its contour being cut inside. The cracks appeared due the plate bending in vertical plan and due the torsion on two directions (vertical and horizontal), (see Fig 5, 10 si 11) both in welding coordinates and its structure.

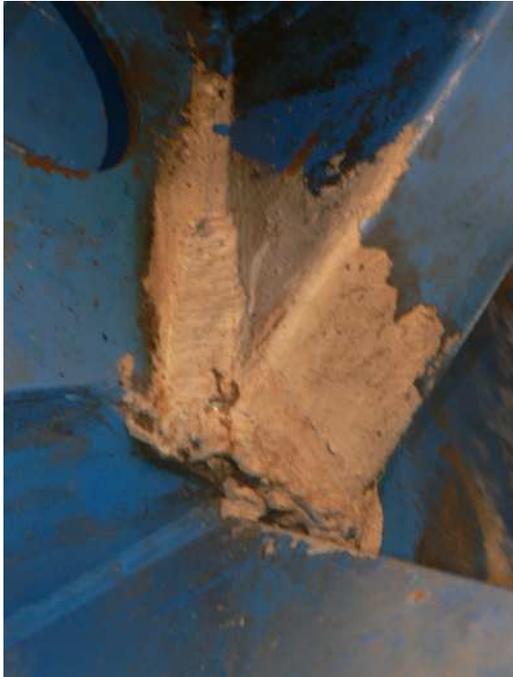
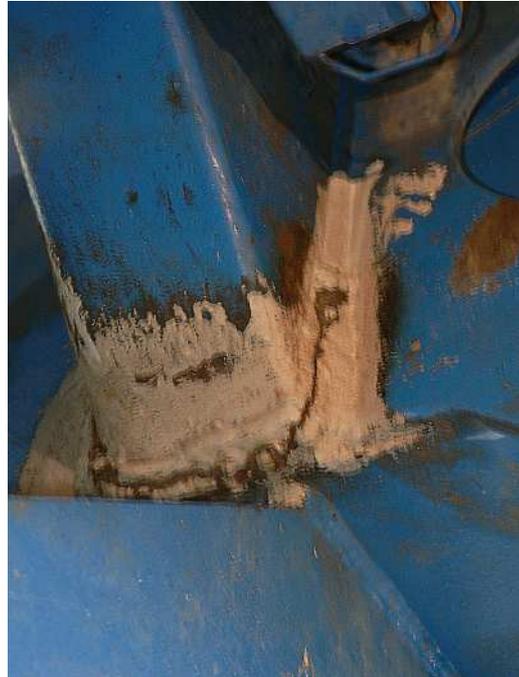
Figure 6

Figure 6,a shows the right back gusset and the Figure 6,b shows the left back gusset on the which one can see the real cracks in the weldings that set the chassis on the back setting casing( Fig.7,a and b). Figure 8 shows the crack in the gusset welding set the left box spare on the front crane casing.

Other cracks are along the plate in set (see Fig 10). The most important are the u-shaped cracks that start sideways from the gusset base and part the longerons from the back pressing-on box casing (see Fig 6,a and Fig 6,b). Other cracks are on the left front side (see Fig 8). Here the cracks are in the horizontal welding seam of the u-shaped gusset. They show a split of the welding under the action of chassis bending during operating. The metallic construction is stiffened in the middle by a plate where the rotation crown is set, linking the superstructure with the chassis. The area where cracks appeared on the cut plate of the chassis is in front of the back motor deck (see Fig 5, photo 2006 and the Fig 10 si 11, photo 2007).

a) Normal breaking of the weldings by their parting as shown in Fig 13; it corresponds to the cracks in the welding coordinates of the u-shaped gussets that connect them with the back box (Fig 6,a and 6,b) and front gusset respectively

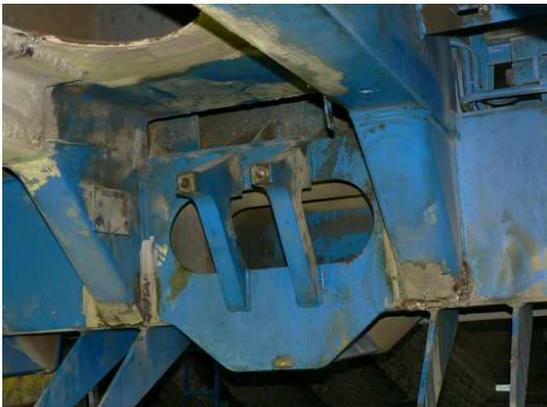
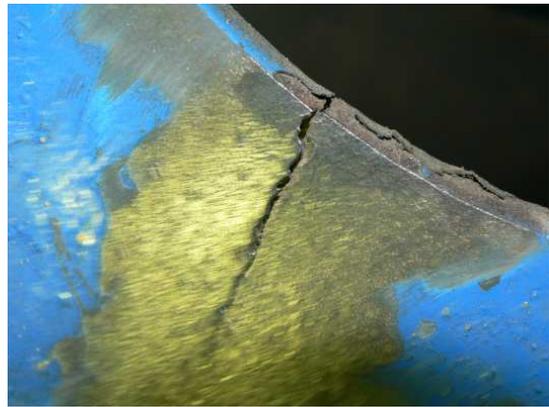
Figure 7

b) The breaking of the welding and material by sliding due to the lateral shear shown in Fig 14. It can be seen at the basis of the u-shaped gussets (Fig 7,a and b) that are welded to the back pressing-on box casing

c) The breaking of the welding and material by sliding due to the longitudinal shear shown in Fig 15. It correspond to the cracks in the plate (see Fig 7,b).

They represent strong bundles that disturb the homogeneity of the stress fields and creates local favourable conditions for the microcracks. This fact was detected from the development of the cracks too during a year, when they were monitored (Fig.7,a and b).

4. The cracked plate between the longerons and the web of the rear support which is also cracked along the gusset ( see Fig.7,a) they will be removed from the construction and will be replaced with the plates according to the project.

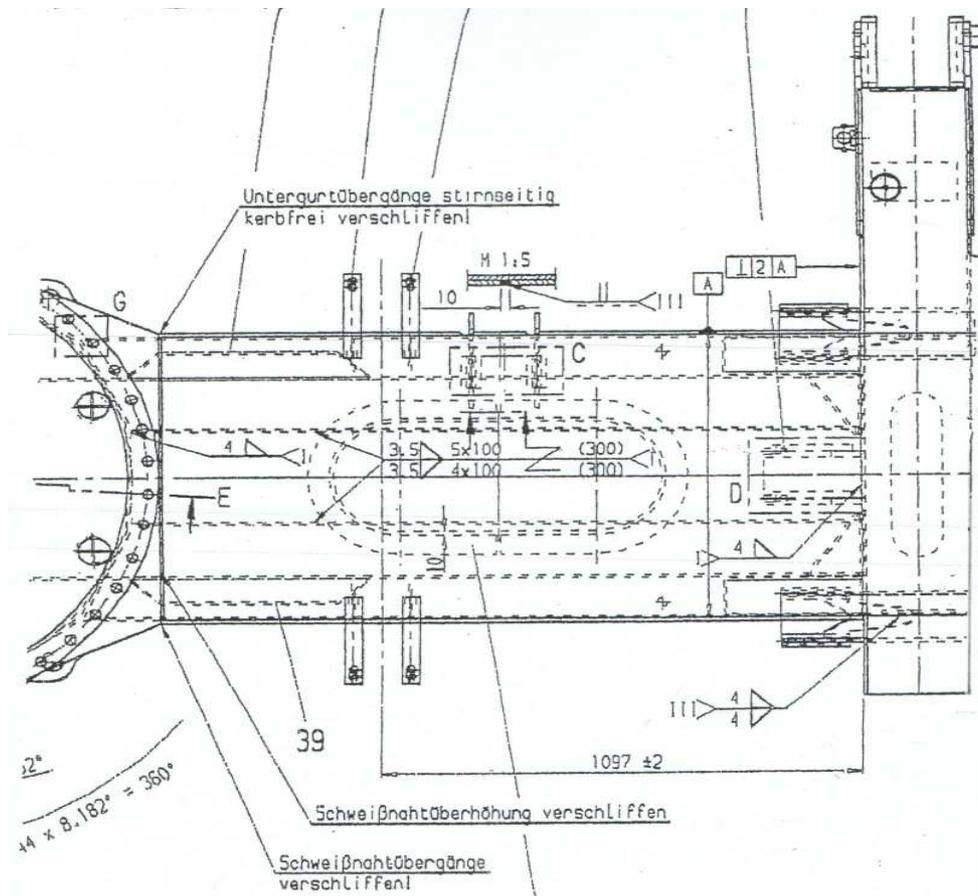
Figure 12[1]

The area of the cracked plate on the general plan of the metallic construction is shown in Fig 12. On this plan the constructor, after the initial construction put strengthening ring shown in Fig 17.

As a consequence of the cracks in the chassis structure, the German constructor proposes the welding of a strengthening rib as a horseshoe of 7 mm in the cut area of the cracked plate (see Fig 12).

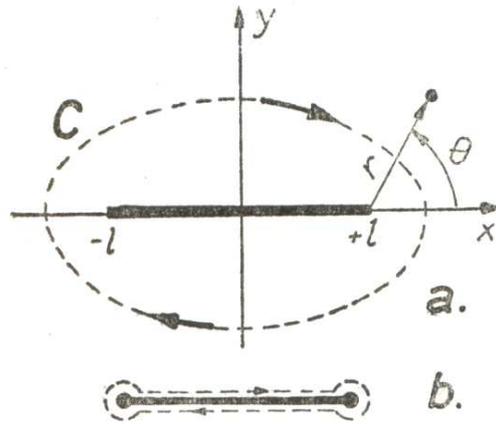
Figure 16 [2]

Por the space with the cracks subject to longitudinal shears, analysed by a calculus pattern as that one shown in figure 16,a and b where the crack of  $2l$  length is surrounded by a contour  $C$ ; an isolated crack point placed outside the contour is taken into account (see Figure 16 a). For this case, under the point [2] the index  $K$  is indicated called stress intensity coefficient, representing a distribution characteristic of the stresses near the crack peak during its propagation (it must not be mistaken with the like factors from the stress bundles).

The obtained solution were about the square cracks in infinite bodies. Instead, the deducted relations (4.1-4.7) will characterize the behaviors and movements of the stresses near the edges of some holes of any form if by  $r$  it is understood the distance from the normal to the crack contour (fig 16 a).

It results that it is necessary to compute the potential energy variation of the body during the process of crack enlarging. Taking into account the fig 16 a, near the crack peak it is obtained:  $\theta = \pi, r = \Delta l - x = \Delta l(1 - \zeta)$

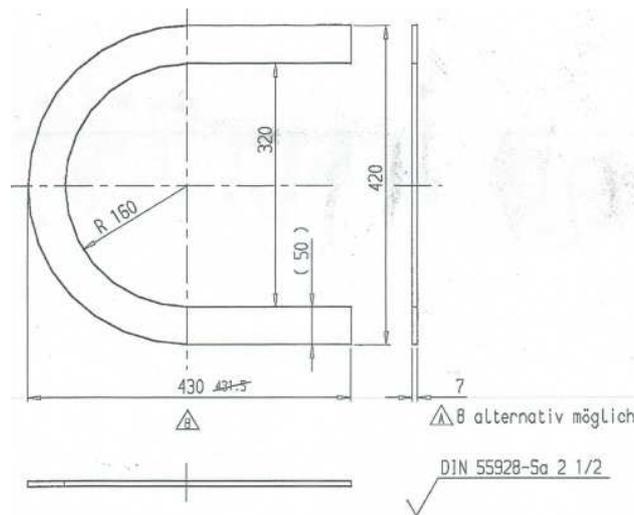
Figure17[ 1]

2. The affected areas stiffening is done with strengthening U – shaped elements built according to the hole curve in the plate indicated by the manufacturer (shown in Fig 17) having a depth of 7mm in order to eliminate the enlargement of the crack made by the stiffening; otherwise the crack development will go on in this area.
