## Development of Visual and Other NDE Methods

### **An Assessment of Remote Visual Methods to Detect Cracking in Reactor Components**

S.E. Cumblidge, M.T. Anderson, S.R. Doctor, F.A. Simonen, Pacific Northwest National Laboratory, USA; A.J. Elliott, Oregon State University Corvallis, USA

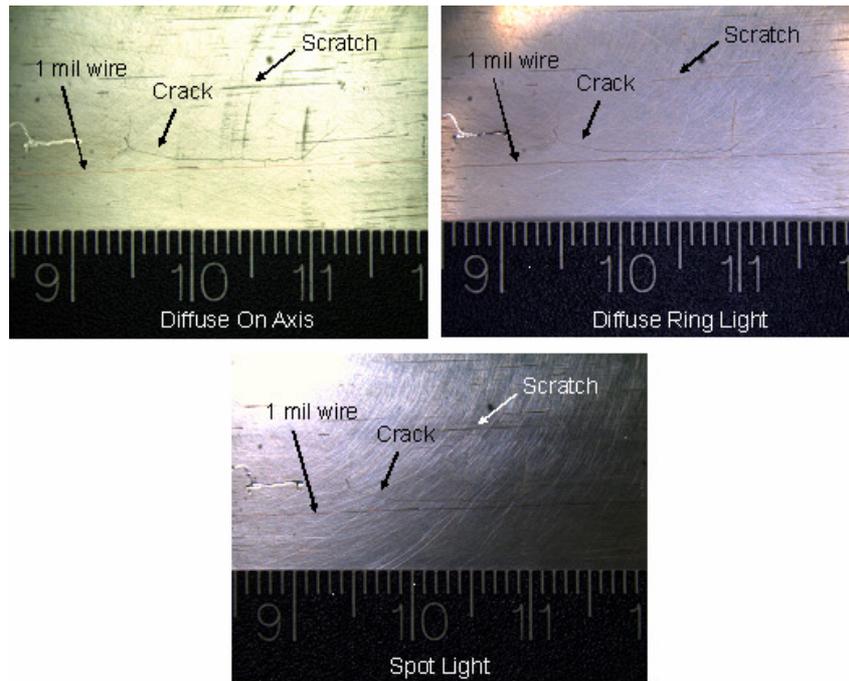
Figure 1 - Images of Crack, Wire, and Scratches Taken Using Diffuse On-Axis Light, Diffuse Ring Light, and Bare-Bulb LED Spotlight

### **Lighting Style**

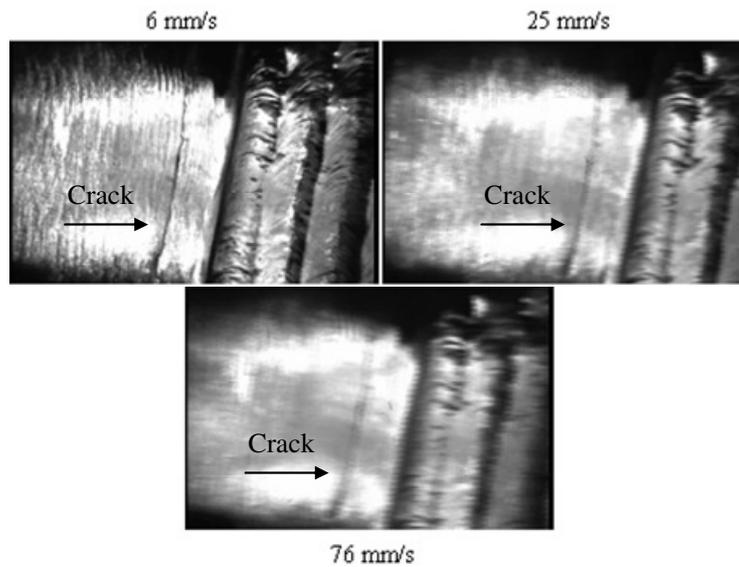
Figure 2 - Sample Images of a 125-mm COD Crack Imaged at Three Scanning Speeds

The radiation-hardened pan/tilt/zoom camera was scanned at speeds ranging from 6 mm/s to 76 mm/s (0.24 in./s to 3.0 in./s) over a 125- $\mu$ m (0.005-in.) COD crack, and the resulting images were examined. Example images from this experiment are shown in Figure 2. Slow scanning appeared to cause little distortion in the image, while scanning at 76 mm/s caused gross distortion in the image.

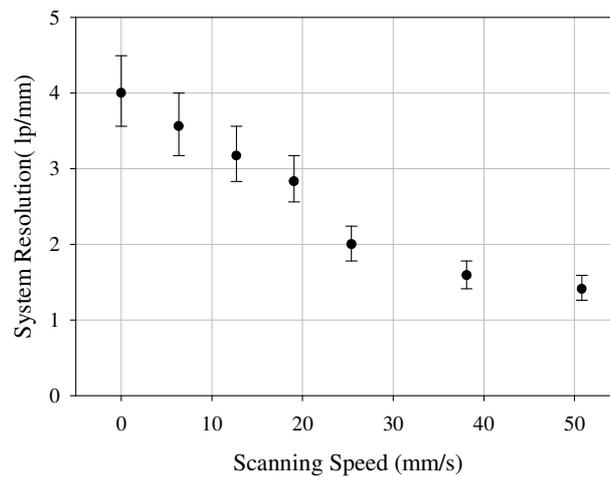
Figure 3 - Effects of Scanning Speed on Resolution of Radiation-Hardened Camera

For the resolution tests, the camera was scanned over a 1951 Air Force resolution target, and the camera resolution was recorded for each pass. The smallest resolvable group and element number were recorded, as well as the corresponding number of lines per millimeter. The theoretical maximum resolution for the magnification was 4.7 lp/mm, which is close to the 4 lp/mm that was obtained on a stationary target. A graph of the results of the scanning speed versus resolution experiment is given in Figure 3. It must be stressed that these results are for a given radiation-hardened camera under one set of conditions, but the results for another camera under other conditions may be different.

The scanning experiment shows that the resolution loss at slow speeds such as 6 mm/s (0.24 in.) do not greatly reduce the resolution of the system, while scanning at higher speeds reduces the resolution to less than half the acuity of a stationary camera.
