## High Temperature Ultrasonic Scanning

**R. J. Carswell**  
Saudi Aramco  
Dhahran, Saudi Arabia

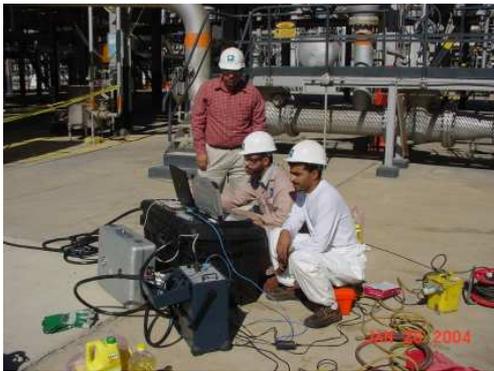
Figure 1:  
system

components and crew

- Scanner with motorized X & Y axis - Mechanical Integrity (Mfg)
  - Cobalt magnetic wheels
  - Motor cooling with pressurized air through vents
- Ultrasonic signal processor - Eight Channel Pocket Scan – Technology Design (Mfg)
- Couplant delivery and recovery system
- Laptop with control, inspection and analysis software
- 250' Umbilical
- High temperature transducers 2.25 and 5MHz - Technisonic (Mfg.)

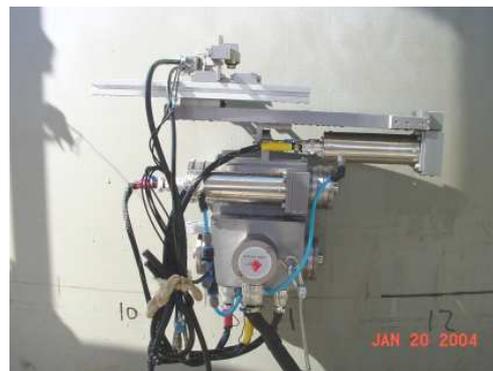
Figure 2: scanner inspecting a vessel

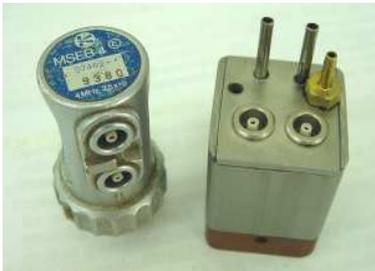
Figure 3: top of transducers

- Two openings to deliver oil at 5 psi for coupling sound and for cooling
- Compressed air – one inlet for 5psi air and an outlet hole
- Two Lemo connectors to transmit and receive signals

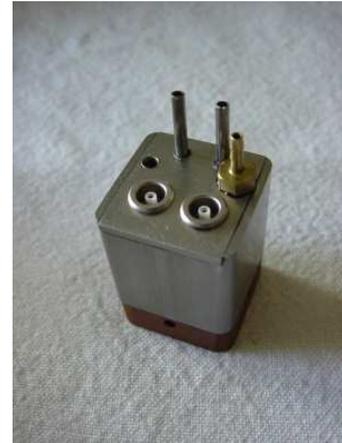
Figure 5: top of HT transducer

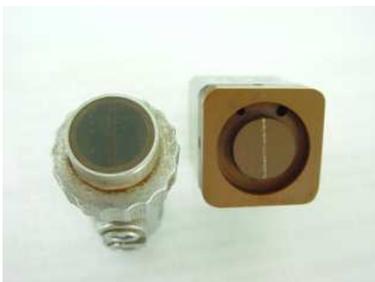
Figure 4: bottom of HT transducer

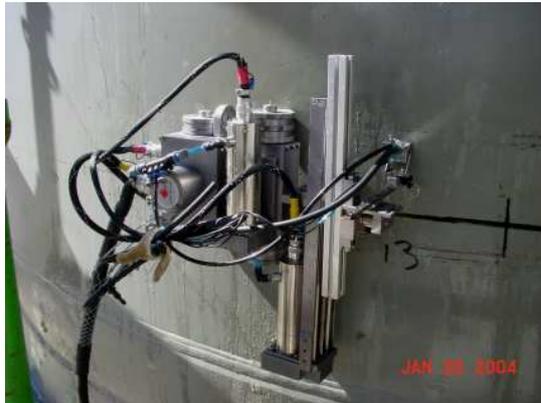
Figure 8:  
scanner  
inspection  
vessel

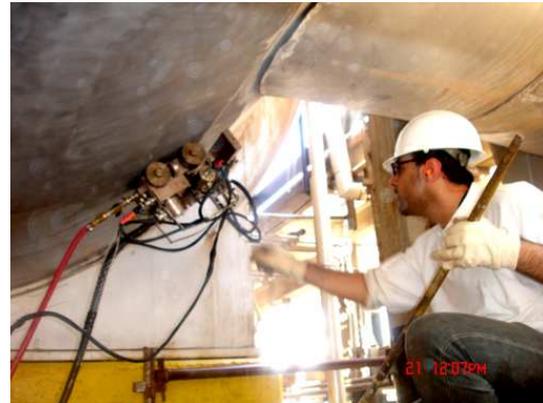
Figure 9:  
operator  
adjusts

the scanner
