HOW TO DEFINE INSPECTION PROCESS THROUGH SIMULATION

- Straddle root blade fitted LP row 1 Komati set 8 & 9
- Straddle root fitted originally
Ingagane 1-5 Komati 4 -5 , Hendrina 1-10

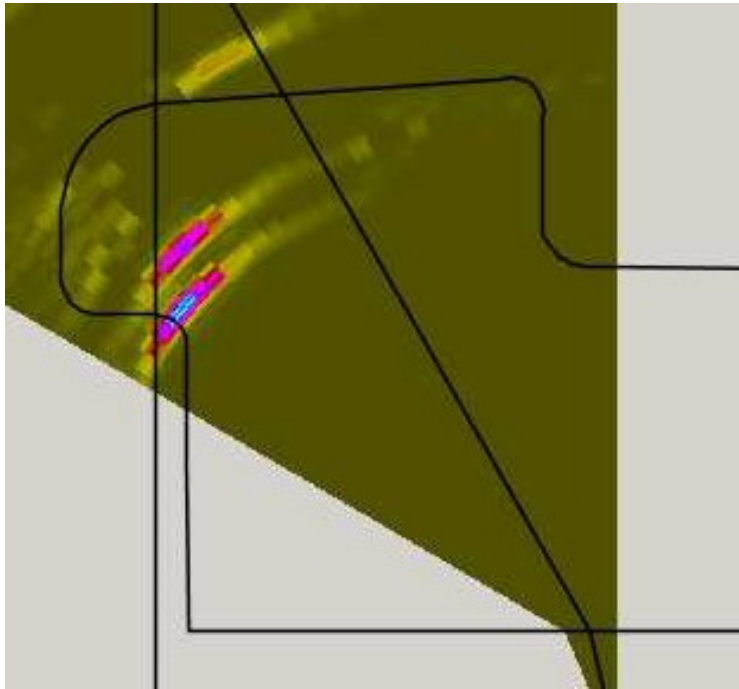
Twin Phase array probe

Echo type	Amplitude (% of screen)
Diffraction	5
Specular	weak
W edge	weak
