SELECTION OF THE OPTIMUM NDT METHODS FOR DETERMINATION OF STEAM BOILER REMAINING LIFE

N.G. Orfanoudakis¹, K. Krallis²

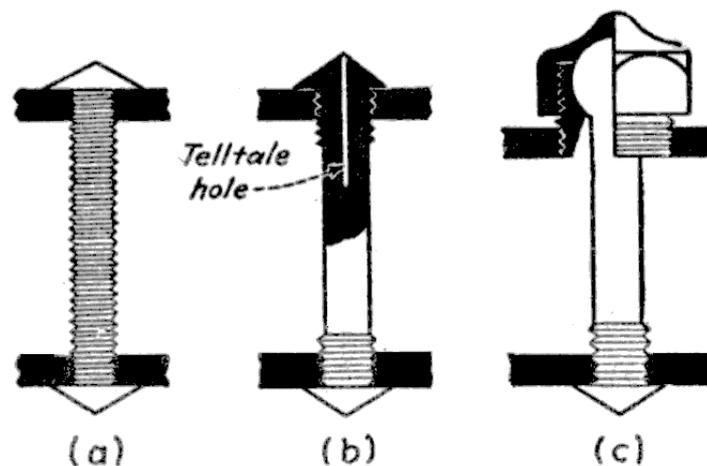
Fig. 1: Special technique to detect cracked staybolts [10].

<i>Staybolts</i>	<i>Cracks after repeated stress cycling</i>	<i>Visual, acoustic emission</i>

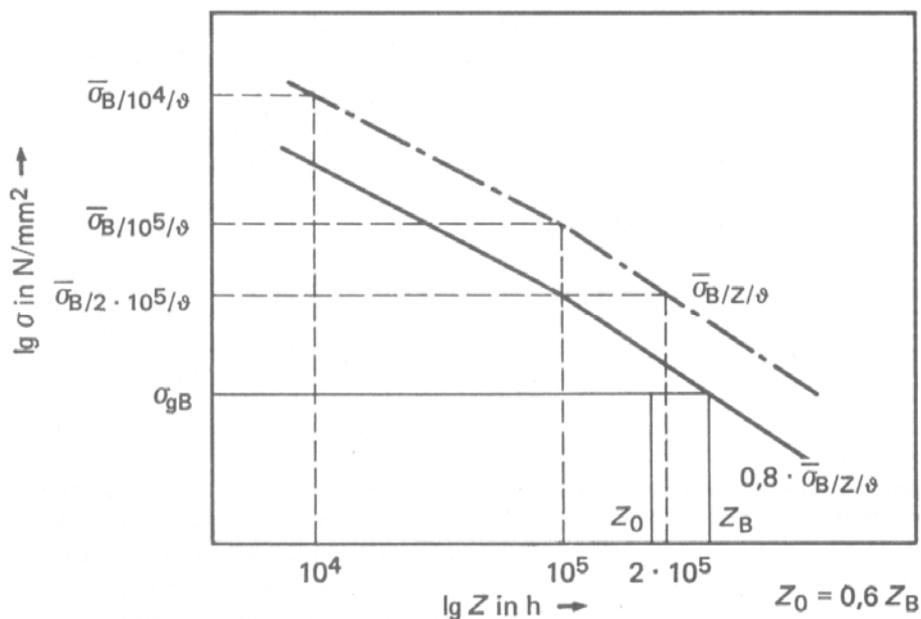
Fig. 2: Long term high temperature creeping stress values – TRD 801 Anl. 1 [7].

A special type of flaw appears at the hottest parts of the steam boiler, mainly the superheater and reheater tubes. The flaw consists of plastic deformation that occurs over a long time interval after application of the load and is described as “high temperature creeping”. All boiler design codes (including EN 12052-3) pay special attention to this problem and specify additional strength

calculations. Types of steel used for boiler construction (boiler plate to EN 10028-2, tubes to EN 10216-2 and EN 10217-2) have specified high temperature creeping characteristics. These characteristics (stress for creep failure after 10000, 100000 or 200000 hours) can be used to calculate the remaining life of the boiler, based on its record, i.e. the length of time it has operated at a given pressure induced stress. The procedure is detailed in EN 12952-4. Briefly we present the qualitative diagram from TRD, which gives a qualitative view of the allowable stress for prolonged high-temperature service as a function of expected operational time (Figure 2).

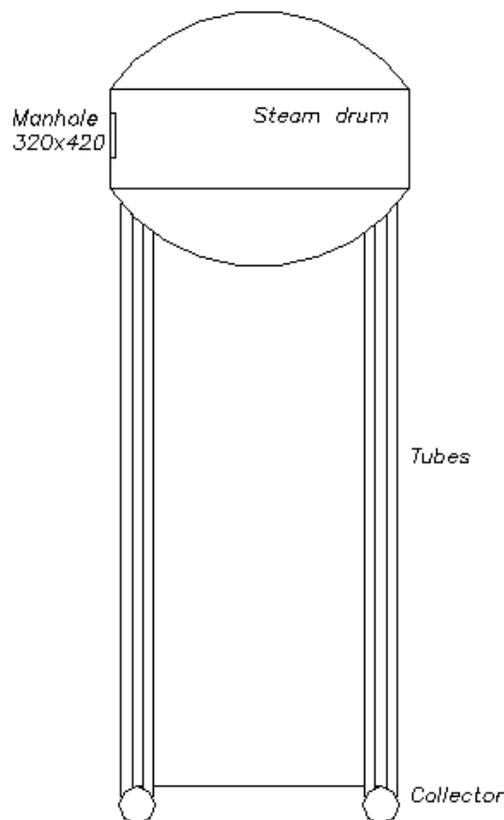
Fig. 3: The Rheinstahl – Henschel IK 5-12 IS boiler.

The existing old steam boiler at G. Keranis Tobacco S.A., Piraeus is a special type of water tube boiler with vertical tubes (Rheinstahl – Henschel IK 5-12 IS). Its basic configuration is shown in Figure 3.

Boiler specification is 5 t/h of saturated steam at 12 bar(g). The tubes are arranged in two concentric rings and are made of St 35.8 steel (DIN 17175). The space between the two rings and between the outer ring and the insulated wall is not accessible. The tubes support the cylindrical drum at their top. Water is fed to the tubes by natural circulation.

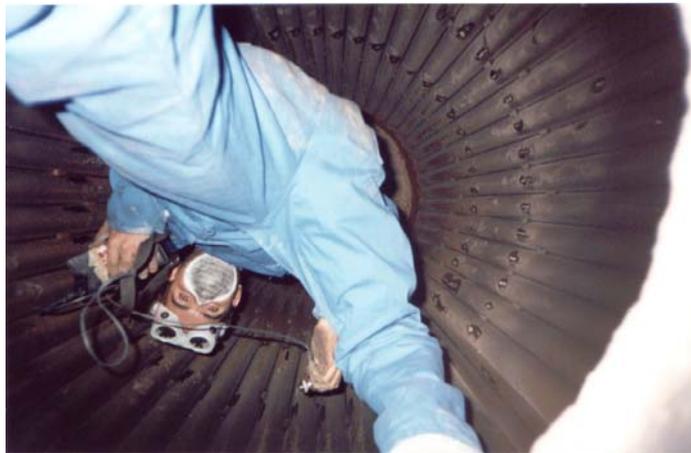
Fig. 4: Ultrasonics thickness measurement of tubes.

- All tests were scheduled for only one day (Sunday)
- The burner was removed.
- The water space was emptied and left to drain out and dry.
- All accessible steel surfaces were visually inspected in order to identify signs of erosion and corrosion.
- The wall thickness of each water tube of the inside ring was determined at three locations with ultrasonics (Figure 4).

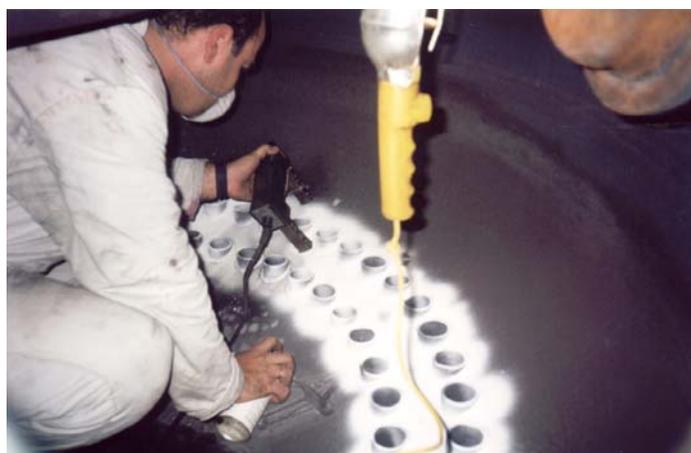
Fig. 5: Examination of tube-to-drum joints using magnetic particles.

- The wall thickness of water tubes near the flue gas outlet was also determined with ultrasonics.
- The welded joints of the water tubes to the steam drum were examined with magnetic particles (Figure 5).
- The welded seams of various nozzles at the top of the steam drum were examined with liquid penetrants.

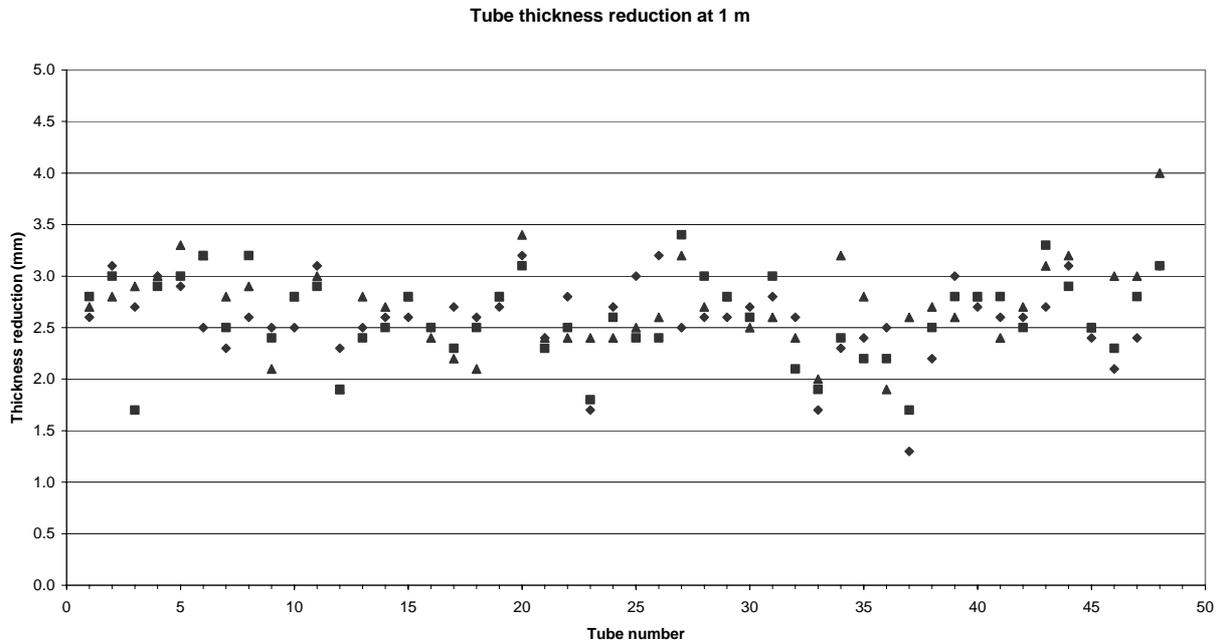
Fig. 6: Tube thickness reduction at 1 m above collector.

The measurements of tube wall thickness (a total of 144 individual measurements) were imported to a spreadsheet for statistical calculations and production of graphs.

- All welded seams (including 104 joints of tubes to the steam drum) were in perfect condition after 27 years of operation including daily cycling.
- The tubes of the inner ring had suffered from uniform corrosion and erosion of about 38% their initial thickness (Figures 6 and 7).
- The tubes of the outer ring near the flue gas outlet had suffered from intense corrosion and at some locations the thickness loss was over 50%. This effect was attributed to the high sulfur content of the fuel during the early years of operation
- The remaining life at de-rated pressure of the boiler was estimated to 5 years.

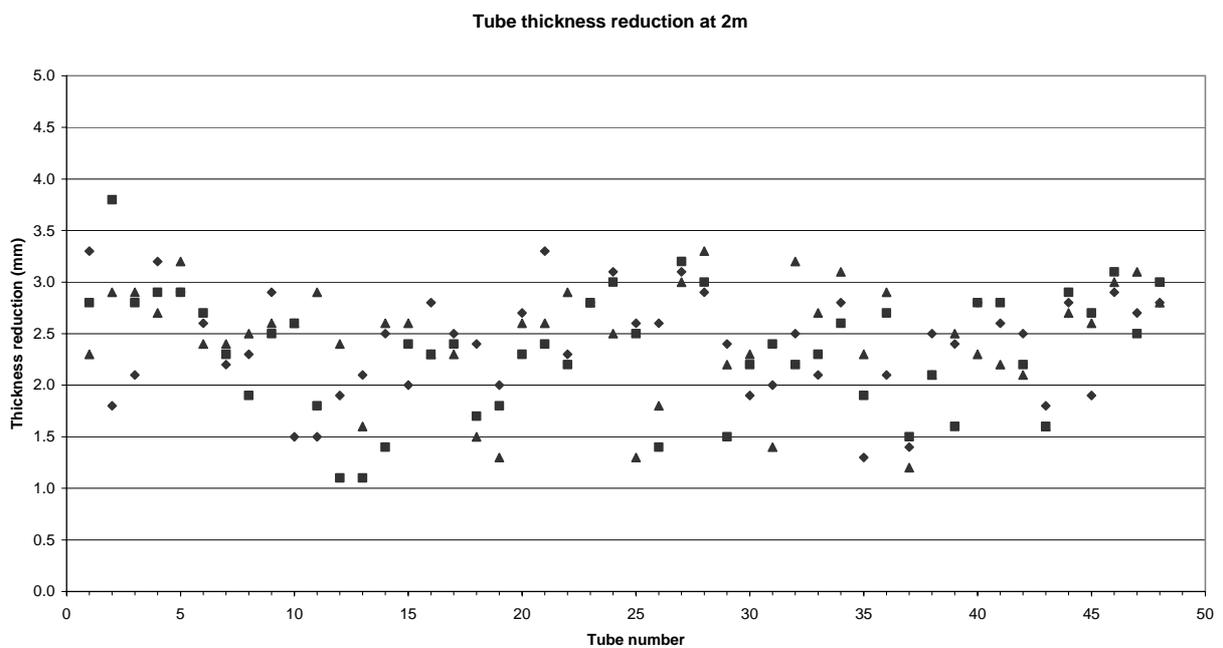
Fig. 7: Tube thickness reduction at 2 m above collector.

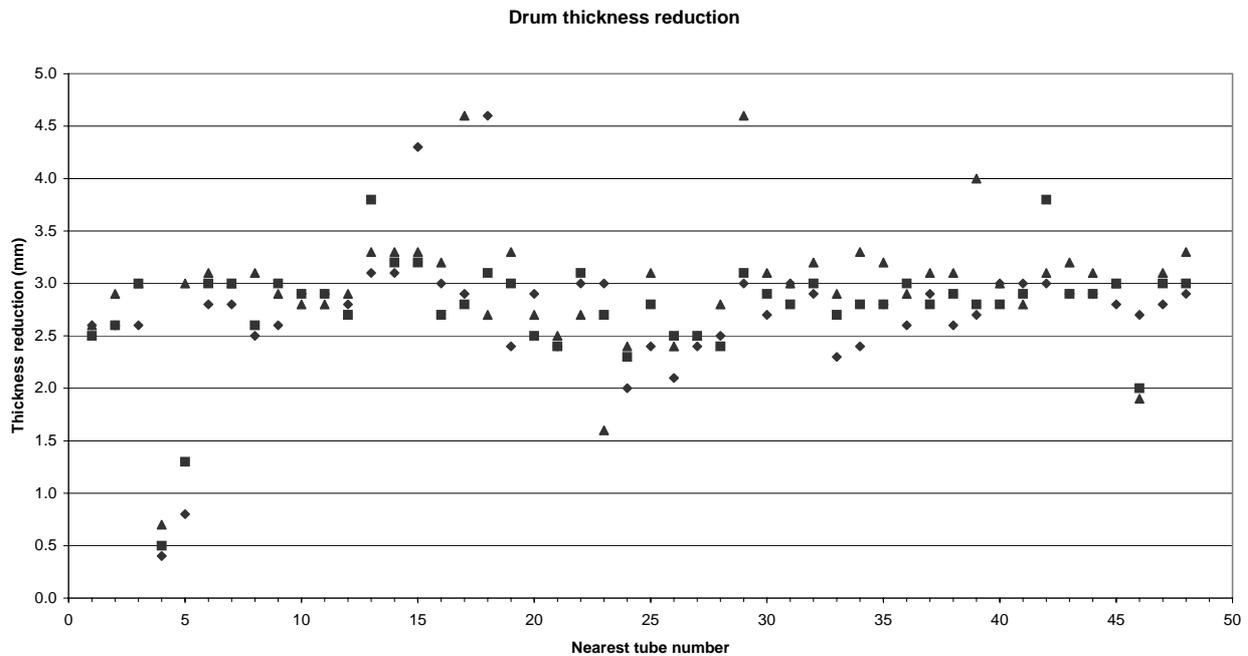
Fig. 8: Drum thickness reduction.
