An analysis of the guided wave patterns in a pipe by a magnetostrictive sensor technique

Yong-Moo Cheong*, Shin Kim, and Hyun-Kyu Jung
Nuclear Material Research Center, Korea Atomic Energy Research Institute
Yusong P. O. Box 105, Daejeon, 305-600, Korea
Telephone: +82-42-868-8091
Telefax: +82-42-868-8346
E-mail: ymcheong@kaeri.re.kr

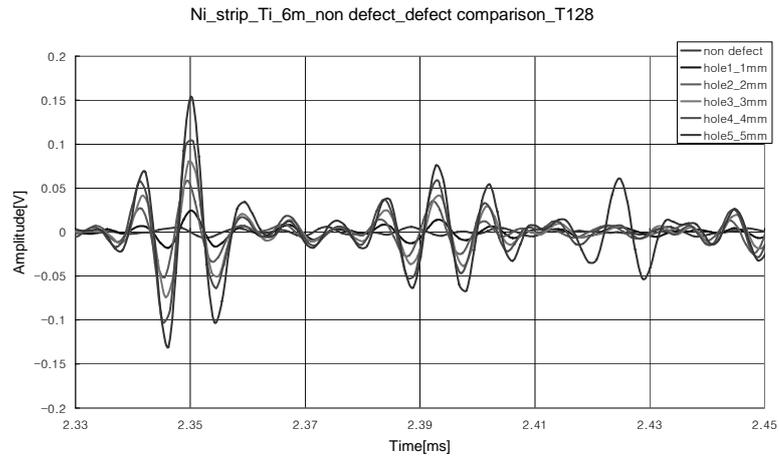
Fig. 1 Comparison of waveforms of various defect sizes with Ni strip sensor. The number of holes is from 0 to 5 at the distance of 3.5 m from the tube end.

Fig. 1 shows the ultrasonic waveforms obtained from the various holes in the titanium tube by a Ni strip sensor. Because of the strip sensor location from the tube end, multiple beam paths are possible, as shown in Fig. 1. There is almost no change or distortion in the waveform structure, except for a variation of the amplitude. The signal amplitude increases, as the number of holes increases from 0 ~ 5, i. e. as the defect size increases and a linear relationship is proposed, as shown in Fig. 2. Based on the signal amplitude by three times the noise level, the detectability of this experimental condition was determined as approximately 0.5% CSA.

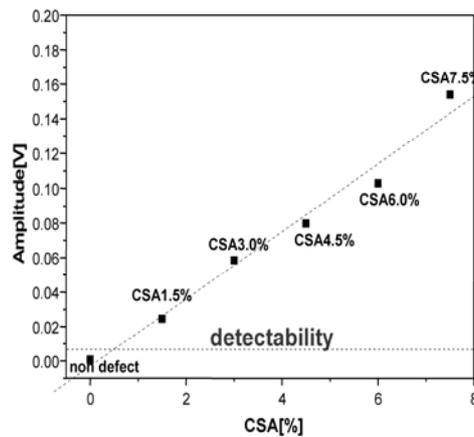
Fig. 2 A plot of amplitudes of various defect sizes with a Ni strip sensor. A detectability was determined based on the three times of the noise level.

It is also noted that there is no change or distortion of the waveform structure, except for a variation of the amplitude. The signal amplitude increases, as the number of holes increases from zero to five, i. e. as the defect size increases and a linear relationship was proposed, as shown in Fig. 2. The detectability is estimated based on the signal amplitude by three times the noise level and determined as below 0.5% CSA. Because the Fe-Co-V alloy strip is used in the in-bore guided wave probe, a higher amplitude is estimated compared to the Ni strip sensor, which results in a good signal-to-noise ratio.

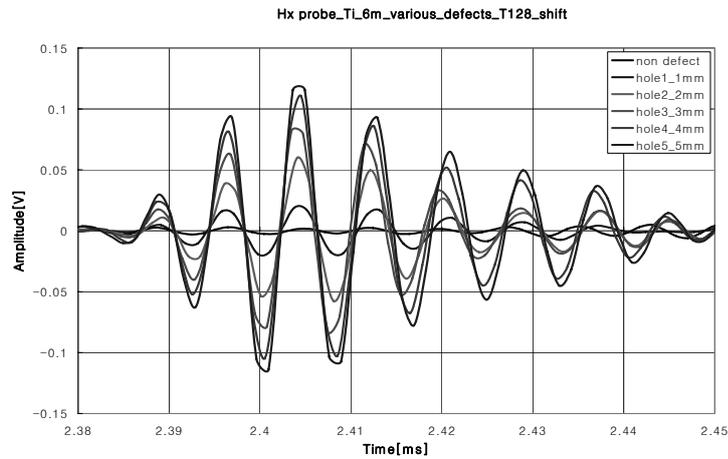
Fig. 3 Comparison of the waveforms of various defect sizes with an in-bore guided wave probe. The number of holes is from zero to five at the distance of 3.5 m from the tube end.

Fig. 3 shows that ultrasonic waveforms correspond to Fig. 1, but from an in-bore guided wave probe. The waveform structure is more complicated. We believe the complicated waveform is due to the multiple array structure of the probe.

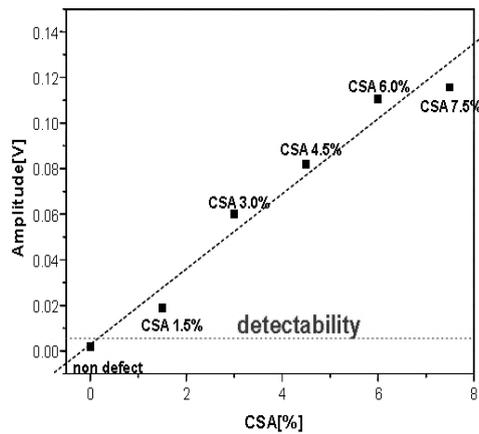
Fig. 4 A Plot of the wave amplitudes of various defect sizes with an in-bore guided wave probe. A detectability was determined based on the three times the noise level.

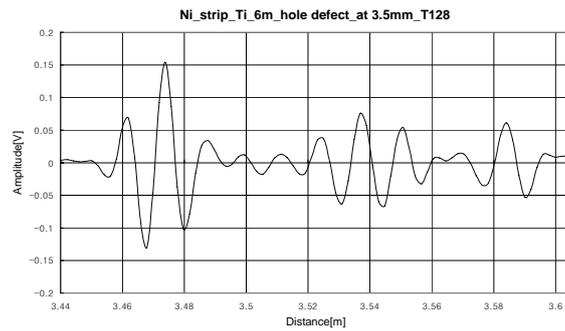
Fig. 5 Typical waveforms by a Ni strip sensor.

Figs. 5 and 6 show a typical wave pattern by a Ni strip sensor and an in-bore guided wave probe respectively. As mentioned earlier, the signal pattern in Fig. 5 from the Ni strip sensor is very clear and simple. These signal characteristics can be a potential indicator for a structural health monitoring (SHM) in a pipe experiencing degradation and the evolution of a defect or aging after a performance demonstration, such as a high temperature endurance test.

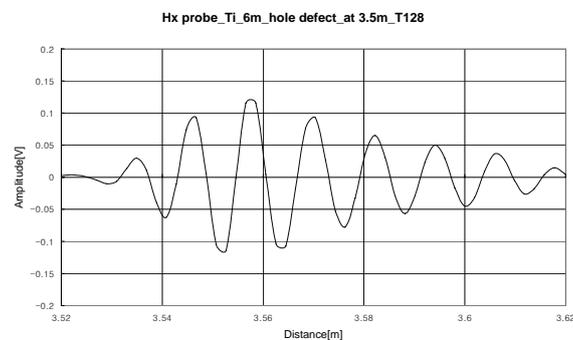
Fig. 6 Typical waveforms by an in-bore guided wave probe.
