## Application of the ultrasonic transmission tomography for inspection of the petroleum tank floor

R. Raišutis, R. Kažys, L. Mažeika, R. Šlīteris

Ultrasound Institute, Kaunas University of Technology, Lithuania

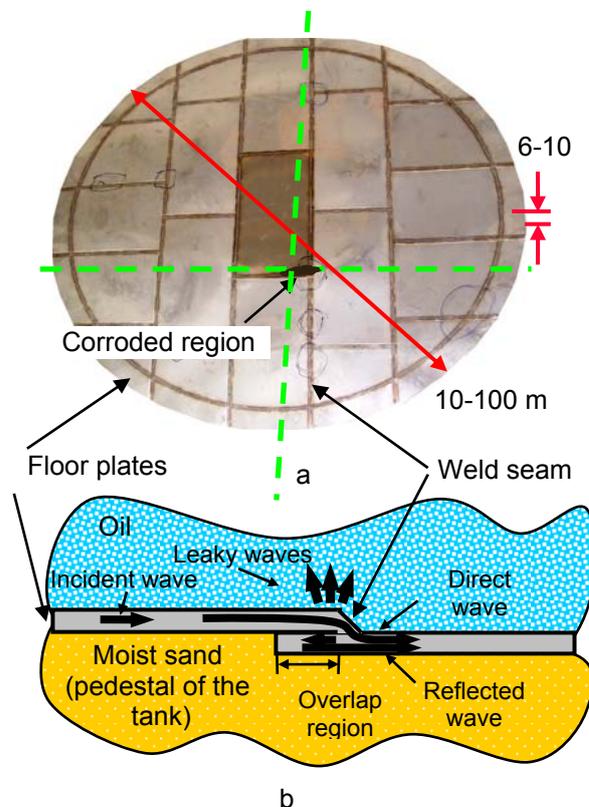
Fig.1. The typical geometry of a tank floor (a) and the model of Lamb wave propagation through a lap joint weld (b)

The tank floor consists of the set of steel plates having thickness 6-8 mm joined together using lap welds and may have the diameter up to 100 m (Fig. 1(a, b)). The guided waves propagate in planar structures such as plates or

where  $H_{plate}(j\omega, x)$  is the complex transfer function in a through transmission mode of the loaded steel plate of an arbitrary length  $x$ ,  $H_{weld}(j\omega, m)$  is the complex transfer function in the through transmission mode of a single weld with the wave propagation path in the welded plates (loaded by diesel and moist sand) equal to 1 m,  $j = \sqrt{-1}$ ,  $U_{ref}(j\omega)$  is the Fourier transform of the reference signal  $u_{ref}(t)$  which is picked up by the ultrasonic transducer placed in front of the welded zone, IFT denotes the inverse Fourier transform,  $m$  is a number of the welds in the tank floor arrangement. The model of the petroleum tank bottom, which is welded by lap joints is presented in Fig.1.

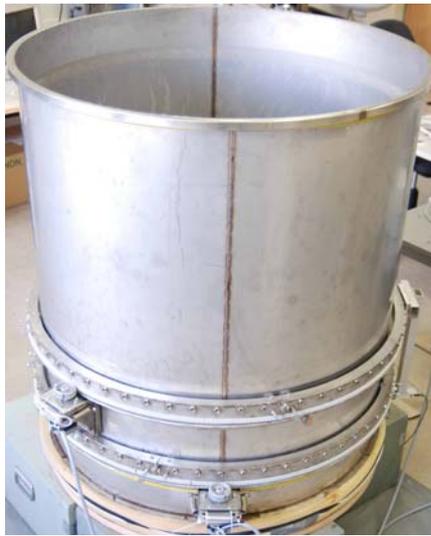
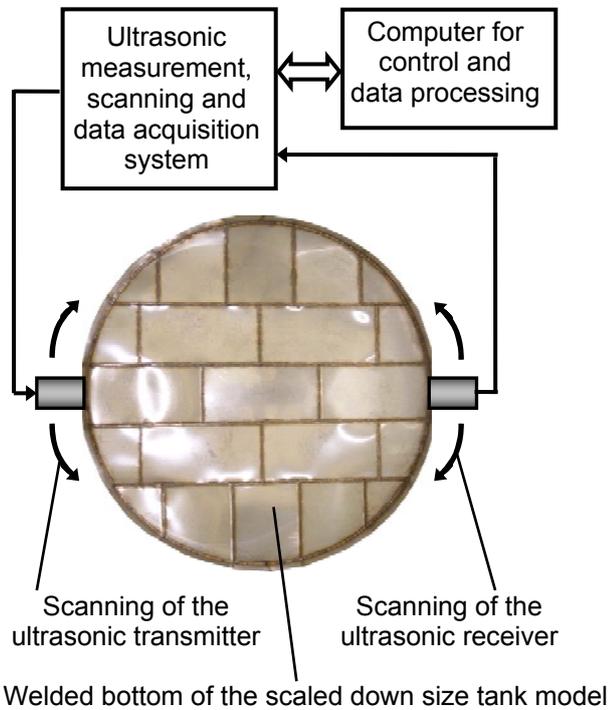
Fig.2. Photo of the 1:8 scaled down size tank mock-up (a) and the measurement set-up (b) used for investigation

For experimental investigation the scaled down size tank mock-up (scaling factor 8:1) placed on wet sand and filled with water was selected (Fig.2a). The internal diameter of the tank was 1 m, the height 1.1 m, the thickness of the floor plate was 1 mm. The experimental set-up used in the investigation and the plates arrangement of the welded floor is presented in Fig.2b.

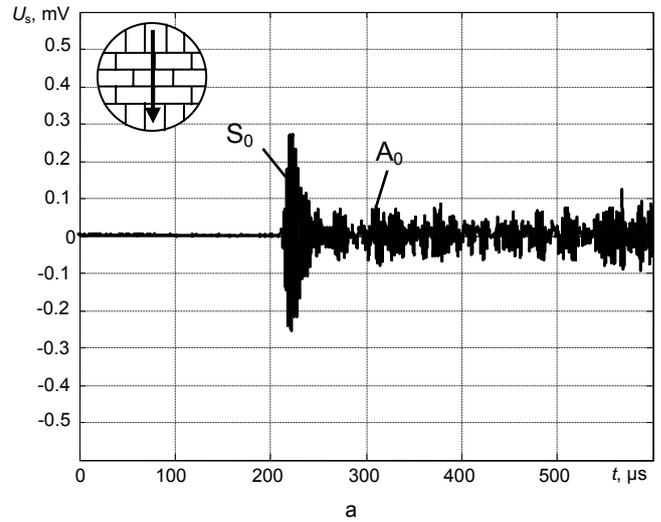
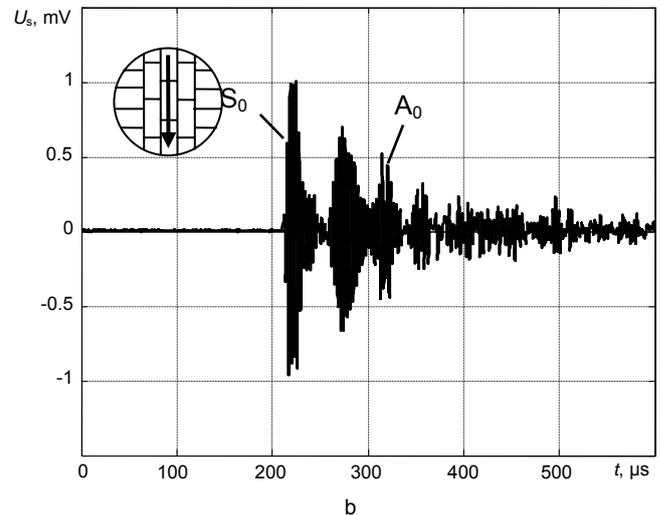
Fig.3 The examples of the received ultrasonic signals, which propagated through the welded tank floor in two perpendicular directions: a – along five welded plates, b – along three welded plates

The measured leakage losses of the  $S_0$  mode in the floor of the scaled down size tank mock-up (the diameter 1 m and the thickness 1 mm of which correspond to the diameter 8 m and the thickness 8 mm of the real tank), which was resting on moist sand and loaded by water from the top side are:  $(5.5 \pm 0.6)$  dB. The calculated losses using the global matrix method [4] are 4.7 dB (at 50 kHz, the thickness of the floor plate 8 mm and the diameter 8 m). The calculated losses using the finite difference method [4] are 6.1 dB (at 50 kHz, the thickness of the floor plate 8 mm and the diameter 8 m). The experimental verification of the  $S_0$  mode attenuation, caused by propagation through a few welds, was performed using the scaled down size physical model. A good agreement is obtained between the simulated and the measured results. The estimated attenuation of the  $S_0$  mode transmitted through a weld in the direction perpendicular to the weld seams was  $(7.95 \pm 0.76)$  dB and through the two welds was  $(15.9 \pm 1.5)$  dB (Fig.3 a). That corresponds very well to the results (7.8 dB) obtained by modeling using the finite difference method, also proves the assumption about additive transmission losses [4]. The examples of the ultrasonic signals, which propagated through the welded tank floor (as presented in Fig. 1) in two perpendicular directions, are presented in Fig.3.

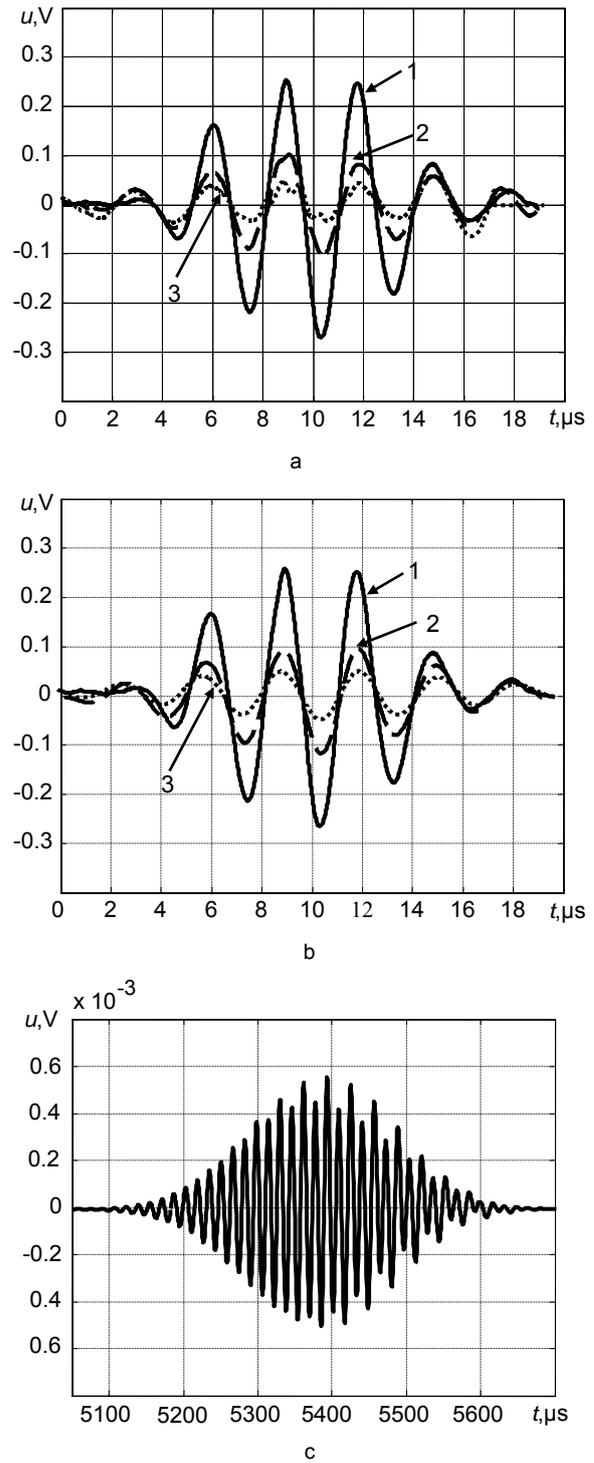
Fig.4. The measured (a) and simulated (b) waveforms of  $S_0$  mode wave in front of and behind the welded lap joint: 1 – in front of the 1<sup>st</sup> weld, 2 – behind the 1<sup>st</sup> weld, 3 – behind the 2<sup>nd</sup> weld; c – simulated waveform of the distorted signal, which has been transmitted through the structure of length 30 m of bottom plates interconnected by 11 welded lap joints.

where  $\alpha_0$  is the attenuation coefficient in dB at the frequency  $\omega_0$ , in the presented case  $\alpha_0 = (3.91 \pm 0.4)$  dB/m at  $f_0 = 66.3$  kHz,  $m$  is a number of the welds,  $\Delta\theta$  is difference between the phase spectrum of the signal picked up before the weld and the phase spectrum of the signal transmitted through a single weld,  $A$  is the amplitude of the harmonic oscillations generated by a harmonic function in order to mimic the attenuation function of the weld,  $t_0$  is the initial time shift of the harmonic function. The measured and predicted waveforms of  $S_0$  mode wave in front of and behind the welded lap joint are presented in Fig.4 a and b. These results are relevant in the case of the analysis of the broadband ultrasonic pulse propagation through the welded plates of a petroleum tank floor. For example, in Fig.4 c is presented simulated waveform of the distorted ultrasonic signal (operating frequency was 66 kHz), which has been transmitted through the structure of length 30 m of bottom plates (8 mm thickness) interconnected by 11 welded lap joints. The total losses of the ultrasonic wave transmitted through such structure have been close to 76 dB.

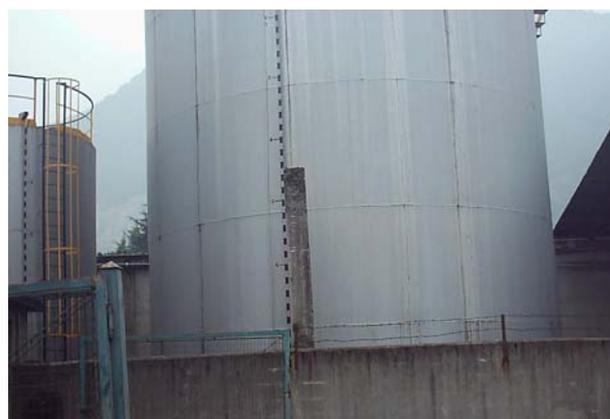
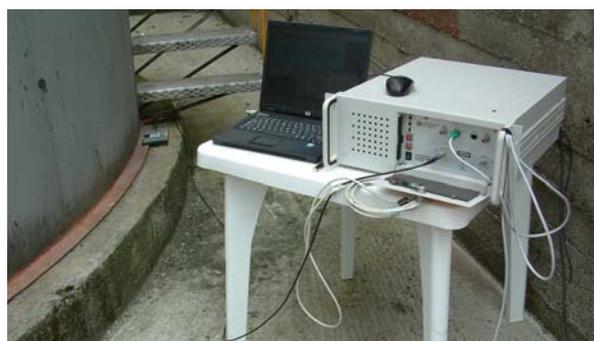
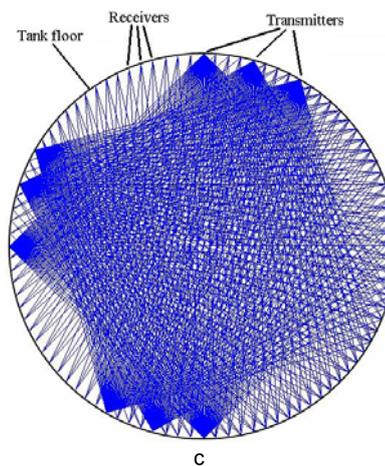
Fig.5. Application of the transmission tomography for inspection of a petroleum tank floor: a - photo of the real tank, which is necessary to inspect, b - experimental set-up, c - the transmitter and receiver positions during *in situ* experiments

In order to estimate the performance of the developed reconstruction algorithm, the experimental measurements have been carried out *in situ* on a small 8 m diameter tank (Fig.5 a), with the step 25 cm along the circumference of the tank floor. The total number of measurement points was 441. In the measurements 50 kHz ultrasonic transducers were used. The transducers were attached to the edge of the tank floor using liquid coupling and magnetic fixing. The tank floor edge was prepared in advance by grinding. For the signal excitation and reception the ultrasonic imaging system developed by the Ultrasound institute of Kaunas University of Technology was used (Fig.5 b). The transmitters were excited using the three periods burst.

In such a way the number of projections was acquired. The projection in the ultrasonic transmission tomography is assumed to be the distribution of the attenuation versus transmission direction or angle (Fig.5 c) for one transmitter position. In our case the transmitter was attached to the edge of the tank floor on one side and receivers were placed at different points on the opposite side of the tank floor covering approximately  $180^\circ$  sector. At each position from the acquired signals the relative attenuation (losses) are measured. The other projections are acquired in a similar way, only the transmitter is attached to the edge of the floor at different positions with some step from the previous one and the measurements on the opposite side of the tank in a corresponding sector are performed. In general, the tomography requires as much as possible of different projections, because the accuracy and resolution of the reconstructed images depend on the number of projections. On the other hand, the accuracy depends on the wavelength of the exploited Lamb wave. So, the optimal number of projections should be determined for each particular case. During investigations 9 tomographic projections were acquired (Fig.5 c). To increase reliability and reduce a noise at each point 11 measurements were performed.

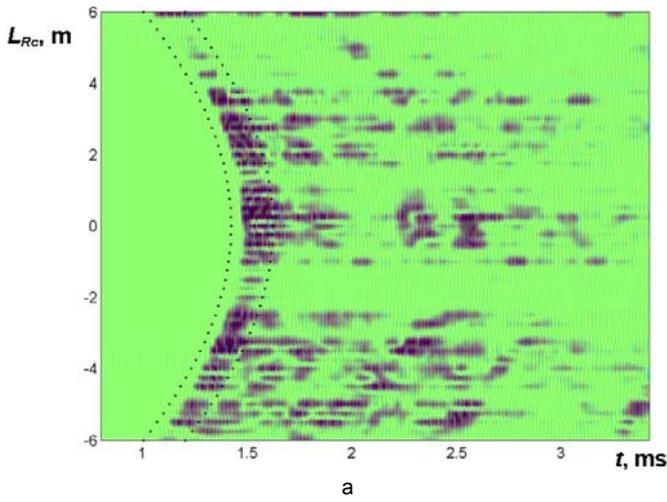
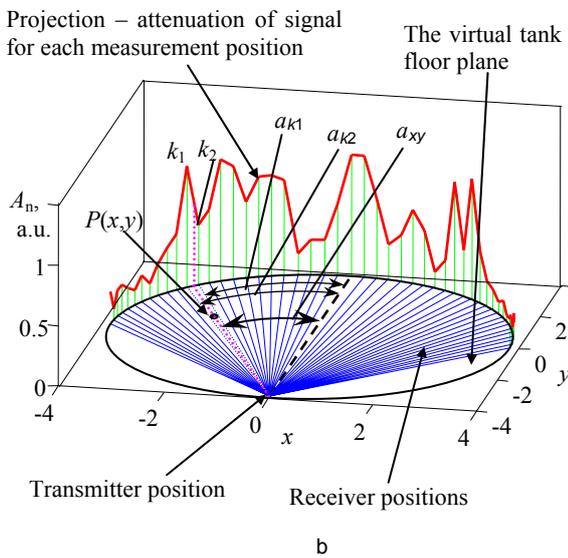
Fig.6. Information extraction from the data collected around the tank floor: a - explanation of the backprojection of the single projection in the virtual tank floor plane, b - the B-scan image of the signals measured at one position of the transmitter. Black dots denote boundaries of the time window for  $S_0$  mode selection:  $L_{Rc}$  is a distance along edge of the tank floor.

was calculated and the approximate directivity pattern was obtained. This function will be used as the projection for tomographic reconstruction of distribution of the attenuation in the tank floor (Fig.6 b). In this figure  $a_{xy}$  is the angle of the point  $P(x,y)$  under analysis with respect to the projection,  $a_{k1}$  and  $a_{k2}$  are the angles of the closest point of the projection,  $k_1$  and  $k_2$  are the numbers of the closest measured points,  $A_n$  is the normalized amplitude. The backprojections obtained from the data acquired at different transmitter positions are integrated and the final reconstructed image is obtained.

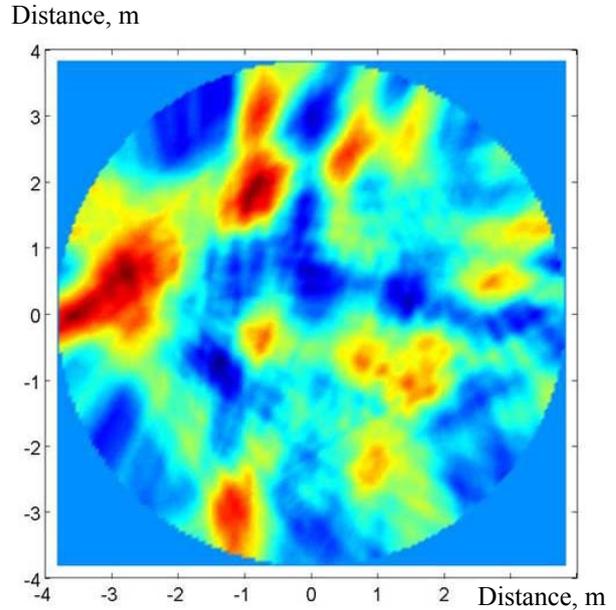
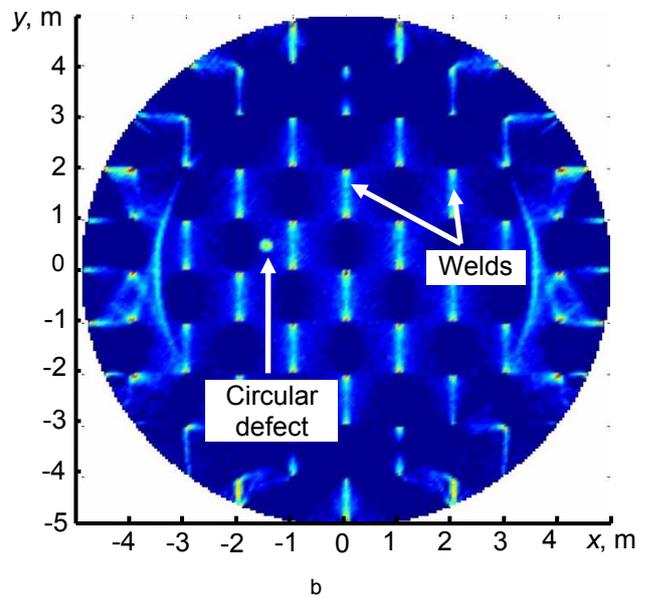
Fig.7. Spatial localisation of the tank floor non-uniformities by ultrasonic transmission tomography: a - ultrasonic image of the petroleum tank floor reconstructed from the experimental data. The areas of the intensive colour correspond to the zones with an essentially higher attenuation of the  $S_0$  mode Lamb wave, b - reconstructed ultrasonic image of the petroleum tank floor with a circular defect (from simulated data)

The experimentally obtained spatial distribution of the attenuation of propagating Lamb waves in the floor of the real tank is presented in Fig.7 a. The darker areas correspond to the zones with a higher attenuation of  $S_0$  mode Lamb waves, what is correlated to large corroded areas. The resolution of the presented image depends on the number of projections used in the tomographic reconstruction.

In order to estimate the performance of the reconstruction algorithm, the tank floor with the diameter 10m and having the overlapped welds as presented in Fig. 1 was simulated. The tomographic projections were obtained calculating the total attenuation along different chords of the tank floor. It was assumed that there is the 0.5dB/m attenuation due to leakage and 8dB losses on each weld. The total losses across the tank vary in the range 75-100dB depending on a chord angle. The artificial circular defect with the diameter 10mm was inserted close to the

tank floor centre. It was assumed that it causes the 4dB losses of the Lamb waves transmitted around it. The reconstructed image of the non-uniformities in a tank floor is presented in Fig.7 b. The positions of all welds are seen precisely. The absence of horizontal welds can be explained by specific features of the reconstruction algorithm and the fact that these welds are linear across the whole tank floor. The exact position of the defect can be seen precisely as the bright circular spot in the image.
