Practical application of non-destructive test methods at a single-shell tunnel lining

As a sophisticated case, a 2550m section of a power tunnel concrete liner in Nepal was inspected with non-destructive test methods. The specific feature of the power tunnel were its challenging boundary conditions: constructed as single-shell tunnel, layer identification was complex; a synthetic foil for sealing, which usually acts as impedance contrast between grout and sprayed concrete, did not exist; the lining was not cast with watertight concrete and was therefore accordingly wet.

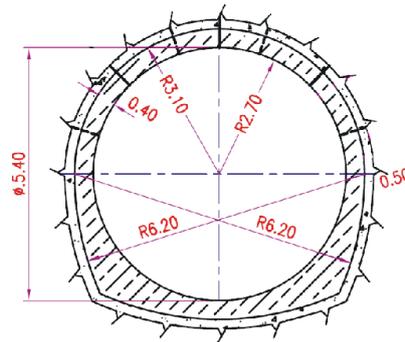
The excavation of the 5230m long headrace tunnel was accomplished by drill and blast method at 6.4 m diameter. It was designed as single-shell construction. Hereby, 'single-shell' describes a tunnel where the outer shell (sprayed concrete) acts in bond with the inner shell (sprayed or poured concrete). Unlike, a double-shell tunnel holds a geomembrane and a synthetic foil between the two shells. This is the by far mostly used construction method, simply because of the demand for a 'dry' tunnel.

Figure 1: Headrace tunnel cross-section

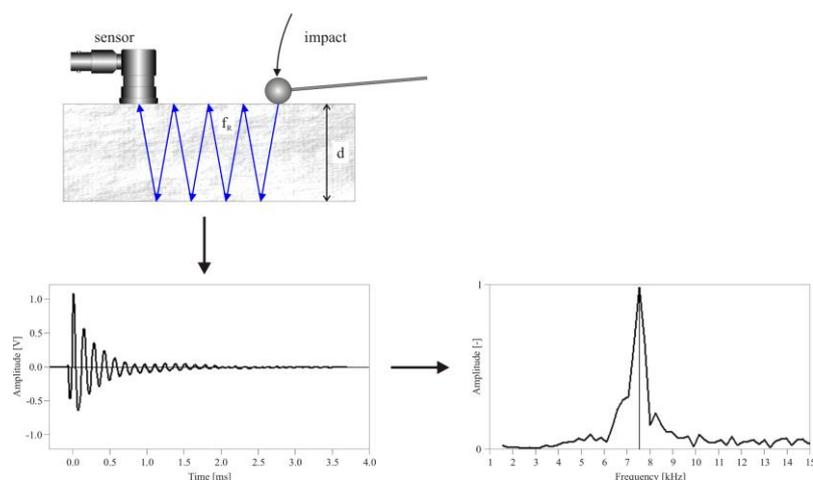
The idea of the Impact - Echo method is to send an acoustic signal into the test specimen and record the reflection from internal flaws, material layers or other interfaces. By analysing the reflected signal, conclusions about the depth of the reflecting surface can be drawn (Figure 2).

The acoustic signal is commonly produced by the mechanical impact of a steel sphere, mounted on a spring-steel rod, the impactor. When the so produced elastic stress wave travels through the specimen and encounters an interface, part of the wave energy is reflected. Multiple reflections between the interfaces excite local modes of vibration, corresponding to the depth's resonant frequency. On the surface, the displacement is recorded by a sensor and transmitted to a computer. Transforming the obtained voltage versus time signal into the frequency domain leads to a plot of amplitude versus frequency.

Figure 2: Impact Echo method scheme

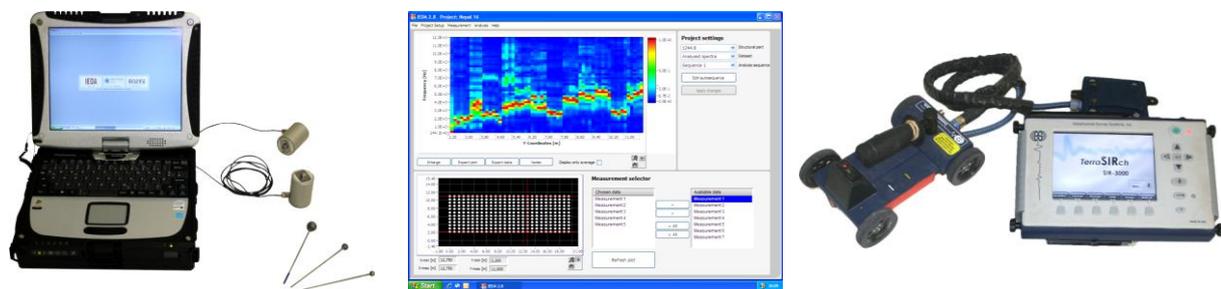
Figure 3: MPA Stuttgart IE device, IEDA 2.30 software and GSSI GPR system

Overall, a tunnel length of 2550m had to be tested, resulting in 24000 measurement points. Assuming a time of one minute per point for marking and measuring, the total time needed was calculated to be 400 hours. This was proven to be quite accurate. The system used for recording and analysing the signal was IEDA 2.30, self-developed by the MPA Universität Stuttgart (Figure 3). The Ground Penetrating Radar was acquired from Geophysical Survey Systems, Inc. (GSSI). Employed was a SIR-3000 control unit with a Model 5100B, 1.6GHz antenna.

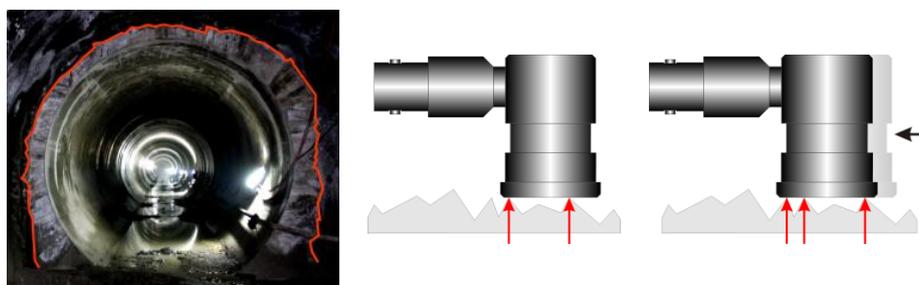
The undulated layer surfaces, as seen in Figure 4 (left), made it virtually impossible to directly compare neighbouring measurement points and thus to verify the results on site. It also prevented a calibration for sound velocity near points with known depth. To solve this problem, a total of 12 concrete cores over the entire testing length of 2550m were drilled. The sound velocity was found to be in a range from 3370 m/s to 4190 m/s. This resulted in a depth accuracy of $\pm 4\%$ from velocity uncertainties only.

Figure 4: Theoretical and actual lining thickness, different sensor couplings

During the trial measurements it became clear, that coupling the sensor to the concrete surface would pose certain difficulties. Due to the efflorescence, the surface was very rough in vast areas, often the concrete was completely covered. The sensor's 20mm diameter bearing area contributed to the coupling problem. A small change in location or excitation could have altered the results (Figure 4, right). Therefore, at least 5 measurements were taken at each point to be able to identify outliers.

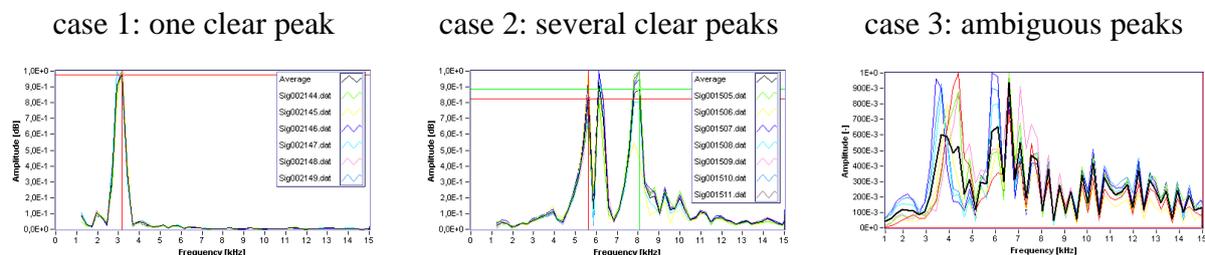
Figure 5: FFT categories

This case was generally associated with a sound structure. It often came along with only a low amplitude signal (0.2 to 0.8V), although not exclusively.

- A layered system with distinct surfaces. Those could for instance be the known interfaces concrete/grouting, grouting/shotcrete or shotcrete/rock.
- A small void, which partly reflects the incoming and diverts the ongoing wave. In a standard IE test, this could be verified by comparison with the surrounding points. Verification was not possible here.
- Multiple reflections from vertical cracks, grout- or drainholes can also be a reason for several clear peaks. This can be cross-checked with the on-site documentation, provided that the obstructions were visible on the surface.

A sign for honeycombing inside the structure or a diffusive reflection horizon is a multiple peak FFT. Not only does honeycombing scatter the p-wave as shown, but also decrease the frequency of deeper reflections. Diffusive reflections at rough interfaces can deflect the wave to a point, where the recorded return signal amplitude vanishes behind the noise level. Hence, a definitive statement about the lining thickness is not possible.

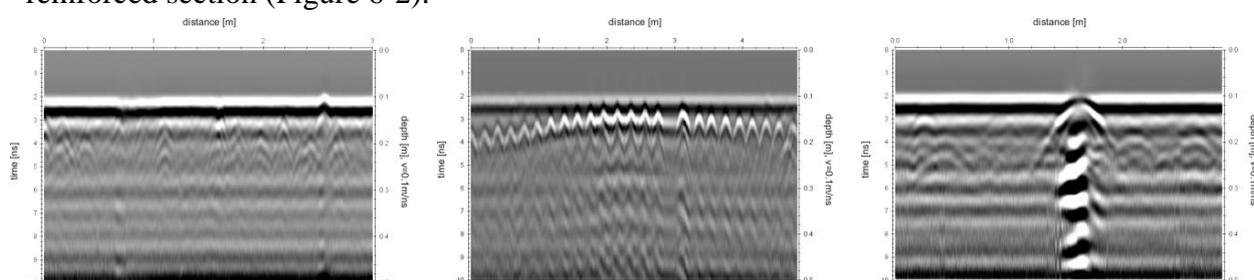
Several testing runs were performed with the GPR. The in-situ groundwater had soaked the tunnel lining and thus heavily decreased the penetration depth. In parts, the usable depth range was well below the aim of 40cm and thus did not have the required reliability to test the whole tunnel lining. Additionally, concrete-grouting boundaries with little difference in electrical impedance can hardly be detected. The idea to see the steel fibre reinforced sprayed concrete also did not prove to be serviceable most sections (Figure 6).

Much avail on the other hand did the GPR have to identify acoustically detected delaminations as remains of the concreting pipe (Figure 6-3), as well as for scans in the reinforced section (Figure 6-2).

Figure 6: GPR outputs

Figure 6-2 is a GPR scan in radial direction. It is clearly visible, that the concrete cover of the inlaid reinforcement decreases towards the crown. A following open cut confirmed a concrete cover of only 5mm.

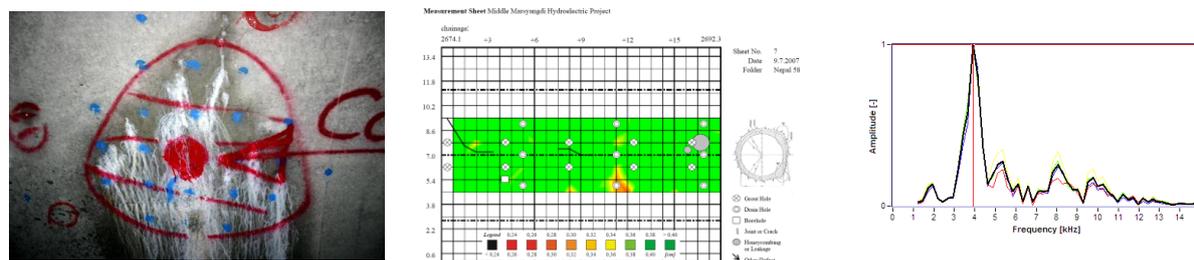
Noticeable leakage on the tunnel lining at chainage 2691 called for a concrete core. From the leakage alone, a badly compacted concrete was expected, which was proven right (Figure 8). However, a close IE examination of the borehole location prior to the drilling did not reveal any major voids. An interface was expected at around 49cm according to the obtained FFT (Figure 7).

Figure 7: Core location at chainage 2691, corresponding measurement sheet and FFT from the centre point

The drawn concrete core disclosed a void at about 34cm between concrete and sprayed concrete. An IE measurement assigned the present concrete a wave speed of 3510 m/s, which would require a peak between 4.8 to 5.2 kHz for the void. The FFT in Figure 7 inherits a matching peak, but it would have never been picked as ‘critical’. On the measurement sheet for the area under consideration, the leakage was marked, but the structure was considered sound with a depth of greater than 40cm.

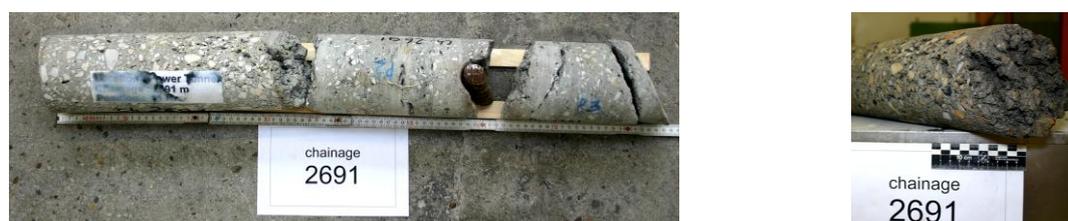
Figure 8: Concrete core from chainage 2691

A plausible explanation for this phenomenon is, that the void was very limited in its lateral dimensions. The sound had to travel around the flaw to be reflected at 49cm, where close examination revealed an enclosed grout layer. Going back to the general limitations in 2.1, two values were given for detectable void sizes. The minimum lateral extensions are the bigger of 14 times the sphere diameter or 1/4 of the depth. This would be 126mm or 113mm respectively. With a core diameter of 100mm, it is possible, that the present void was smaller than the required dimensions.

Other than that, the concrete back surface of core 2691 is heavily fragmented. It does not form a face, from which the waves can be clearly reflected back to the sensor. They are more scattered than at the boundary in a depth of 49cm. Additionally, in this special case, two effects of the IE method interfere with each other. More shallow voids trigger higher resonant frequencies. However, those high frequencies are more susceptible to absorption and diffusion than lower ones. In case of a sound overlay this is not critical, whereas in the case at hand with porous concrete, the high frequencies hardly reach the surface again. This is confirmed by the low return signal amplitude of 200mV.

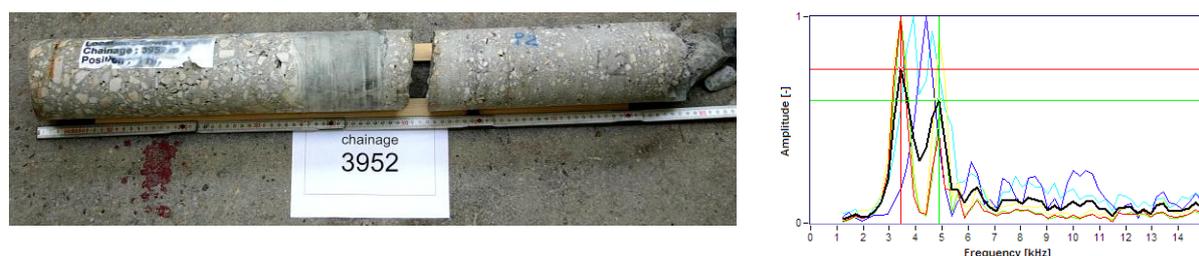
The second example refers to the concrete core from chainage 3952. The case 2 FFT (Figure 9) pointed towards a layered structure. The location for the core was picked to calibrate the sound velocity.

Figure 9: Concrete core from chainage 3952 (left is inside) and corresponding FFT from the centre point

A verification of the IE measurements was possible with the drawn core. The FFT peaks are at 54.2cm and 37.9cm. Compared to the interfaces in the concrete core at 37cm and 52cm (Figure 9), the results are within the stated accuracy of $\pm 4\%$. The interface at 48cm is not visible in the FFT, which is evidence for a good bond between the two layers.
