LASER-BASED NDT OF TITANIUM AIRCRAFT ENGINE COMPONENTS

J. Doyle Jr and M. J. Brinkman

Laser Techniques Company, LLC, Bellevue, USA

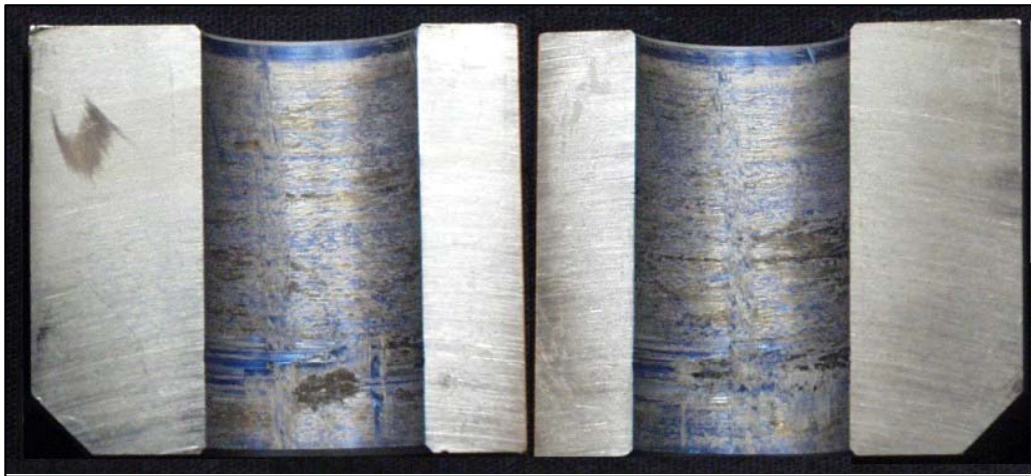
Figure 4. Photograph of inner surface of sectioned titanium sample

This Preliminary Feasibility Study was directed toward the application of the LVI method for the detection of metallurgical anomalies such as parent metal smearing (re-deposition), lapping and metallurgical changes that have been highlighted using the blue acid etch process. All of these features create unique scattering of light and/or preferential reflection of certain optical wavelengths. For example, Figure 4 shows a photograph of a sample (provided by Volvo) that clearly has three types of features: blue, dark grey and an edge from a smear or lap.

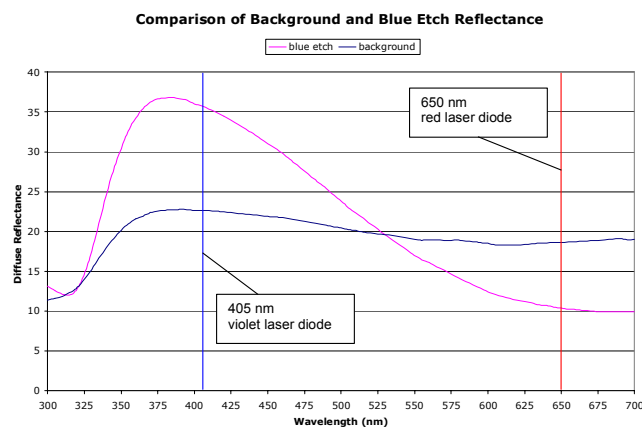
Figure 5. Spectroscopic analysis of titanium sample.

Experimental Setup: Spectroscopic reflectance analysis of the samples provides helpful insight into the spectral properties of the machined surface. Tests were conducted to determine the comparative reflectance of the blue features (from overheating and BAE) and the background as a function of wavelength. The results are shown in Figure 5 below. The grey background of the samples reflects consistently over a wide range of wavelengths, but the blue features reflect more strongly for short wavelengths (350-450 nm) than for long wavelengths (>600 nm). This analysis suggests that a two-wavelength approach could result in high contrast for differentiation of blue features from those generated by laps, scratches or smears.
