USE OF THE TOTAL STATION FOR SERVICEABILITY MONITORING OF BRIDGES WITH LIMITED ACCESS IN MISSOURI, USA

W. Merkle¹, J. J. Myers¹

¹ Center of Infrastructure Engineering Studies (CIES), Department of Civil Engineering, University of Missouri-Rolla, Rolla, MO 65409, USA

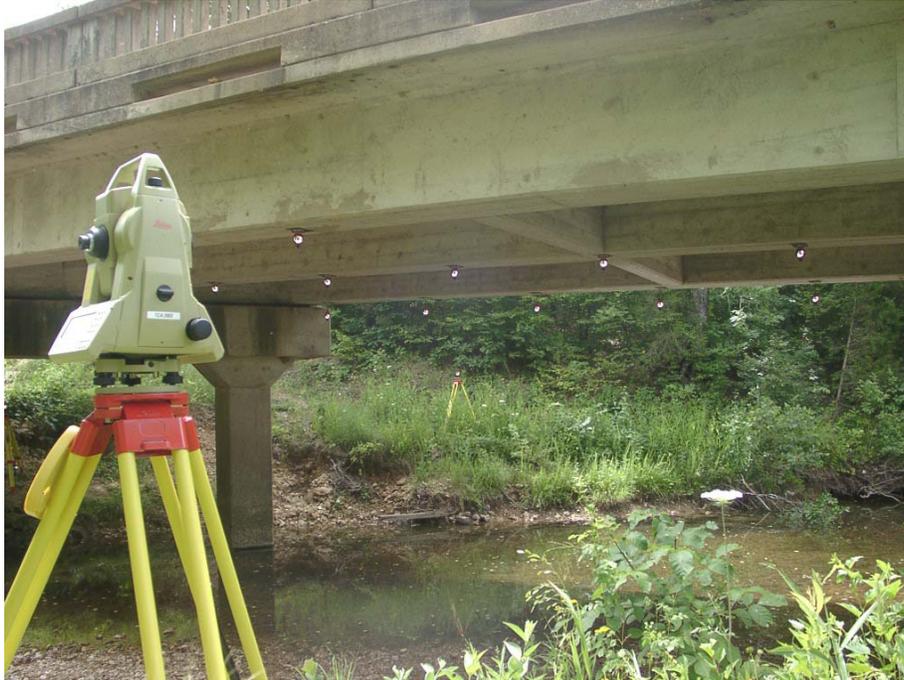
Figure 1: Leica TCA 2003 set up for Load Testing

Traditional land surveying techniques utilized many components, with the Total Station as the principal device. The total station (Figure 1) was set atop a secure tripod in a location with an unobstructed view of the field targets. Reference points (Figure 2), or backsites, were set in place to transfer a horizontal angle or an elevation from the reference point to the total station, and then from the total station to the targets (Figure 3). The reference points also served to check that the total station had not moved. The reference point was simply a prism mounted atop a secure tripod; the targets were simply prisms fixed atop a metal rod (range pole). In the case of load testing, the prisms were fixed to points on the tested structure.

The total station obtained three-dimensional coordinates of every target by measuring a horizontal angle, vertical angle, and distance between points. The Leica TCA 2003 [3] could measure angles accurate to 0.5 arc-seconds ($1/7200$ degrees) and distances to nearly 1 millimeter, depending on atmospheric conditions. With a horizontal angle, vertical angle, and distance – coordinate geometry was used to transfer three-dimensional coordinates to a target. The total station automatically recorded the coordinates with a point number, point description, date, time, and atmospheric conditions.

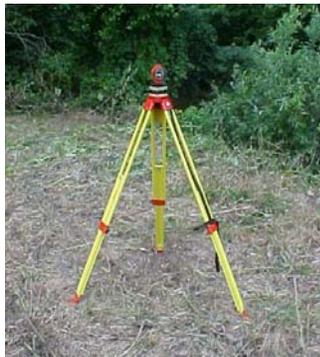
Figure 2: Reference Point

Traditional surveying transferred elevation from one point to another; in the case of structural monitoring, elevation was relative to the instrument. During testing, the instrument located the reference points, followed by all monitored points, and relocated the reference points again. The process was repeated as the structure was loaded and unloaded. During data analysis, the first step was to compare the reference point checks. Instrument or reference point movement was very obvious during data analysis and the error was eliminated, if necessary, by adjusting elevations and transferring this adjustment to the monitored points.

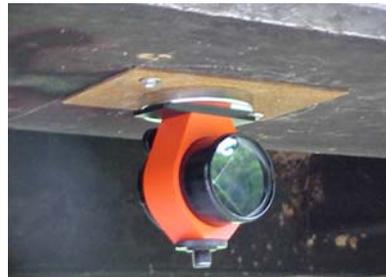
Figure 3: Target (Prism) on a bridge

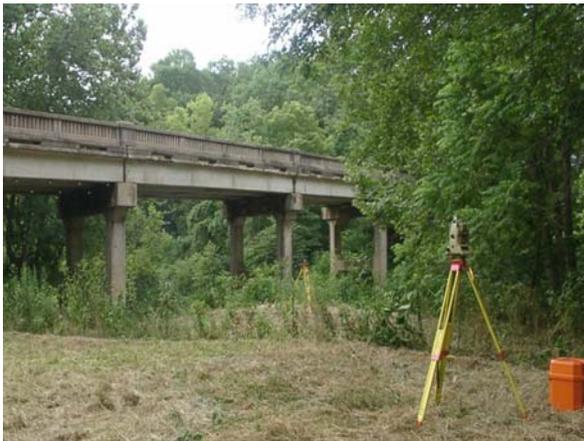
Figure 6: Testing Tall Spans

Setup time of the LVDT system at the bridge site had long been a problem. For spans clearing less than fifteen feet above stable soil, setup time easily took several hours. The soil under the tripods must be compacted, the tripods and LVDT's must be assembled and wired, and the LVDT's must be calibrated prior to use. For a bridge span over deep water or average span height above fifteen feet, scaffolding was mandatory for the LVDT's – adding much more time and effort. For this worst case, the Surveying Equipment was set up in about forty-five minutes (Figures 6 and 7). Every component (soil, scaffolding, and tripods) supporting the LVDT introduces error to the system. Target height and site conditions were practically irrelevant with the Total Station.

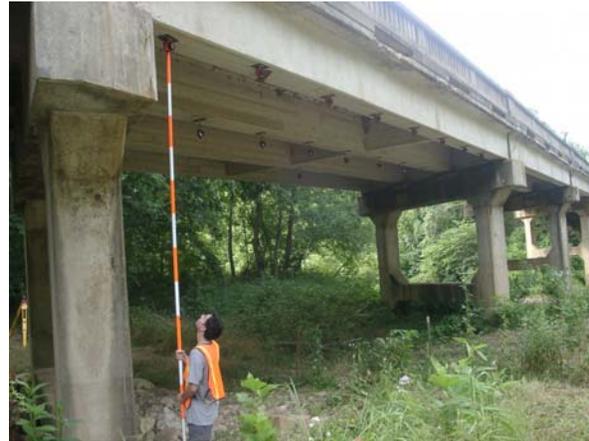
Figure 7: Mounting the Targets

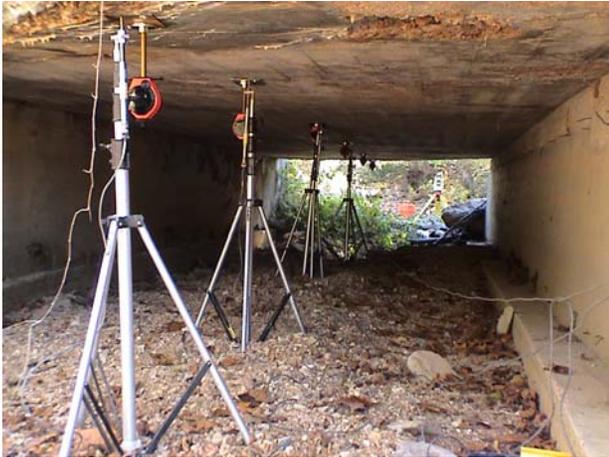
Figure 8: LVDT's and Prisms

Case Study – Field Test 1: The first field test took place at bridge Y-298 in Pulaski County, Missouri. This bridge was chosen for a comparison study due to the easy access underneath the structure, which made setup of the LVDT system relatively easy. Figures 8 and 9 illustrate the low clearance of the substructure, as well as the setup of the LVDT and surveying systems. Setup time for the surveying equipment took about fifteen minutes; setup time for the LVDT system took over sixty minutes.

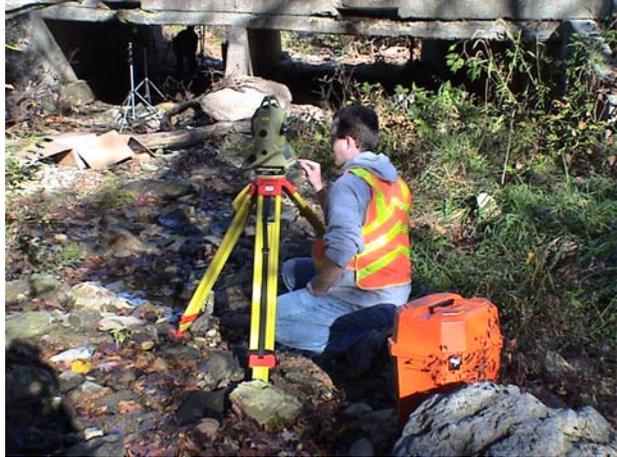
Figure 9: Total Station setup

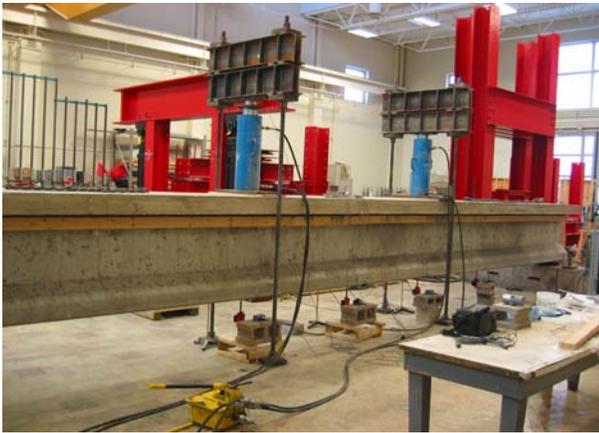
Figure 12: Laboratory Test Setup

Case Study – Laboratory Test: The first laboratory test utilized three deformation – monitoring systems (String Transducers, LVDT's and Surveying Equipment). The goal of a laboratory comparison was to minimize error by testing under ideal conditions. While the Surveying Equipment was primarily designed for field use, the String Transducer and LVDT systems were not. Stable footings low to a concrete floor (i.e. no tall tripods, no scaffolding), organized equipment (Figure 12), and climate control helped eliminate potential error associated with using equipment outside the laboratory. The Surveying Equipment was adapted to laboratory use without incident (Figure 13).

The specimen tested was a 10.4 meter (34 ft.) prestressed concrete I-beam. The I-beam was loaded with two load cells, shown in Figure 5. While the String Transducer LVDT systems were set to monitor deflection continuously, the total station could only measure when the load was constant. The Total Station was set to measure three times throughout the test; the results of one measurement are shown in Figure 14. Some LVDT's and String Transducers were not functioning properly, so they were removed from this analysis.
