THE DEVELOPMENT OF CONDITION MONITORING TOOLS FOR THE POWER GENERATION INDUSTRY

R. Lyon¹

¹ RWE Innogy, Swindon, England

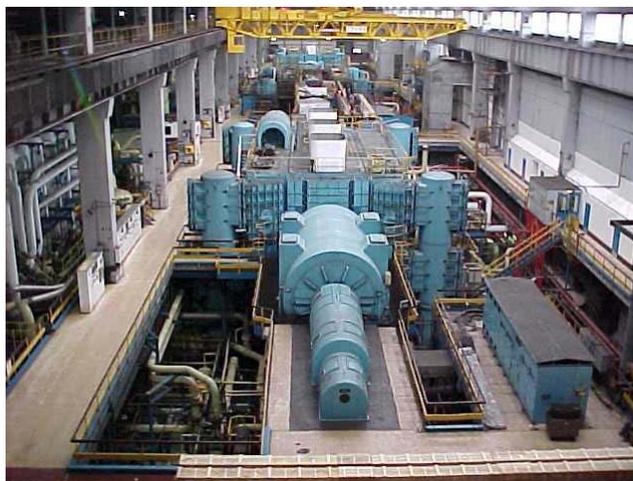
Fig. 2 - Tilbury Power Station Turbine Rotor Plant – Monitored by Power Plant Vibration Diagnostics

Power Plant Vibration Diagnostics: The Plant Vibration Diagnostics product is market driven, that is to say, it is designed to monitor running plant, to identify signs of impending failure and to offer commercial solutions. For example it may be beneficial to continue running with a known defect until it is financially advantageous to effect a repair or alternatively, to take the plant off line immediately to avoid a costly failure; the installation of remote diagnostics allows us to react quickly to potential problems, to identify causes and to offer solutions. Power Plant Vibration Diagnostics is mainly applied to Turbine Generator Rotating plant (see Fig. 2) and currently we are monitoring 62 machines at 17 different locations world wide.

Following failures on similar machines, it was identified that a generator rotor could be suffering from fatigue cracks but due to commercial constraints continued operation was required until an outage could be properly

planned. Successful implementation of vibration plant diagnostics allowed the machine to run safely for a number of months until a convenient outage.

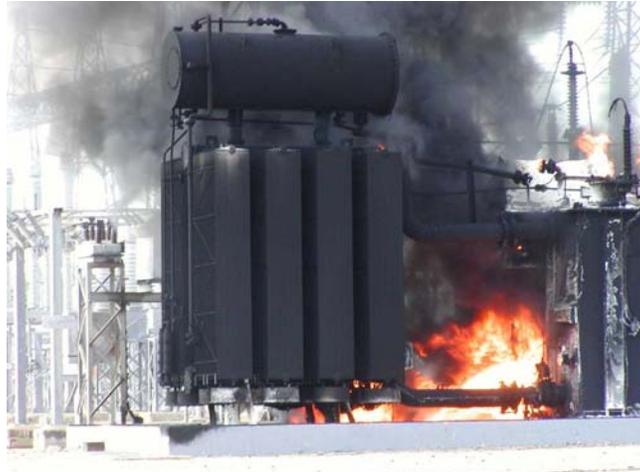
Fig. 3 - What we are trying to avoid

Transformer Oil Dissolved Gas Analyses: RWE's Transformer Oil Dissolved Gas Analyses (DGA) identifies faults within transformers and enables repairs to be carried out at an early stage, before the fault becomes critical (see Fig. 3). Our unique multi parameter approach is essential in transformer fault diagnosis, as no single parameter is capable of giving comprehensive information. We can also perform fault interpretation using oil analysis results. An unexpected failure of a transformer results in significant downtime, loss of generation and income. In extreme circumstances there can be explosion followed by fire.

RWE's routine DGA enables us to identify transformers in distress, to save time and money, to identify a fault at an early stage before it becomes critical, prevent extended outages and avoid long transformer replacement and commissioning periods. RWE identified that a serious thermal fault on the transformer was most likely to have been caused by a bolted connection under oil that had become loose and developed high resistance. An immediate outage of the transformer was required; inspection of all internal connections identified an HV bushing connection with higher than normal resistance. The fault was successfully repaired and with regular DGA, it was confirmed that the fault had been correctly identified and repaired.

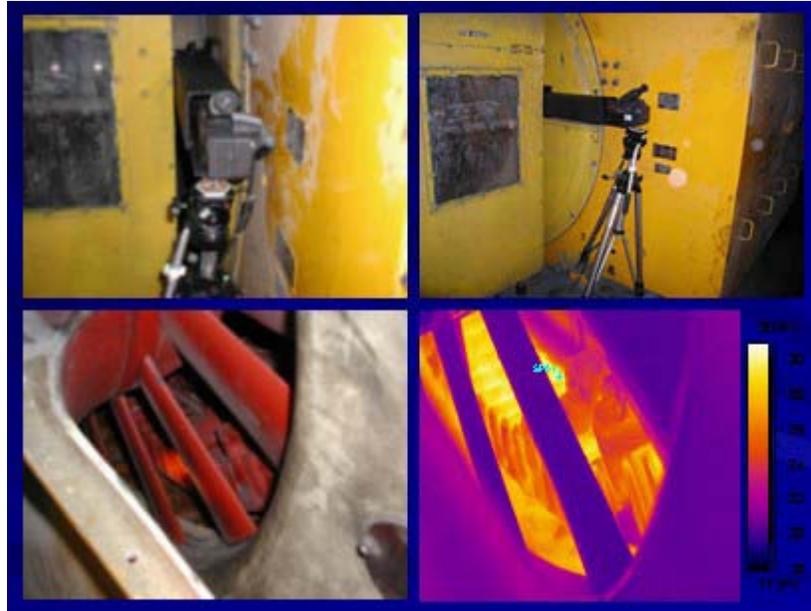
Fig. 6 - Thermographic Condition Monitoring of SSBFP Motor

We have also experimented with periscopic applications (looking round corners or in areas you don't normally have visual access to); failures have occurred in Secondary Superheater Boiler Feed Pump (SSBFP) rotors where overheating of the end-winding bars has caused the soldered joints to fail through the poor creep properties of the solder when exposed to a conductor temperature in excess of 85°C.

The top two pictures (see Fig. 6) shows how we fabricated a periscope that allowed us to view the end winding bars through the air cooling section of the exciter housing; the periscope was then fitted to an infrared camera and a condition monitoring survey was carried out. The bottom two pictures show the view of the end windings through the fan blades using digital and thermographic cameras. Following laboratory trials, the application was successfully carried out at Aberthaw Power Station, which allowed us to monitor the temperature of the windings over a 10 minute running period and also to monitor the temperature increase when the cooling fans were switched off.
