# TEMPERATURE MONITORS WORKS OF ART HEALTH AS HUMAN BEINGS

E. Grinzato<sup>1</sup>

<sup>1</sup> CNR-ITC, Padova, Italy

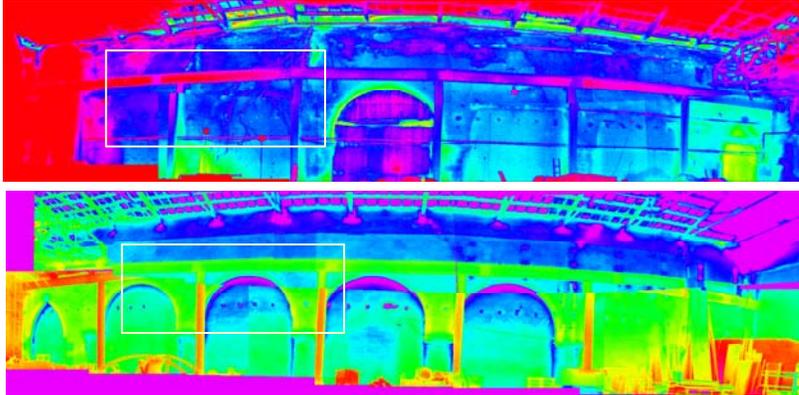
Fig. 1a: Moisture monitoring by statistical analysis of the historical arsenal of Venice (*Tezone 105*): thermograms of internal walls (top West, bottom East), the marked areas have been composed on fig.1b

recording temperature and RH for 24 hours before and during the thermographic taken. The identification of the damp areas is achieved by the comparison between the temperature of the dry and moist surfaces. For instance, two sections of interest (marked on fig.1a) are combined in fig.1b and processed. The superimposed histogram of fig.1b clearly indicates with the first peak a colder and therefore moist area, corresponding to the west side.

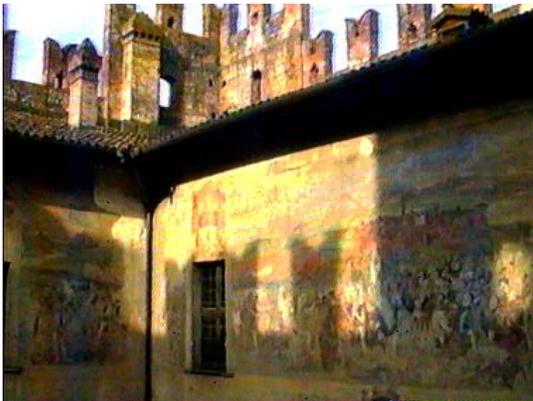
Fig. 2a: upper part of the inner court of the Malpaga (BG, Italy) castle and the inspected area

The second example refers to an Italian castle (XIV-XVI century) using a transient technique driven by the solar irradiation [7]. An interesting use of thermography is discovering of the bonding pattern below the plaster layer and locating hidden structures [8]. The main purpose of the inspection is to verify the age of a part of the castle, because it is known that it was expanded along the time. The original building has been done using rounded shaped stones coming from the nearby river, while the more recent part has been built up using bricks and ashlar. Any destructive technique is excluded, because of precious fresco covering. Here, the underlying idea is the use of the temperature excess due to sun coming out from the shadow, as shown in fig.2a. This approach is related to the wide surface to be examined, hard to be reached without a complex scaffold. A sequence containing 120 thermograms was taken in the 8-12  $\mu\text{m}$  spectral band, at 10 s intervals. The main problem arises from the varying of the thermal process starting point. The data reduction algorithm relies on a simplified 1D thermal model approximating the 0.5 m thick wall to a semi-infinite body. Hence, a linear temperature increasing vs. the square root of time is expected. The fig.2b shows the slopes map for any pixel obtained in the linear

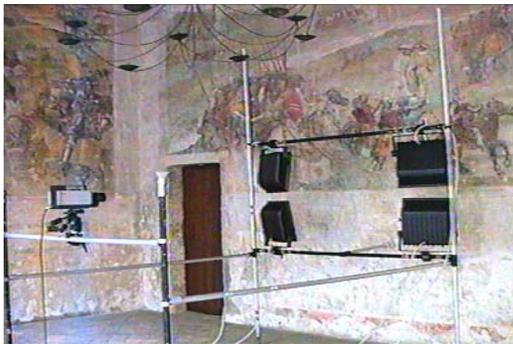
Fig. 3a: experimental set up for the Romanino's fresco delamination testing (Malpaga castle)

The test, performed on a fresco by Romanino at Malpaga castle, adopts TT for TNDT (see fig.3a). A thermograms sequence produces two synthetic images, mapping for each pixel the maximum normalised temperature difference with a reference area (*thermal contrast*) and the time of the maximum contrast (*timegram*). Unfortunately, the underlying 1D thermal model fails, due to the 3D heat diffusion generated by the surface different energy absorption. Calculating by numerical model the surface temperature history for the whole surface, submitted to the actual heating, gets rid of this effect [14], Figure 3a illustrates the experimental set up and fig.3b: the result of the 3D correction by the enhanced TT. Fig.3c shows the raw thermogram at the best

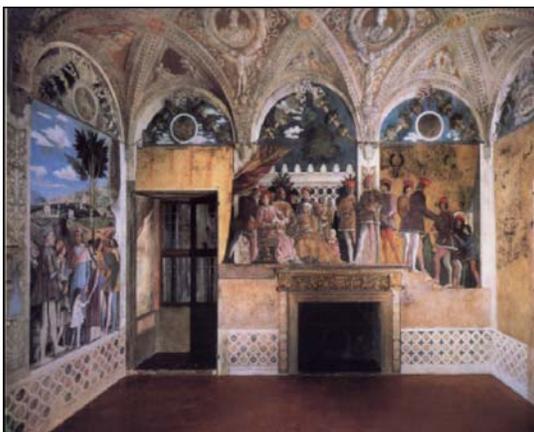
Fig. 5a: the *camera picta* (S. Giorgio castle, Mantova, Italy)

Fig. 5a shows the famous *Camera picta* by Mantegna (Mantova, Italy). It was studied in order to predict air movements and pollution due to visitors [18], taking into account the coupled system room-thermal plant. The first step was the whole lateral surface temperature scanning, by means of a motorized dual-band thermographic system. Then thermograms have been composed and geometrically corrected. Finally, CFD has been feed with resampled temperature data and both temperature field at different places and the air flux at chosen points are computed (see fig.5b). In such a way, the committing authority assessed alternative options.

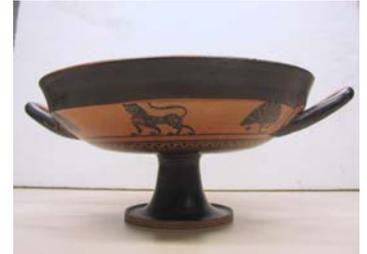
Fig.7a: thermal characterisation of Greek ceramic (V° sec B.C.)

The last case refers to archaeological ceramic (see fig.7a) that is well characterised by the measure of thermal diffusivity and effusivity. The *Flash Method* has been modified [23] to measure diffusivity on authentic and fake pots. After the testing of many different samples, using 3 different techniques, an accuracy of 10% has been found, notwithstanding the non-planar and constant thickness of the pot. An important byproduct of this research is the thickness gauging, which can be very useful for sealed pottery. Fig.7b gives the thickness map of a fragment of Greek ceramic (V° sec B.C.) and the mean value of the diffusivity. Analogous application of thermography concerns bronze statues. The aim is to evaluate the thickness and slugs using a technique derived from the corrosion evaluation on metals by IR thermography [1,13,24].
