COMPARISON BETWEEN CREEP FAILURE ANALYSIS AND MAGNETIC BARKAHUSEN NOISE RESULTS

Abstract:

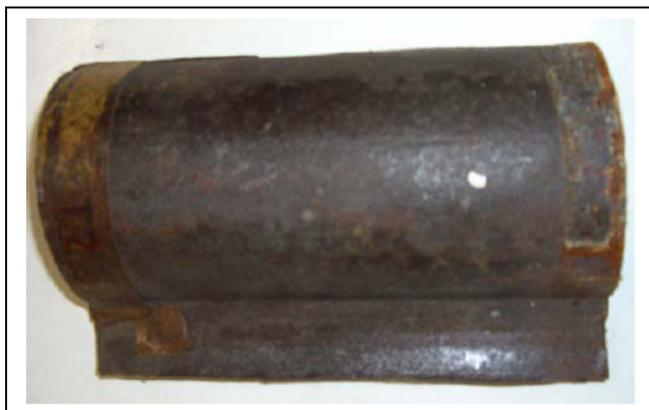
Figure 1: Region without any damage.

We received one water wall tube sample from one boiler to determine its failure causes. After visual examination we took three cross sections to procedure metallurgical examination. We took one sample were on the visual examination the tube shows no damage, far from the damaged area, figure 1. We took two others samples in areas were the visual exams shows indications of the start and the end of failure, figure 2. The sample without any damage we call "standard". The sample we took at the start of the failure we call "T1" and the sample we took at the end of failure we call "T2". The chemical analysis shows a chemical composition similar to a carbon steel ASTM SA-210.

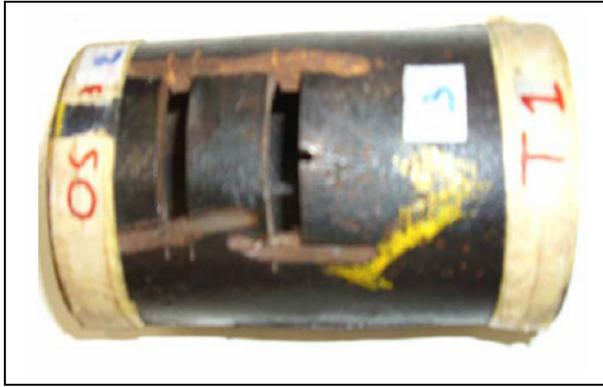
Figure 2: Regions after visual exams shows the start and end point of failure.

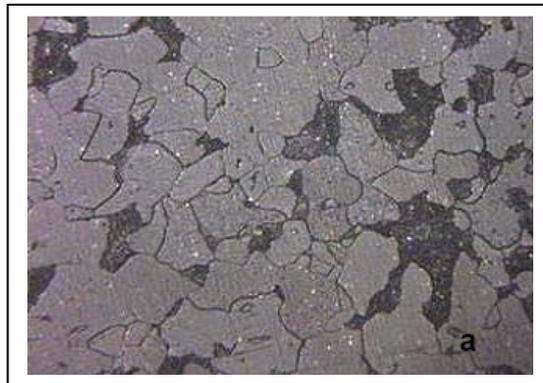
Figure 3: "Standard" microstructure.

As expected the "standard" shows a characteristic micro structure for carbon steel, figure 3. The sample "T2" shows a typical micro structure of final step of creep damage and level "C" and "D" of damage according Neubauer^[1] classification, figures 4 and 5. The sample "T2" shows the initial step of creep damage and level "A" and "B" of damage according Neubauer classification. The figure 6 shows the creep failure curve and the Neubauer^[1] classification.
