Procedure for NDT and Traditional Methods of Ancient Building Diagnosis, by Using Thermograph, Digital Images and other instruments data Analysis.

The research project “**NDT Methods of Ancient Buildings Assessment and Diagnosis of Building Materials and Construction Systems for its Conservation**”, developed at the Polytechnic University of Valencia 2004-2007, involved three main aspects:

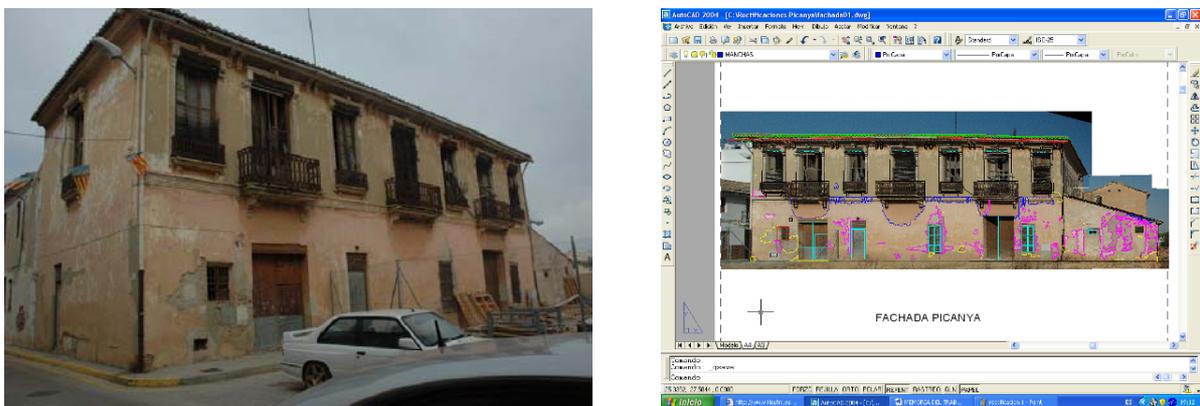
The data necessary for this purpose may be obtained by different methods. High digital images for metric restitution have been proved as a reliable system to apply for this purpose (Fig. 1). It must be taken into account that in some cases there are on site difficulties to fix the reference points necessary for the properly metric transformation of the captured digital images, in order to obtain accurate restitutions^[1].

Fig. 1. Digital image and metric restitution. (Ancient building at Picanya, Valencia).

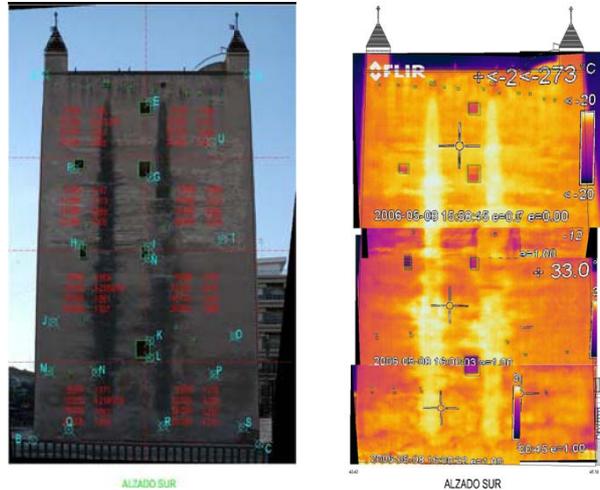
The elevations obtained by applying this method were used as a starting point for the data compilation and later comparison with IRT images, establishing an analogue process of image restitution with both technologies (Fig. 2).

Fig. 2. Comparison of digital and IRT images of a façade (Medieval Tower at Torrent village, Valencia)

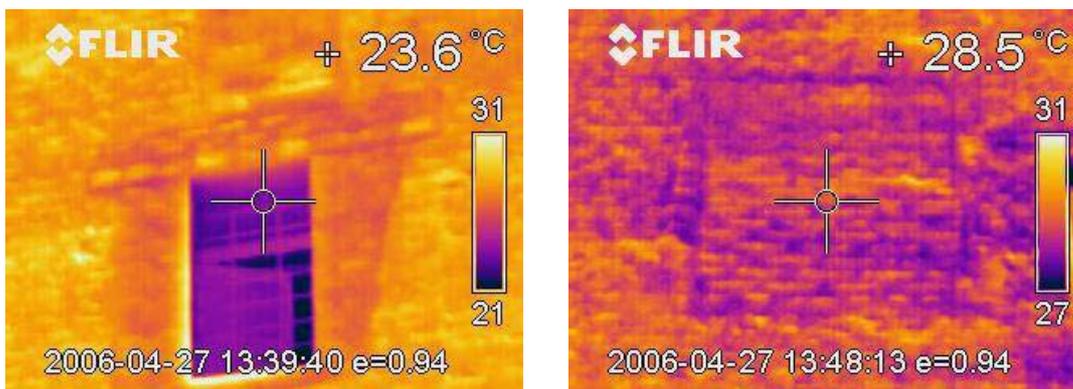
It was especially interesting to verify that IRT images of the façades allowed discovering hidden openings in the walls, repairs, changes in the walls building materials and its renderings, presence of dampness and other pathology (Fig. 3). In all cases this analysis gave completely new information, some times endorsed by comparing the images with old photographs, engravings or drawings [2] [3] [4] [5] [6] [7] [8] [9].

Fig. 3. IRT images showing former repairs and changes in walls, and shape and size of openings (Castell d'Alaquàs, Alaquàs village, Valencia)

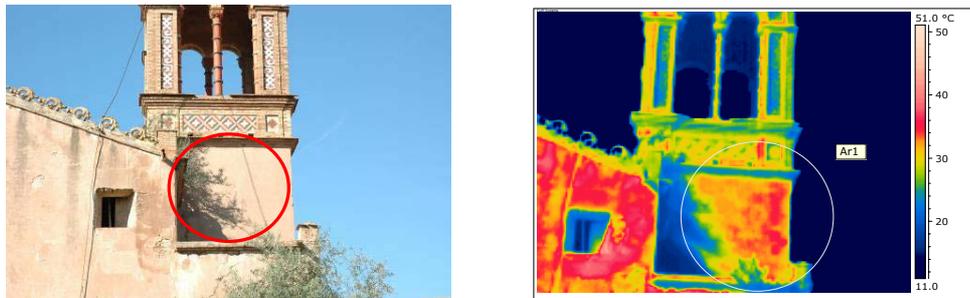
By means of this technique, different walls composition were identified such as bricks, stones and masonry hidden under the mortar coatings, especially when the construction elements were made of very diverse materials (Fig. 4).

Fig. 4. IRT images where can be identified a brick wall beneath the mortar rendering

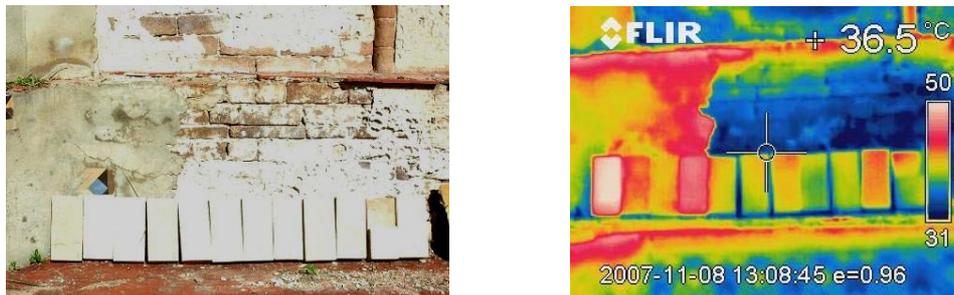
Several mortar probes were prepared at the Laboratory with different conglomerate such as cement, lime and gypsum, varying its thickness (1, 2 and 3 cm). Later were analysed with IRT images, coming out a clear different emissive temperature between them. These differences were clearly recognised with rendering thickness of 1 and 2 cm, but not in those 3 cm thick.

Fig 5. Comparison of mortar probes prepared at the Laboratory with mortar

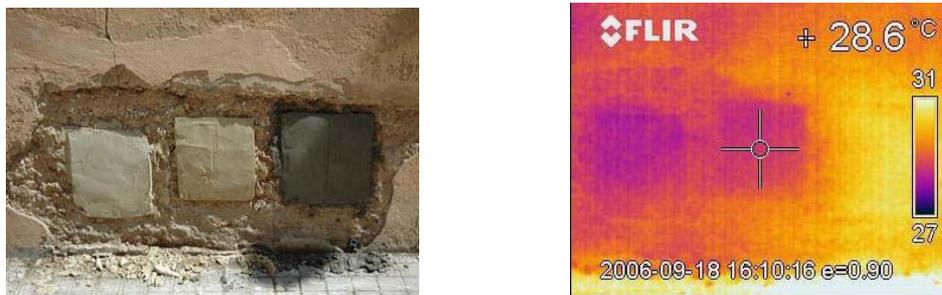
These probes were also applied directly to the building walls of one of the cited buildings, at the Picanya village, in order to identify the mortar rendering type through IRT image analysis (Fig. 6). In all cases, the depth of the rendering must be measured, to make possible this method of identification.

Fig. 6. Probes made on site (left), later analysed by IRT images (right) for its identification.
