Illustrating the relevance of SHM in a case study: the Foz Tua centenary railway bridge

Filipe MAGALHÃES¹, João PACHECO¹, Álvaro CUNHA¹

¹ CONSTRUCT-ViBest, Faculty of Engineering (FEUP), University of Porto
PORTUGAL filipema@fe.up.pt; acunha@fe.up.pt

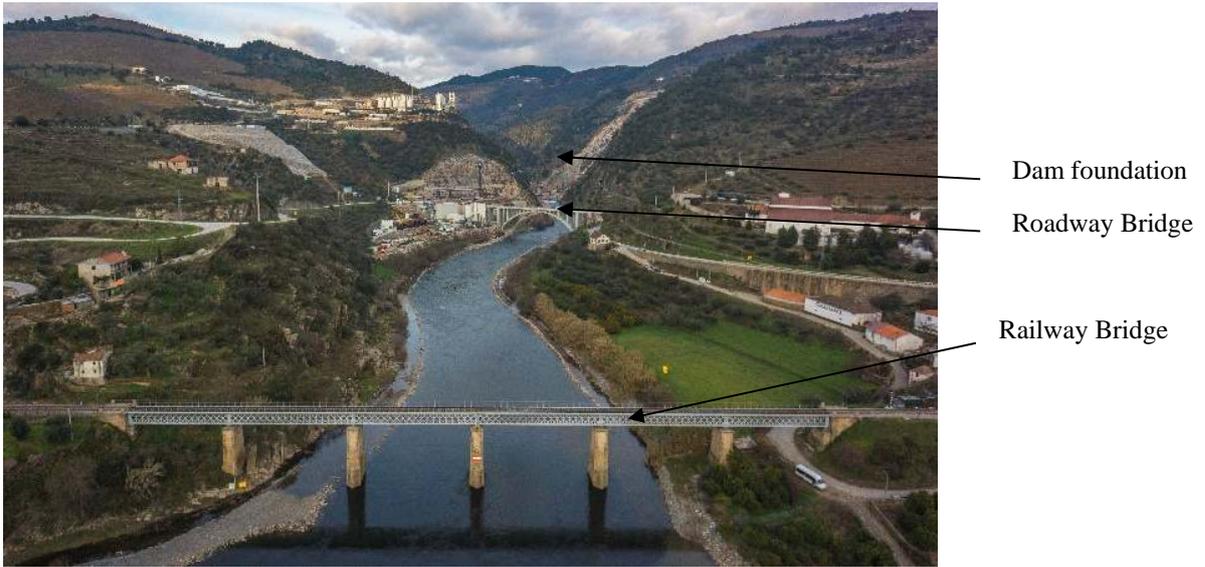
Figure 1: View from downstream at an early stage of the dam construction: Railway Bridge, Roadway Bridge and Dam site [1].

In 2011, it was started the construction of a new hydroelectric powerplant at Tua River, with a dam about 1km upstream the railway bridge (see Figures 1 and 2). Since the dam is also going to be used to store water pumped from the Douro River, the Tua river bed is being deepen in order to create an adequate channel from the Douro River to the water outlet.

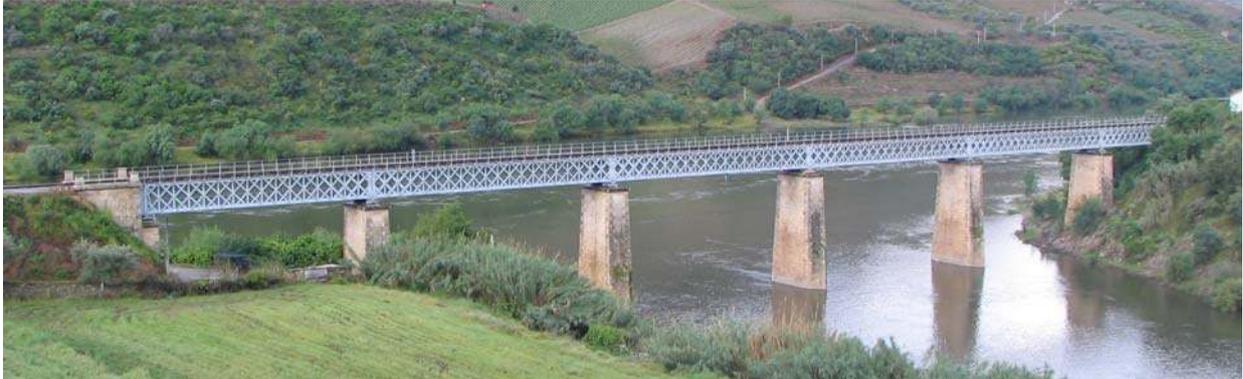
Figure 3: Railway Bridge, view from upstream.

This steel riveted railway bridge constructed in 1882 belongs to the Douro Line, a railway line running next to the Douro river, that in the past connected the city of Porto with the Spain border (nowadays the last part of the line is decommissioned). The bridge crosses the Tua River at its mouth with the Douro River through a steel truss deck with a height of 3m and a total length of 169m, divided into 6 spans, two end spans with 24.5m and 4 intermediate spans with 30m. The deck is supported by 5 masonry piers, three of them being founded in the river bed (see Figure 3). In the longitudinal direction, the deck is only fixed to the central pier, the connections with the other piers and with the two abutments allow relative movements. In the transversal direction the deck is fixed to all piers and also to the abutments.

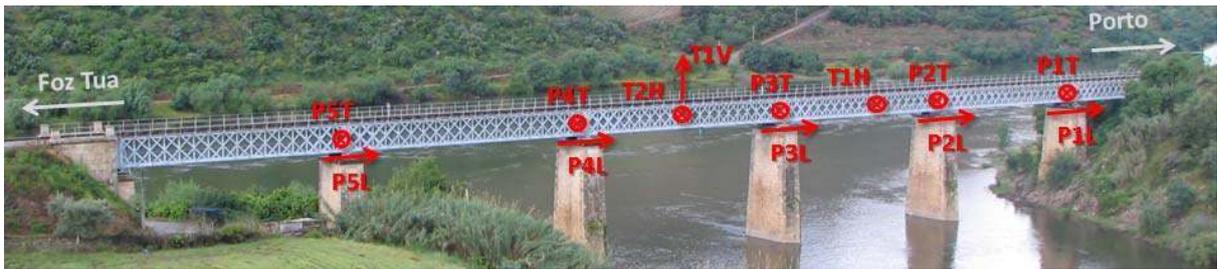
Figure 8: Degrees of freedom instrumented with accelerometers.

The distribution of the sensors aimed the maximization of the quality of the collected information and the minimization of the number of sensors to reduce the system cost and took into account the results of the ambient vibration test and the importance of the piers behavior. Figure 8 represents the degrees of freedom instrumented with accelerometers.
