ACOUSTIC EMISSION EXPERIENCE WITH AE MONITORING OF NEW VESSELS DURING INITIAL PROOF TEST

This paper looks retrospectively at experiences with the AE monitoring of new vessels during initial proof-test and discusses the implications for applying the proposed European Standard for AE monitoring of proof tests.

VERTICAL REACTOR SHOP HYDROTEST

STORAGE SPHERE INITIAL HYDROTEST

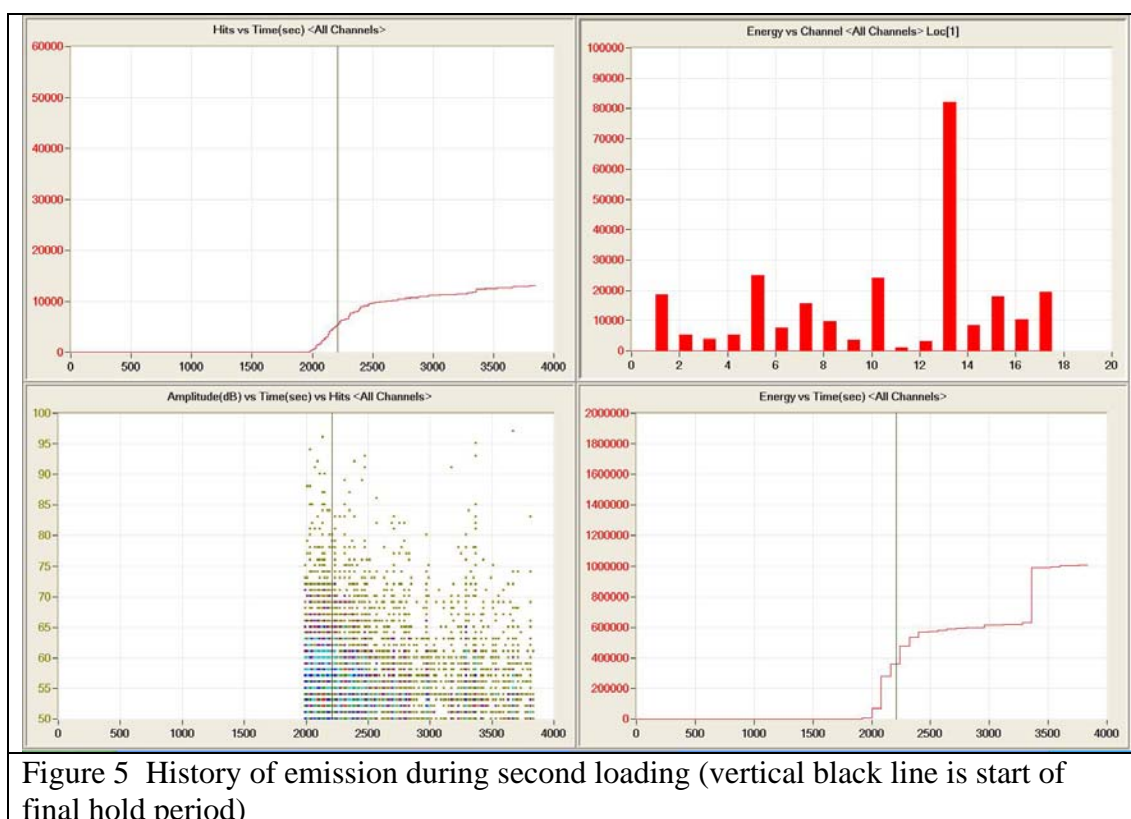
MONPAC™ analysis of the first pressurisation produced grade “E” for the sensors around the man-way area, this activity reduced to “C” on the second loading resulting in a recommendation for further evaluation and possible follow-up NDT.

Post test, extensive NDT was carried out to the man-way weld area, both from inside and outside, no reportable indications were found. Since 90% of the emission from the vessel had come from the one weld there were still questions and an investigation into the manufacturing process ensued. The outcome of this was the discovery that a much lower weld pre-heat had been used on the man-way weld than on any other weld on the vessel, resulting in higher residual stresses, clearly not fully relieved after even two cycles to proof pressure. The reason given for the lower pre-heat was that from a design standpoint the man-way had been treated as a pipe, allowable under the codes, despite this clearly being the most highly stressed part of the vessel.

It is interesting that despite emissions with source amplitudes well in excess of 80dB (usually associated with cracking) no reportable indications were found by NDT. One possibility is that micro-cracking was distributed around the weld and there was as a result no individual “big crack” for NDT to find. Localised inspection may not be sensitive to micro-cracking distributed around a large area; however this can still be a threat to integrity.
