17th World Conference on Nondestructive Testing, 25-28 Oct 2008, Shanghai, China

## Computed Radiography and Microtomography of Riveted Lap Joints of Glare™ Subjected to Constant Amplitude Loading (CAL) Fatigue

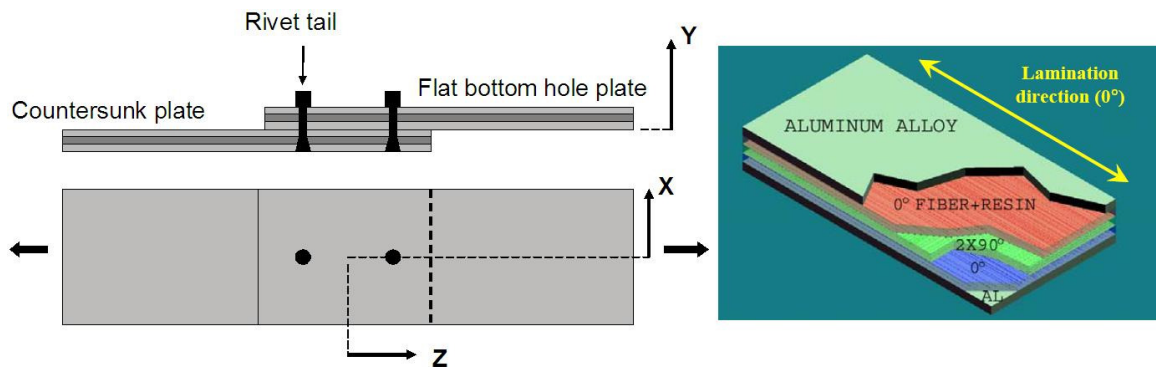
**Figure 1 – Test specimen schematics: direction of cyclic loading and the riveting pattern and geometry. The X, Y and Z arrows represent directions for the tomography. Also shown is a typical Glare™ sheet.**
