KEEPING IT TOGETHER - HYDRO GENERATOR LEG TRANSPLANT

Abstract

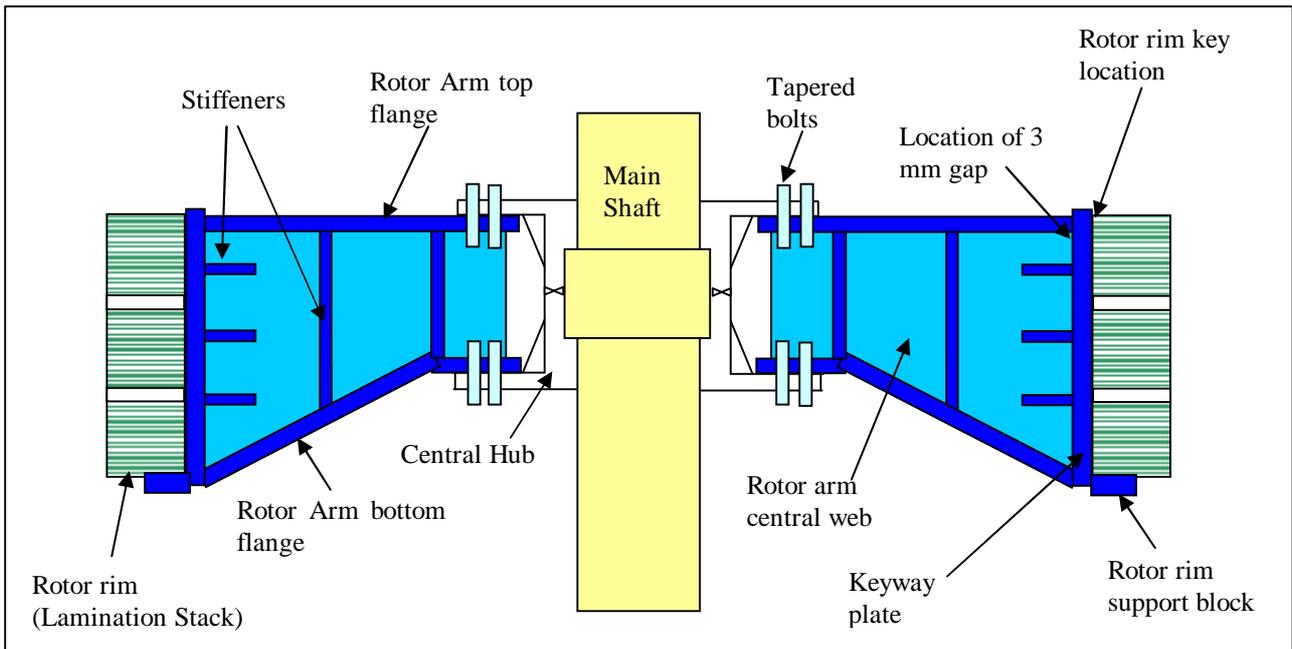
Figure 2 *Detail of rotor construction and part names*

The rotor construction consists of a central hub that is keyed on to the main generator shaft with nine independent rotor arms that are attached to the hub by 16 fitted bolts to form the rotor spider. The rotor rim is made up of hundreds of laminations that are stacked around the outside of the nine rotor arms (see Figure 2) and bolted together to form a solid ring.
