# In-Service Flaw Detection and Quantification on the MiG-29 Composite Vertical Tail Skin

Krzysztof DRAGAN, Sławomir KLIMASZEWSKI  
Air Force Institute of Technology, Warsaw, Poland

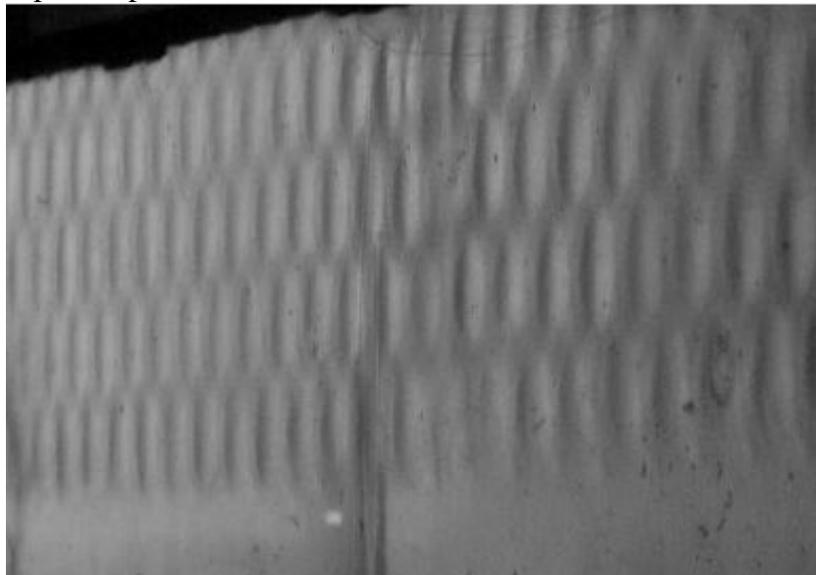
Pic.1 Key feature of DSight™ images – surface without distortion

As we can notice the surface without distortions (Pic.1) gives smooth light distribution. Whereas damages caused by low energy impacts show areas with different gray scale value (Pic.2). The most important feature of data assessing using DAIS® system is the fact that detectable damages have got surface distortions. The main purpose of applying enhanced visual test with the use of DSight™ for composite skin of vertical tail, was to assess number of low energy impact damages. The next step in that approach was to deliver ultrasound test.

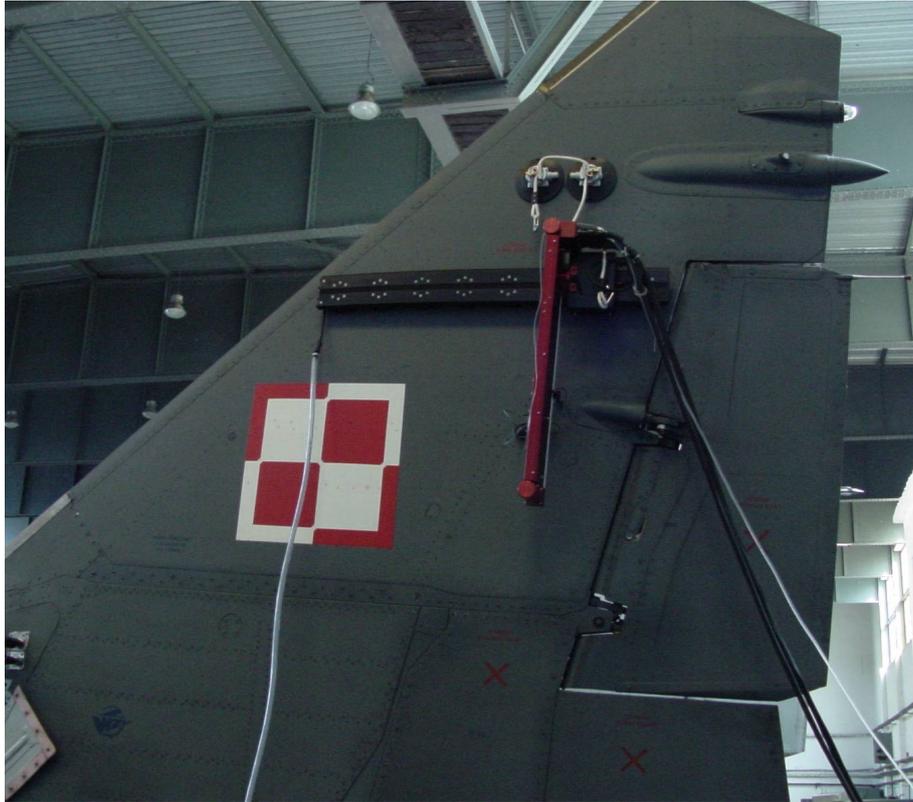
Pic.3 MiG-29 Composite Vertical Tail Inspection.

On the picture scanning arm and flexible track system are presented. Total thickness of composite skin of the vertical tail is between: 1.8 – 3.2 mm. The first step before inspection were specimen preparation and specimen tests. On that stage the damage classification was made. Based on prepared ‘step samples’, tests have been performed [5]. The tested samples gave idea that following damages of the composites could be detected:
