The Detection and Assessment of Carburisation Damage in Visbreaker Heater Tubes

John LILLEY, Veritec Sonomatic Ltd, Warrington, U.K.
Hermenegildo RUIZ CAMARENA, CEPSA, Sanroque, Spain.

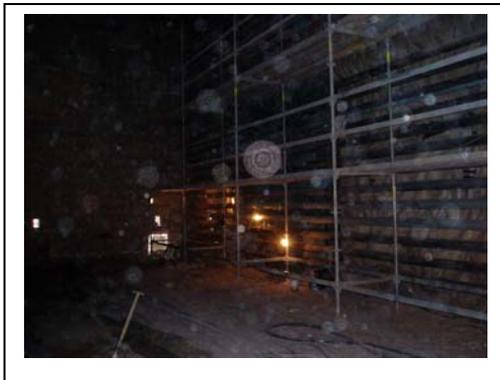
Figure 3. The conditions inside the heater are less than ideal with sand particles from the sandblasting process in the atmosphere.

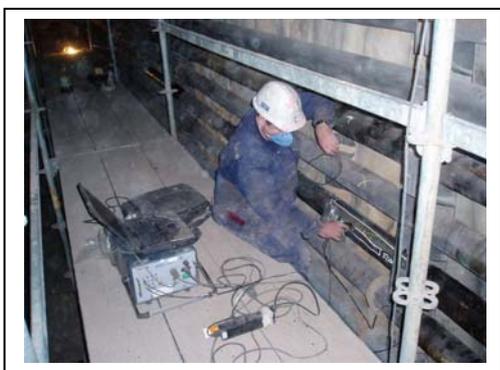
Figure 4. An inspection underway.

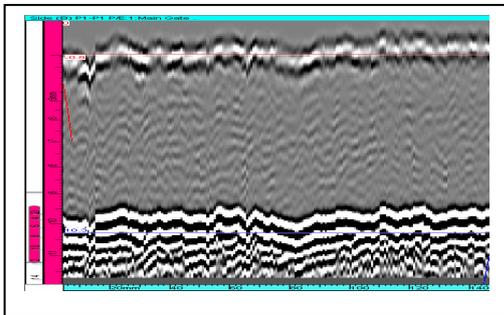
Figure 6. TOFD scan of new pipe, 9.6mm thick. X- axis is distance along pipe. Y-axis is through wall extent. Mottled background is acoustic grain scatter from the wrought material.

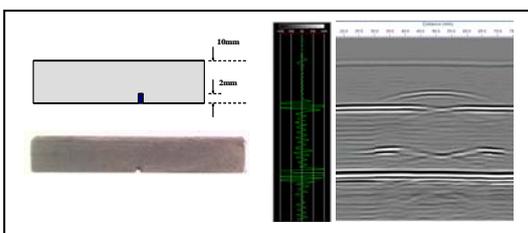
Figure 14. TOFD calibration scan.

A 10mm thick calibration block was obtained of the same curvature as the furnace tubes with a 2mm deep slot. See Figure 14. Calibration scans were collected and the ultrasonic parameters were carefully optimised to give crisp pulse characteristics. The through-wall sizing procedure was established to give precise measurements. The slot could be

measured to within $\pm 0.05\text{mm}$. Note the grain scatter just visible in the background of the image.

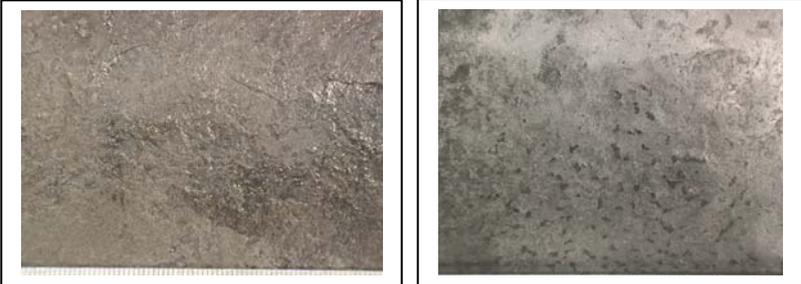
Figure 15. Surface texture comparators

Surface finish was found to be highly important to the inspection. High ultrasonic frequencies are used and these are very sensitive to surface irregularities. Various combinations of grinding, sandblasting, abrasive discs, flapper wheels, and wire brushing were tried until the optimum combination was determined. Comparators were created for site use. See Figure 15.

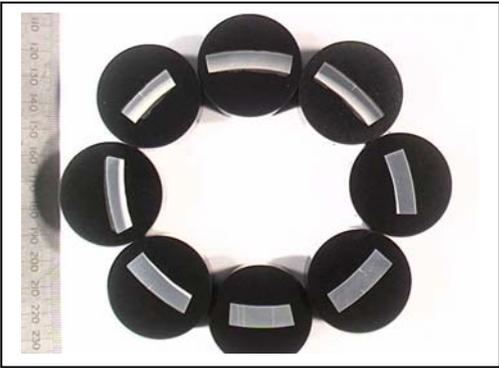
Figure 16. Mounted samples.

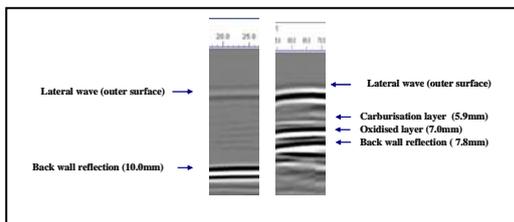
Material close to the internal surface was found to be oxidised and above this a distinct carburised layer was identified (Figure 17). The boundary between carburised and un-carburised material was found to be surprisingly pronounced. Microhardness values also showed a rapid transition between affected and unaffected material (Figure 18). Ultrasonic measurements were able to delineate the carburisation layer from oxidised material and also detect the presence of coke on the internal surface (Figure 19).

Figure 19. Ultrasonic measurements of the various layers.
