APPLICATION OF NON-DESTRUCTIVE TESTING METHODS TO DIAGNOSTICS AND REPAIR OF ELEMENTS OF THERMO-ENERGY SYSTEMS

On the occasion of a preventive inspection of a steam line some critical flaws were detected. They could easily result in a failure of an element of the device if the system continued to operate.

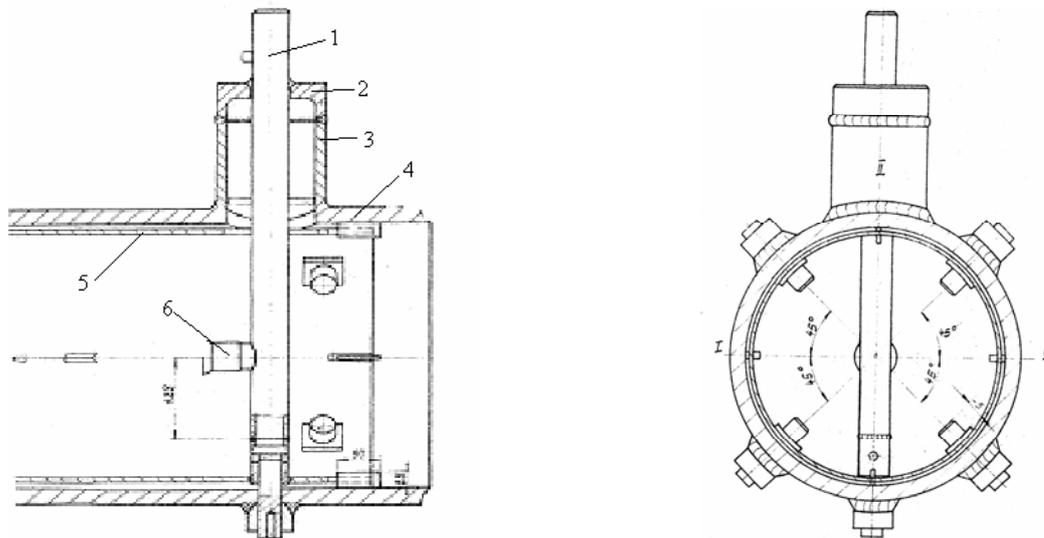
Fig. 2: Longitudinal and cross sections of steam cooler.

The depth of the crack located at the built-in tube attachment (Fig. 2, Pos. 3) could not be measured due to its inaccessibility. The occurrence of cracks at the steam line is not admissible; therefore, a decision was taken, to separate the tube attachment by grinding the fillet weld connecting the tube attachment to the steam line. The liquid penetrant examination was then employed to determine the number and size of cracks.
