Condition Assessment of a 45-year old prestressed concrete bridge using NDT and verification of the results

1 CONDITION ASSESSMENT OF THE BRIDGE DECK

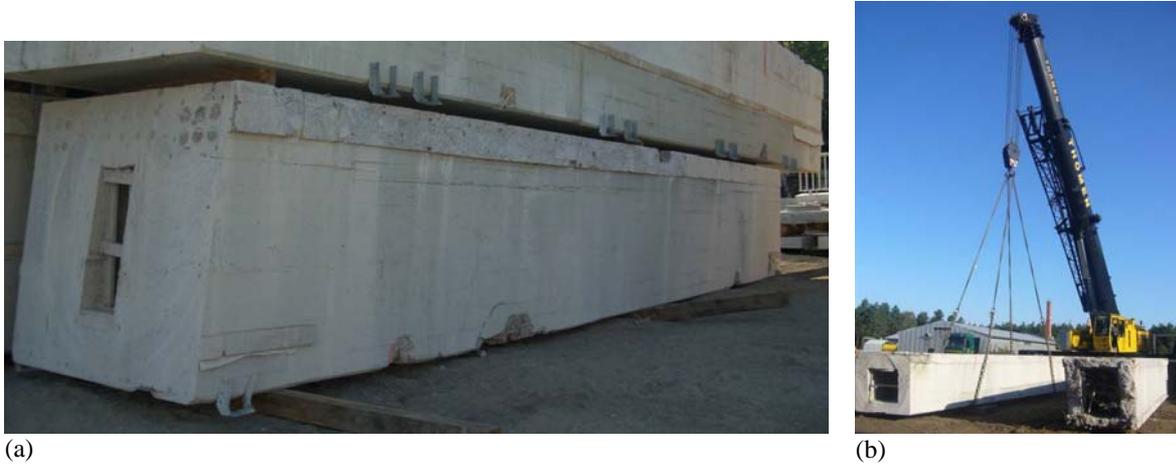
In the bridge deck areas with delamination have been identified. Due to the high interest in this damage pattern in the US and due to the difficulties to built realistic artificial deleminations it was decided to store three parts of a bridge deck a the TTS test-site of BAM in Horstwalde close to Berlin and make it accessible for interested researchers (Fig. 9a). Also two box-girders from that bridge are accessible (Fig. 9b).

(a) (b)
Figure 9: Available real-size test specimens at the TTS from BAM: (a) Bridge deck of the Spandauer-Damm-Brücke with delamination and (b) box girders.
