## EXPERIMENTAL NON-DESTRUCTIVE TESTING OF FRP MATERIALS, INSTALLATION, AND PERFORMANCE, DALLAS COUNTY BRIDGE, MISSOURI, USA

N. Maerz<sup>1</sup>, G. Galecki<sup>1</sup>, and A. Nanni<sup>1</sup>

<sup>1</sup> University of Missouri-Rolla, Rolla, Missouri, USA

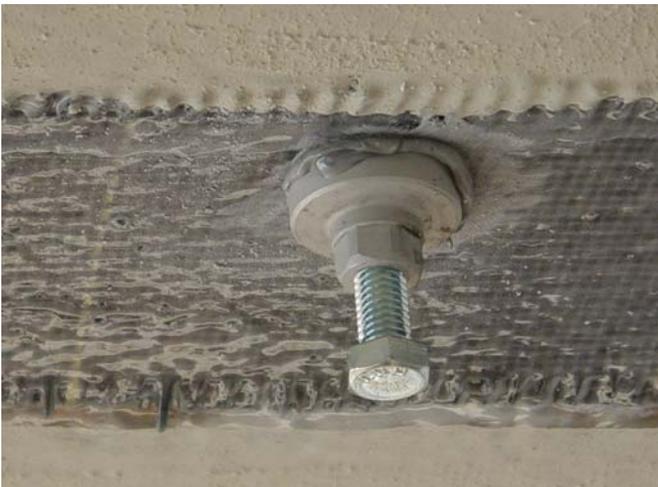
Figure 14: Pull-off plug installed on the bridge deck

4. Pull-off plugs were installed over the FRP sheets on one section of the bridge deck (Figure 14) and on various test sections Figure 16. The substrate roughness under each plug has been measured (plug locations were selected to sit above a wide variety of substrate roughnesses). Non-destructive Pull-off tests will be conducted every 6 months.

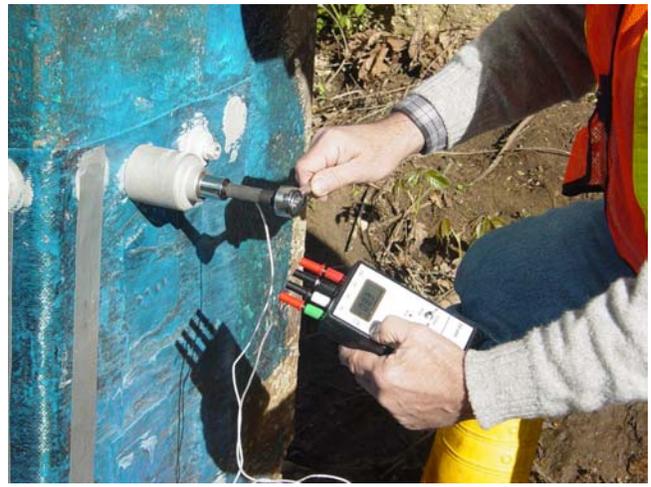
Figure 15: Pull-off testing.

*FRP Bond Pull-off:* The FRP (destructive) Pull-off tests done to date, all failed at the interface between the FRP sheet and to covering epoxy (Figure 17). The average Pull-off load for 10 samples was found to be 9745 lbs. For future non-destructive testing, the plugs will be loaded to 6500 lbs (2/3 of the average strength), every 6 months.

*FRP Bond Pull-off:* The bond Pull-off tests to determine max loads have all failed above the FRP, between the FRP and the epoxy. Although it is expected poor quality epoxy/installation will result failure at lower loads, and perhaps at the FRP/concrete interface, this has not yet been verified.
