## LONG RANGE INSPECTION OF RAIL USING GUIDED WAVES - FIELD EXPERIENCE

P. Cawley<sup>1</sup>, P. Wilcox<sup>2</sup>, D.N. Alleyne<sup>2</sup>, B. Pavlakovic<sup>2</sup>, M. Evans<sup>2</sup>, K. Vine<sup>2</sup> and M.J.S. Lowe<sup>1</sup>  
<sup>1</sup> RCNDE, Dept Mech Eng, Imperial College, London, UK <sup>2</sup> Guided Ultrasonics (Rail) Ltd, 17 Doverbeck Close, Nottingham, NG15 9ER, UK

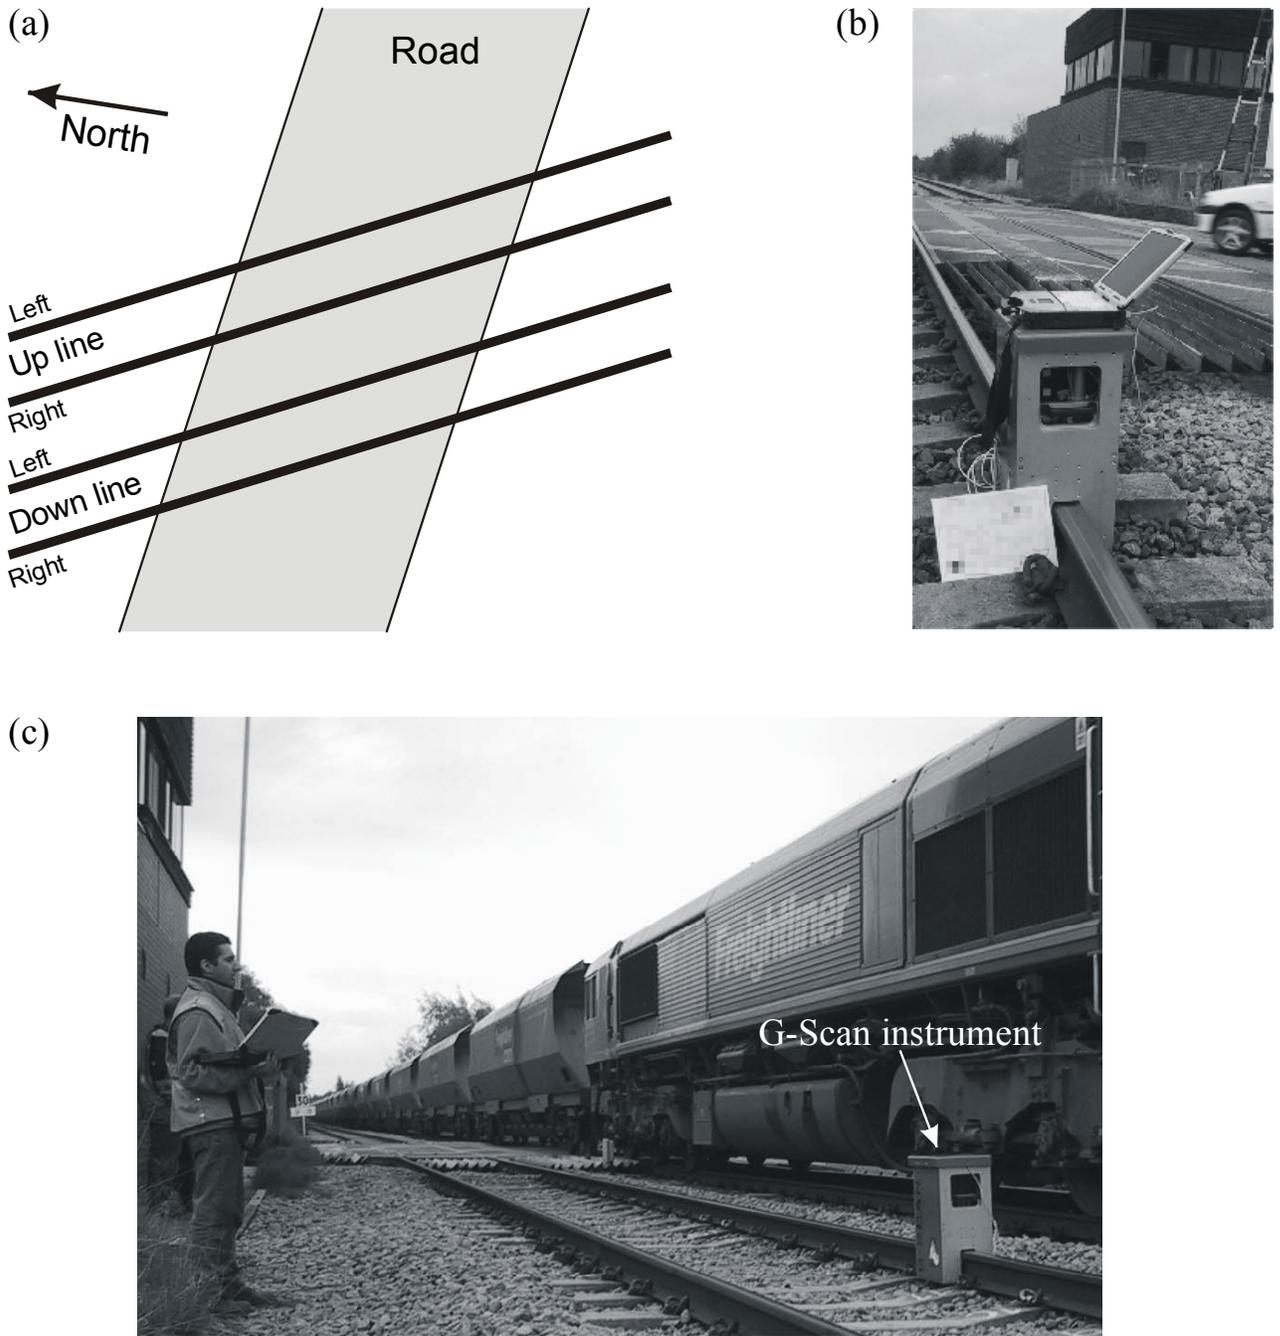
The pre-production G-Scan system has been used to inspect rail on the 'up' and 'down' lines at a Network Rail level crossing. This is part of an ongoing programme of testing to collect a large body of data on different rail conditions and to optimise the interpretation of features and presentation of results. The layout of the level crossing and the test locations are shown in Figure 3(a). Figures 3(b) and (c) show pictures of the G-Scan equipment in use at the level crossing. The tests were performed with both road and rail traffic in close proximity.

Figure 3. (a) Schematic diagram of the layout of the level crossing inspected, (b) and (c) G-Scan system in use at the level crossing.
