ACOUSTIC EMISSION MONITORING OF BUCKLING BEHAVIOUR IN IMPACT-DAMAGED COMPOSITE PLATES.

K.M. Holford, C.A. Featherston, R. Pullin and M. J. Eaton

School of Engineering, Cardiff University, UK

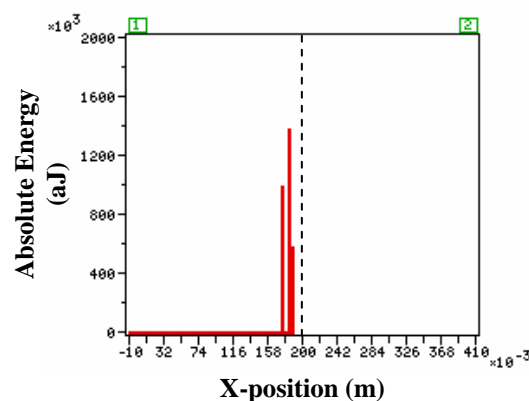
The response of all sensors to PLFs adjacent to the sensor was above 97dB. This demonstrates that all sensors were attached correctly. The loss of signal was 25dB over 400mm, allowing a threshold of 65dB to be used. The velocity of sound in the specimens was measured at 3800ms^{-1} . Figure 2 shows the results of the PLF test to establish the accuracy of the time of arrival location method. The results indicate that the location of damage will be accurate to within 30mm.

Figure 2: Location of pencil lead fractures from centre of specimen

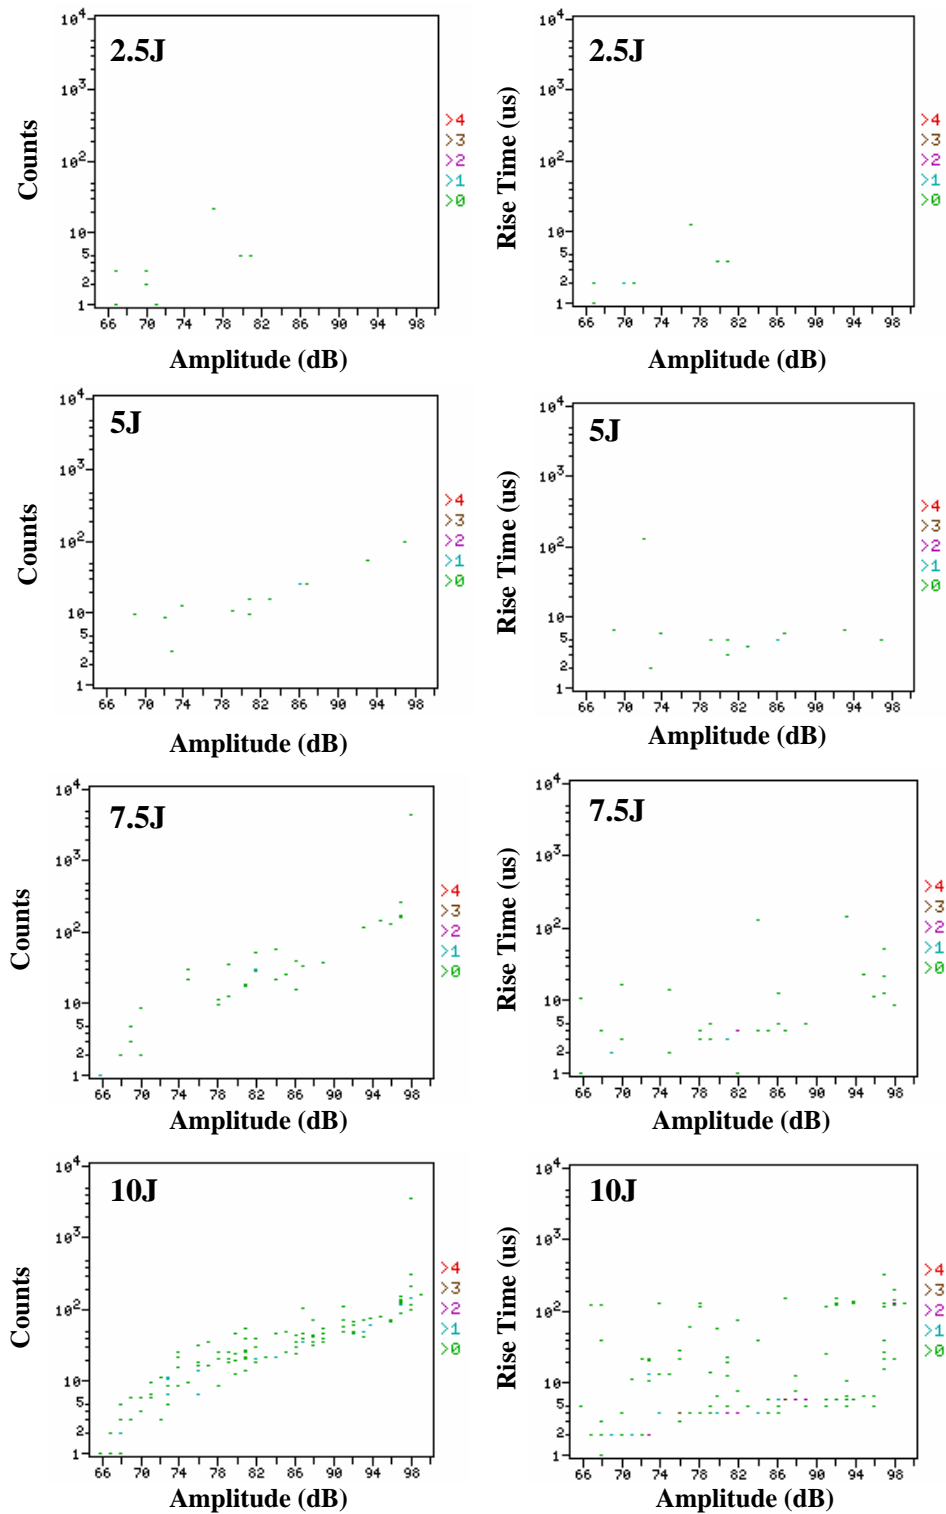
Figure 5 presents the characteristics of the data recorded in the central location for the damaged specimens in terms of counts and rise time against amplitude. The plots show that the peak amplitude increases as the level of induced damage increases (2.5J-87dB, 5J-96dB, 7.5J-98dB and 10J-99dB) and that there is an increase in the number of detected hits. This suggests that there is a possible relationship between the level of induced damage and recorded AE. Further data is needed to ensure that this is not experimental scatter. Comparing the rise time and counts between the levels of induced damage shows little difference in pattern apart from an increase in number of detections. This suggests that the detected emissions are from the same type of source, either cracking in the matrix or delamination, and that with increased induced damage there is an increase in detected damage by the AE.

Figure 5: Characterisation of signals from damaged specimens

Five epoxy glass fibre specimens were manufactured and damaged using an impact test. The specimens were loading to induce buckling until failure. Using AE the induced damage was detected to within 30mm. Levels of energy detected increased with the level of induced damage. Results suggested that there was a relationship between peak amplitude and levels of induced damage.
