## **Inspection techniques for wind turbine blades using ultrasound and sound waves**

### **Abstract**

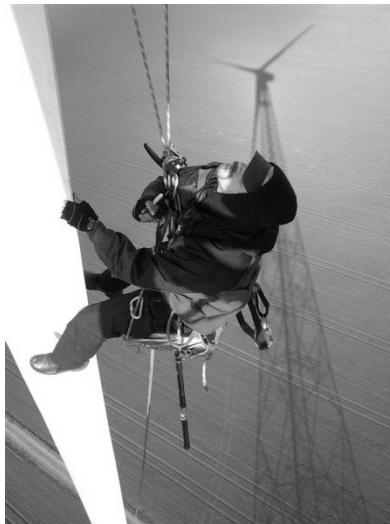
**Figure 1:** Inspection of a wind turbine blade.

In Germany wind energy plants have to be inspected at regular intervals, depending on the size, every two to four years. Besides the tower and the mechanical parts like the gear, the turbine blades are part of these inspections. Due to the constant wind contact the blades are highly stressed parts of the turbine. However the inspections are limited to visual inspections and simple tapping tests. These techniques acquire a high level of experience and are not able to detect internal damages that aren't visible at the surface of the blade. Figure 1 shows an industrial climber roping from the rotor of a wind turbine to inspect critical areas of the blades. Besides the use of basket cranes this is a common way to get access to the blades.

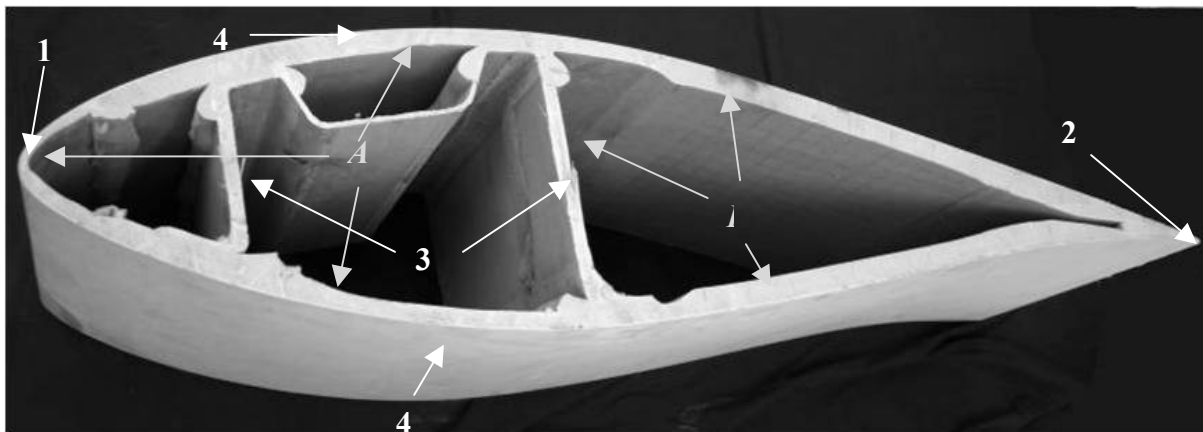
**Figure 2:** Typical cross section of a wind turbine blade. The upper side in the picture is called intake side the lower side is called pressure face. On the left the leading edge (1) and the trailing edge (2) can be seen. The spar (3) stabilizes the turbine blade and is glued to the shell (4). Large areas are built of GFRP (A). To reduce weight some regions (B) are built as composite of GFRP and wood or plastic foam.

Wind turbine blades are mainly built of fiber reinforced plastics and lightweight materials like plastic foam or wood. Glass fiber reinforced plastics (GFRP) are due to the cheaper price preferred to carbon fiber reinforced plastics (CFRP) that are common in aerospace industries. A typical cross section of a wind turbine blade is shown in Figure 2. Depending on the manufacturer of the blade the cross section can contain different materials. However, the main parts like shell and spar and the aerodynamic shape are similar in most blades.

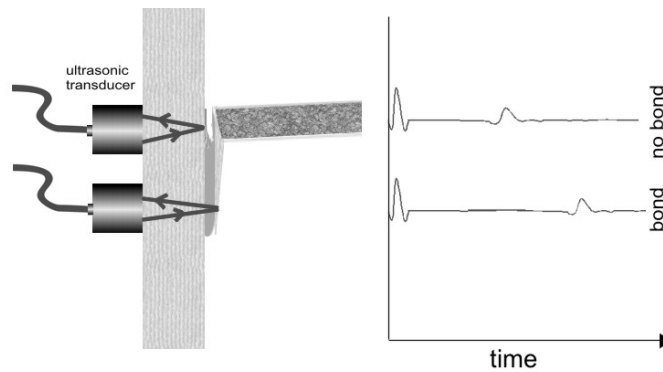
**Figure 3:** *Ultrasound echo at a bonding area of wind turbine blade.*

The ultrasound-echo technique is a common and very well investigated technique in non-destructive testing [3]. The measurement principle shown in Figure 3 is very simple. The technique is used to detect the bonding areas through several centimeters of GFRP. An ultrasonic pulse is sent into the material. The waves are reflected at material changes or at the back wall. The echo will be very strong and will arrive earlier if there is no bond between shell and spar. If shell and spar are linked very well the clear echo will move to later arrival times or will vanish completely.

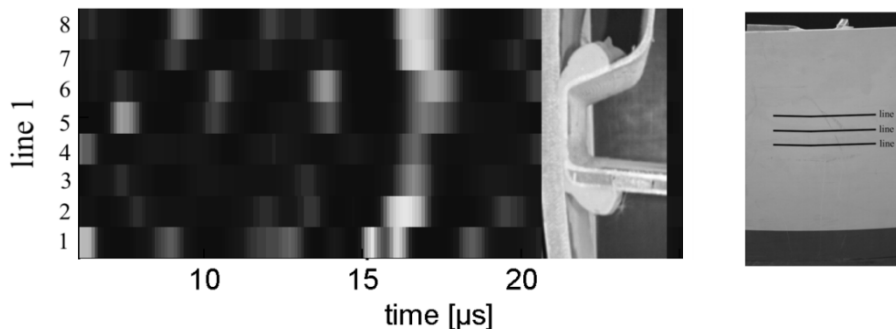
**Figure 4:** *Results of an ultrasound-echo measurement at a wind turbine blade sample.*

The ultrasound echo technique was applied to a sample of a wind turbine blade containing the bonding area between shell and spar. The sample was about 50 x 50 centimeters big and is shown in Figure 4 on the right. Three lines of measurements were done covering the bonding area.

The time series of the eight measurements done along line 1 are visualized in Figure 4 on the left. The cross section of the test specimen is also shown in the figure. It can be seen that there's a clear echo at about 16  $\mu$ s in measurements 1, 2, 7 and 8. The echo is getting smaller in the measurements 3 to 6. These four measurements cover the bonding area between shell and spar. The traveling sound waves dissipate in the plastic foam the bars are made from. The absence of the clear back wall echo in comparison of adjacent points allows a statement about the quality of the bond.

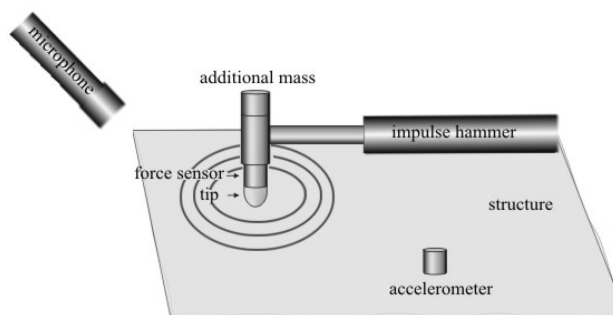
*Figure 5: Measurement principle of the local resonance spectroscopy.*

The ultrasound-echo is advantageous for the inspection of thick layers of GFRP. To detect shallow delaminations or air trapped near the surface, the local resonance spectroscopy can be used. The technique is an advancement of the simple tapping tests which are done by the surveyors during the regular inspections of wind turbine blades. The measurement principle is shown in Figure 5.

An impact is generated on the surface of a wind turbine blade using an impulse hammer. The structure starts to vibrate in the region of the excitation and a sound is generated. The excited sound is recorded using a microphone and depends on the contact stiffness of the surface [6]. The contact stiffness is linked to material and condition of the structure. As the contact stiffness also affects the contact time of hammer and material, the force recorded at the hammer tip gives additional information about the inner structure [7].

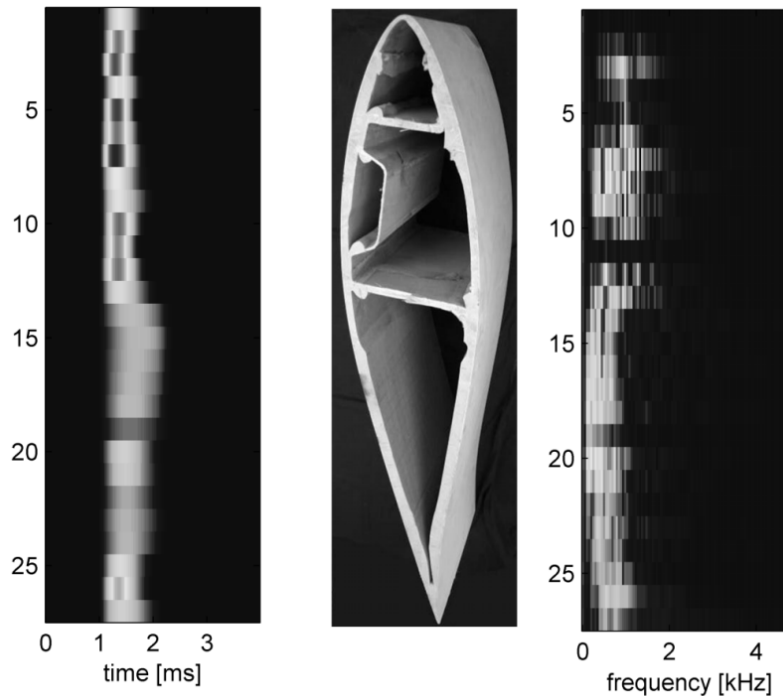
**Figure 6:** Left: Time series of the excitation force recorded along the cross section of a wind turbine blade. Middle: Cross section of a wind turbine blade. Right: Amplitude spectra of the recorded sound signals.

On the left of Figure 6 the time series of the excitation force recorded at the hammer tip is shown. Along the cross section of a wind turbine blade 27 measurements were done. Comparing the duration of the hammer signal to the cross section of the turbine blade it can be seen that the contact between hammer and surface is shorter if the impulse is excited to the GFRP areas of the blade.

The contact time is shorter because the material is harder. The sandwich areas are much softer and therefore the contact time is longer.

The excited sound of the hammer impulse is recorded using a microphone. The amplitude spectra are shown on the right of Figure 6. As the excitation is shorter the excited sound consists of a broader frequency range. The sound signals of the excitation on the sandwich areas contain only deeper frequencies. Furthermore the measurements 11 and 5 show the smallest sound amplitudes compared to the other measurements. These measurements were done on the bonding areas between shell and spar. The sound is probably damped within the bonding or the sandwich material of the spar.

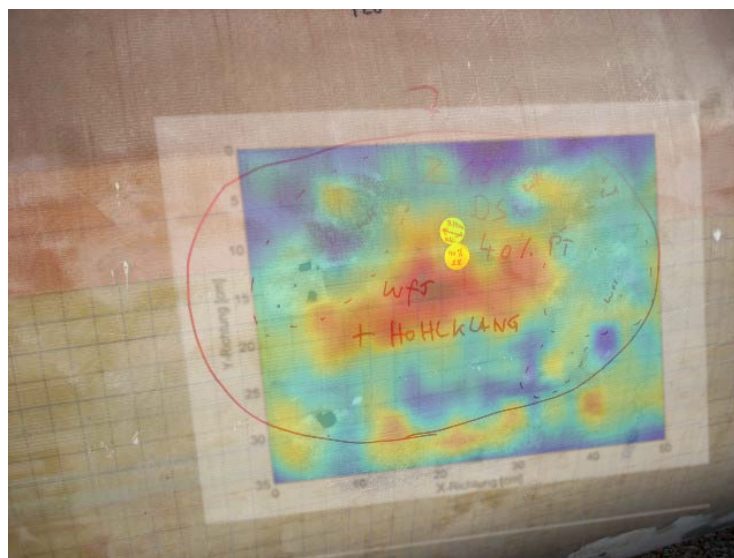
**Figure 7:** Halfwidth of the excitation signals at a damaged area of a turbine blade.

The results of a measurement at a damaged part of an entire wind turbine blade without a coating are shown in Figure 7. The halfwidth of the force signals recorded at the hammer tip are compared to the marks that were done by a surveyor. The darker area in the middle corresponds to a longer contact time between hammer and surface. This area was marked to sound hollow by the surveyor several weeks before the measurements took place. The brighter areas on the right and on the left top correspond very well to areas where air was trapped near the surface. Thus the technique is suitable to detect near surface damages.
