## Thermographic detection of defects in wood and wood-based materials

P. Meinschmidt

Wilhelm-Klauditz-Institut (WKI), Fraunhofer-Institute for wood research, Braunschweig,  
E-mail: mei@wki.fhg.de

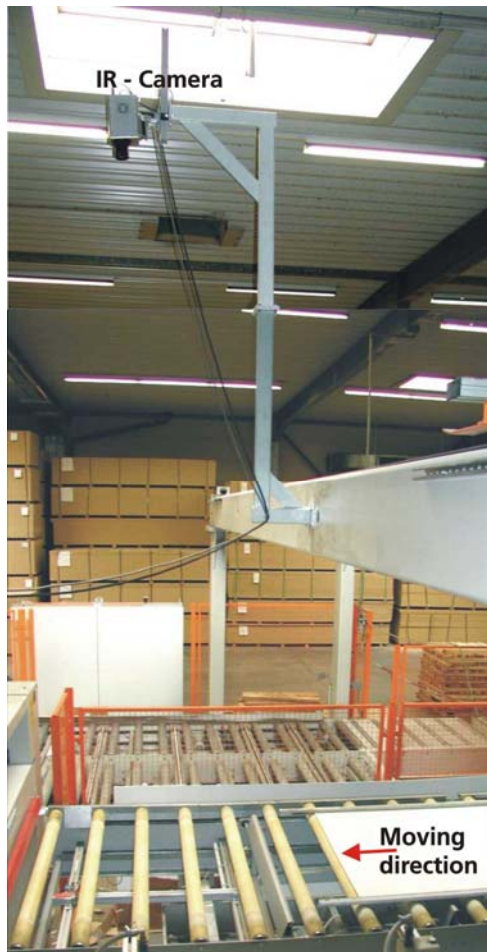
**Fig. 3:** Thermographic set-up just behind a paper laminating press. By moving the material along the infrared camera possible defects can be detected.

For measurements in industrial production lines -using the heat of the production process- the thermographic camera can be positioned on a steel frame above the conveyor belt (Fig. 3). Depending on the used camera lens, the distance has to be adjusted to observe the full width of the produced material.

The measurements can be carried out immediately behind the laminating press to use the production heat. Locally different temperatures like cold and hot spots observed on the surface, indicate defects either within the glued joint or in the carrier material.
