NON-DESTRUCTIVE EVALUATION OF MANUFACTURING ANOMALIES IN AERO-ENGINE ROTOR DISKS

W. D. Feist¹, G. Mook²; S. Taylor³; H. Söderberg⁴; A. Mikic⁵; T. Stepinski⁶

¹ MTU Aero Engines GmbH, München, Germany; ² University Magdeburg, Magdeburg, Germany; ³ Rolls-Royce plc, Bristol, UK; ⁴ Volvo Aero Corporation, Trollhättan, Sweden; ⁵ Snecma Moteurs, Evry, France; ⁶ University Uppsala, Sweden

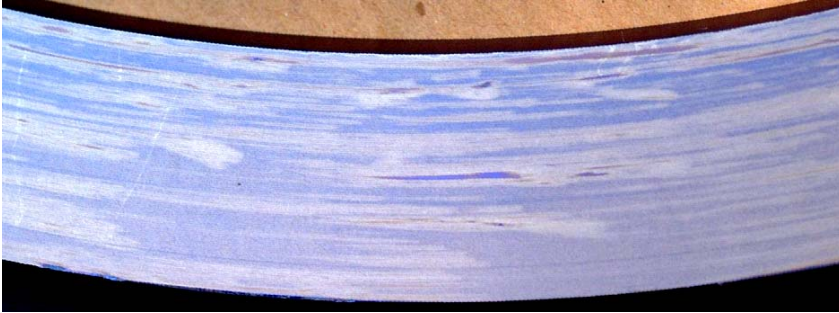
Fig 11: BEA image of distorted surface from friction with non cutting tool material after rework (no anomaly visible before the etch treatment) (prior to rework: see Fig. 3)

5.3.2 Blue Etch Anodize: The BEA process showed up streaks of different color that correspond to zones of different affected micro structure (Fig. 11).
