NONDESTRUCTIVE TESTING OF DALLAS COUNTY BRIDGE IN MISSOURI, USA

M. Ekenel¹, J. J. Myers¹

¹ Center of Infrastructure Engineering Studies (CIES), Department of Civil Engineering, University of Missouri-Rolla, Rolla, MO 65409, USA

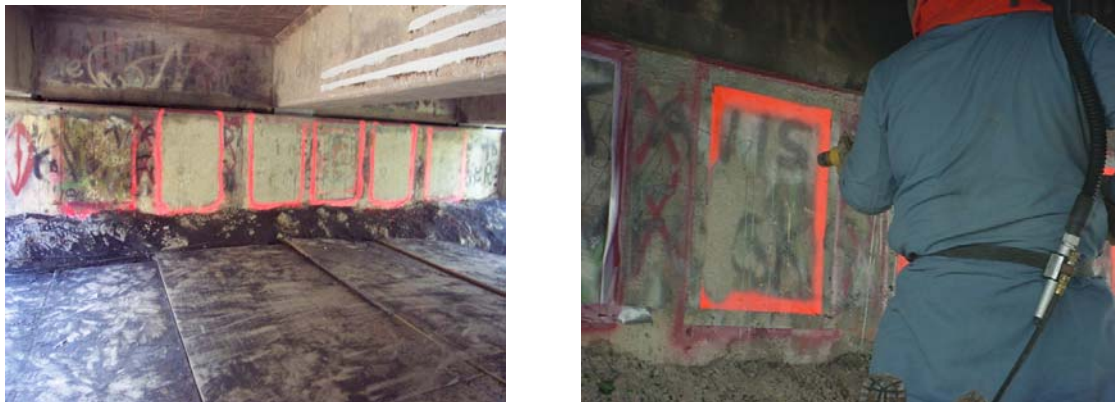
Figure 2. Surface Preparation on Abutment

Six different locations were selected on the south abutment and five different surface roughnesses were applied by contractor for study. Surface preparation was performed using a sand blasting technique. The sand used was carbon-based material, obtained from a coal plant by-product. One location was left unroughened to serve as a control unit. This location was cleaned using a wire brush to remove any dirt. The surface roughness of concrete was varied by adjusting the distance between surface and nozzle. All five locations have been scanned to determine the surface roughnesses of each relative to control unit, which had no preparation. Representative pictures are shown in Figure 2. The plan of abutment is presented in Figure 3.

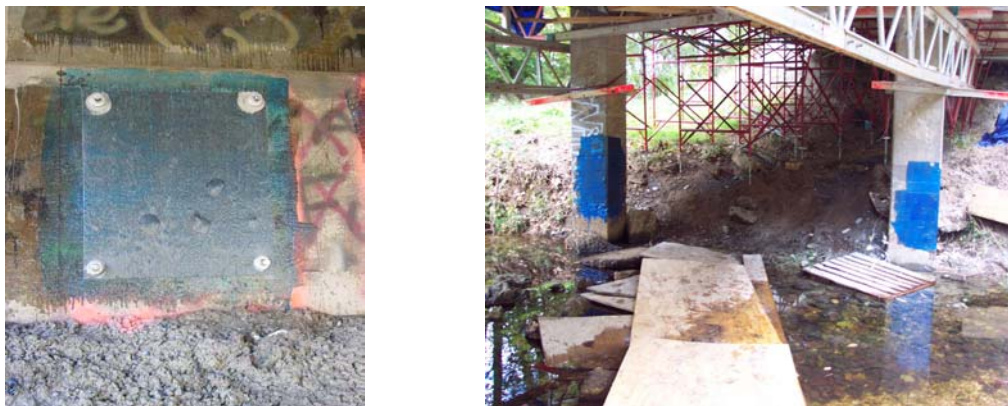
Figure 8. CFRP laminates with delaminations on south abutment and north bent

On-going Events: Rock Mechanics nondestructive group from UMR placed pullout test plates on four corners of each CFRP sheet [18]. These plates will be pulled out within five years to investigate the bond strength over time. Some examples are shown in Figure 8. Moreover, the same NDT group placed a special woven CFRP fabric that is externally bonded to a structural element by the wet lay-up method and enables to measure the angle of the fiber misalignment. Delaminations have been scanned by echo-impact [18], microwave technology [19] and ultrasonic NDT devices. These measurements will continue for five successive years and the results will be compared with each other.

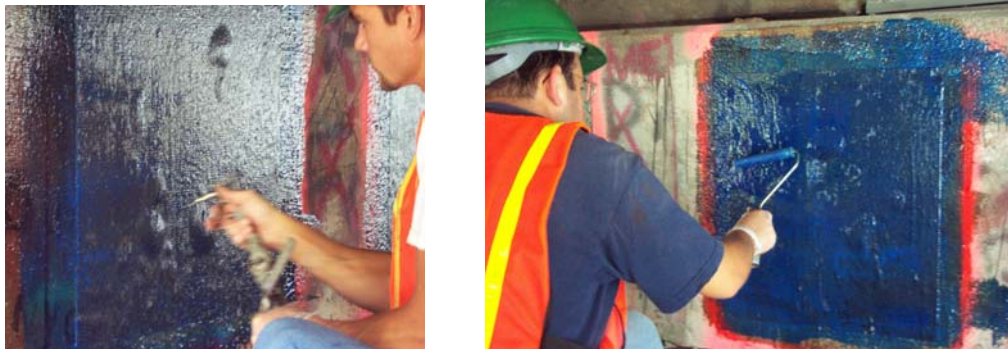
Figure 9. Creating delaminations

Delaminations were created on all CFRP laminates. Delaminations were formed by applying pressured air beneath CFRP sheet when the epoxy was in fresh state. Because it was hard to control pressured air, the number and the sizes of the delaminations could not be controlled. The final shapes were formed by rolling a roller spike around delaminations. Each single CFRP sheet contained different size and numbers of delaminations. Figure 9 shows how the delaminations were formed.
