HEALTH MONITORING OF COMPOSITE REPAIRS OF AIRCRAFT STRUCTURES

The work focuses on aircraft structures and their parts which are designed using the damage tolerance approach. The main goal is design, verification, monitoring and certification process of fatigue crack repairs of the selected critical places on the Czech light combat jet L-159A. The repairs were carried out using carbon/epoxy composite straps and patches and cold-setting glue SW 9323. A new type of repair was developed and tested. It applied a boron/epoxy composite and FM 73 glue system with the grit blast/silane surface preparation. The aim of the tests was to prove better characteristics of the repair with the use of boron double-sided patch in comparison to the carbon repair as identified by fatigue testing. Possibility of application of the health monitoring methods is discussed here, especially the acoustic emission method and application of strain gauges and optical fibers with Bragg grating for the detection of strains in monitored or repaired locations.

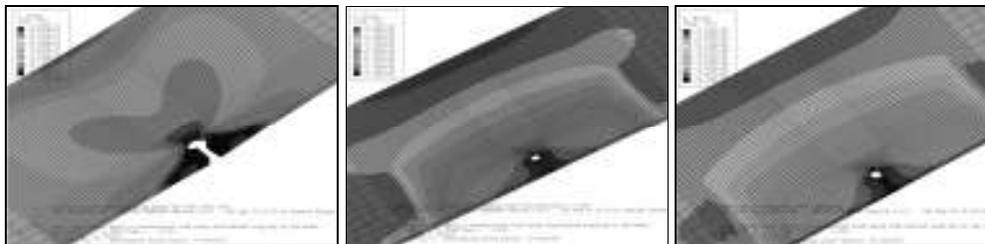
Fig. 9,10 & 11. Mises stress distribution in the aluminum, without and with carbon or boron patch respectively. Note the effect of compliance discontinuity.

The distribution comparison of illustrate (see Fig. 9,10 & 11) that the stress near the cracked/drilled hole region of the aluminum substrate have been dramatically reduced even when compared to the carbon patch case. An effect due to the compliance discontinuity generates high stresses at the ends of the adhesive and in fact satisfies the failure criterion at the regions located most longitudinally distal from the cracked/drilled hole region, see Fig. 12 and 13. It will be verified experimentally.
