Use of Sonic and GPR Tests to Control the Effectiveness of Grout Injections of Stone Masonry

Anna ANZANI, Luigia BINDA, Maurizio LUALDI, Cristina TEDESCHI, Luigi ZANZI
D.I.S. Politecnico di Milano, Milano, Italy

Abstract. Some specimens reproducing three leaf stone masonry walls frequently used in Italy, have been built at DIS, Milan, using two different types of stones and tested under compression and shear, up to failure. Subsequently the damaged wallettes were repaired by injection and the effectiveness of the injection was controlled by several NDT (non destructive techniques)

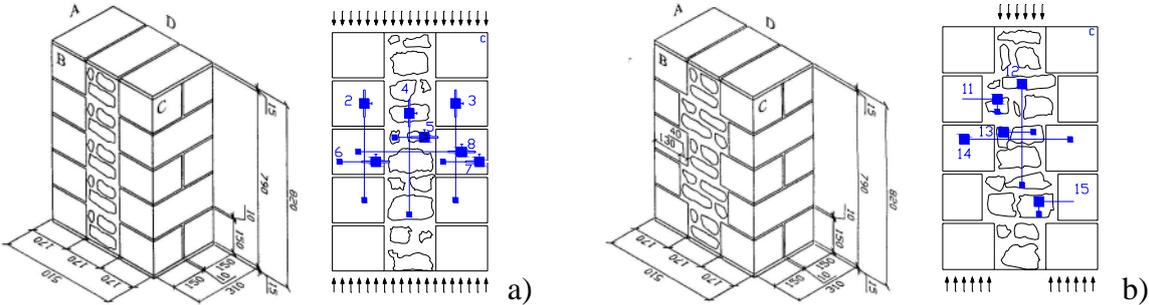
Figure 1. Geometry of the walls and types of loading conditions: (a) flat collar joints and compression test; (b) keyed collar joints and shear test.

The specimens were built choosing the materials and morphology in order to reproduce the behaviour of multiple leaf walls and piers frequently encountered in historical centres. Two external leaves, made of stone blocks with horizontal and vertical mortar joints, were connected to an internal leaf in rubble masonry made of mortar and pebbles of the same stone. Two types of connection between the leaves (with flat collar joints and with keyed collar joints) were adopted to build specimens of dimensions $310 \times 510 \times 790 \text{ mm}^3$ (figure 1).

Two types of load conditions were considered: compression tests (figure 1a) and (pseudo-) shear tests (figure 1b).

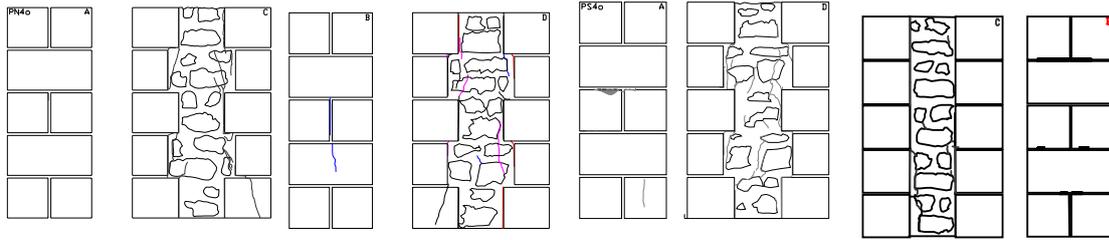
Figure 2. PN4 after shear test.

Figure 3. PN6 after shear test.

Figure 4. PS4 after shear test.

Figure 5. PS3 after compression test.

Considering the pseudo-shear tests, the Serena stone specimens presented an average peak load of about 1.5 times higher than the ones of Noto due to the higher strength of the stones. Analysing the crack patterns, many vertical and sub-vertical cracks on the inner leaf can be detected. In the case of the Noto stone specimens, such cracks often cut the stones (figures 2 and 3), whereas in the case of the Serena stone specimen cracks tended to diffuse in the mortar at the interface with the stone fragments (figure 4). This is due contemporarily to the better adhesion between the mortar and the Noto stone, characterized by a higher porosity than the Serena one, and to its lower strength. The outer leaves, in the case of the Noto stone, suffered from some cracks appeared at the base of the specimens.

The failure of the Serena specimen PS3 tested in compression was not achieved being the required load beyond the limits of the testing machine. The inner leaf underwent very low vertical strains compared to the external ones, and almost naught horizontal strain. This indicates that no collaboration between the leaves took place, that the load-bearing role was mainly played by the outer leaves, and that the outer leaves exerted a confining action towards the development of transversal deformations of the inner leaf. This was confirmed by the crack pattern, where only the separation between the leaves can be seen (figure 5).

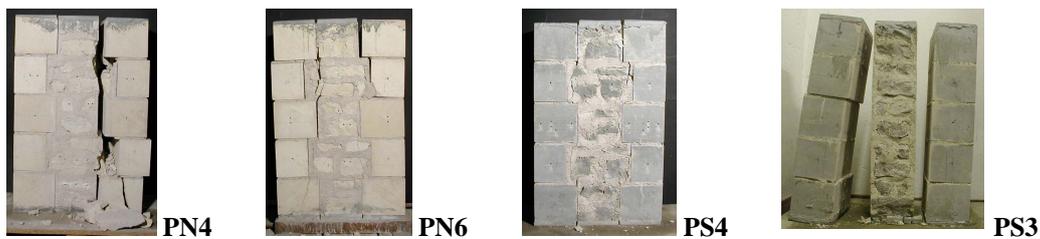
Figure 6. Aspect of the specimens once removed from the testing machine.

Once removed from the testing machine and stored in the laboratory, the aspect of the walls was that visible in figure 6. Before repairing them by injection, a partial reconstruction of the outer leaves was necessary as appears in figure 7a. The injection was aimed to fill the main cracks appeared at the interface between inner and outer leaves. The materials chosen for the intervention were completely inorganic mixes based on microfine pozzolanic binders.

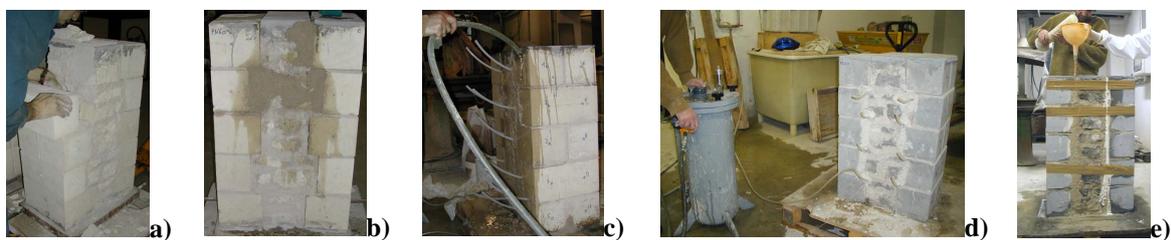
Figure 7. Phases of the repair by grout injection.

The walls were injected in wet conditions through small pipes drilled at regular distances along the collar joints, introducing the grout at pressure not higher than 6 atm starting from the lower pipes. Once the mix started to exit from the upper level of pipes they were then injected too. In the case of wall PS3 the injection was carried out by gravity, once the leaves constituting the wall had been re-connected as shown in figure 7e and the collar joints had been sealed for a depth of about 10 mm in order for the mix not to leak. After the wall reconstruction and after the grout injection the walls were tested by NDT as described in the following paragraph.

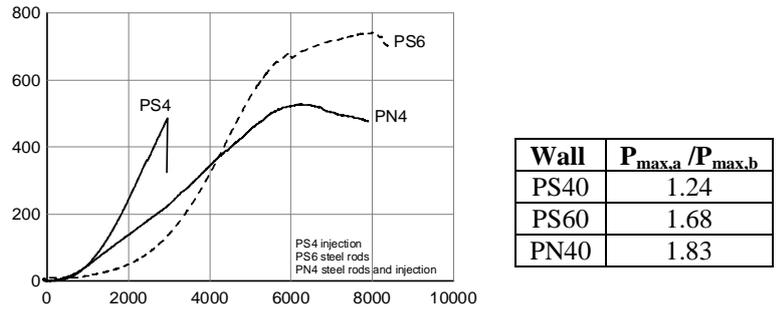
Figure 8. Results of pseudo-shear tests on the repaired walls and ratio between the maximum load after and before the repair ($P_{max,a} / P_{max,b}$)

After about seven months of curing, two of the walls were tested again in pseudo-shear conditions. The results are reported in figure 10 where a comparison with wall PS6 repaired only through steel rods can be done. A higher load increase was achieved in the case of the wall PN4 repaired with both techniques; the use of grout injection only resulted into a

stiffer and more brittle behaviour, whereas in the case of steel rods only a particularly ductile behaviour was performed.

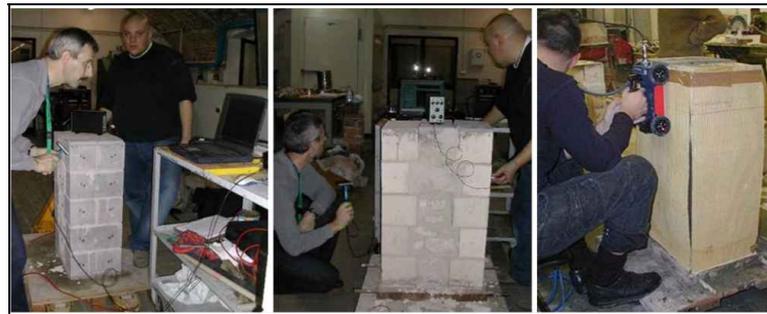
Figure 9. Sonic measures and georadar survey.

Sonic measures and georadar survey (figure 9) have been carried out on the masonry specimens in order to study the possibility of estimating the effectiveness of the injections, that is the penetration and diffusion of the grout soon after injection. The aim is the application of NDT to define in-situ the effectiveness of the injection technique.

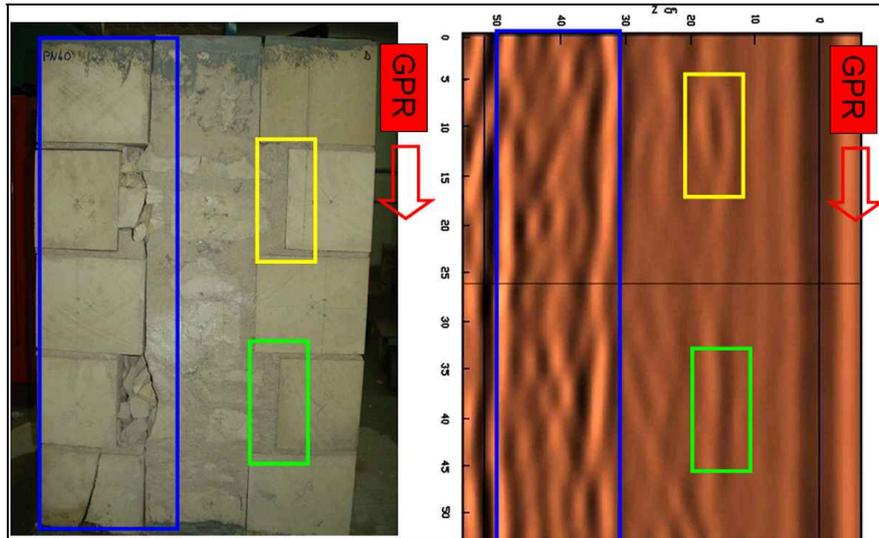
Figure 10. GPR 2D survey carried out by a 1.5GHz antenna on wall PN40.

Before the injection, a GPR 2D surveys were carried by a 1,5GHz antenna in order to produce a map of cracks and voids present inside the masonry (figure 10).

Many fractures are evident in the area enclosed in the blue rectangle, corresponding to one of the interfaces between inner and outer laves, whereas the yellow and green rectangles point out smaller cracks corresponding to the second interface.

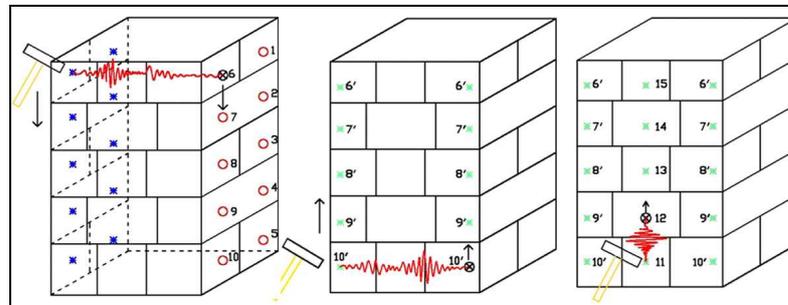
Figure 11. Scheme of the geometry of the sonic measures: on the left transmission mode, in the middle horizontal surface mode and on the right vertical surface mode.

Sonic measurements have been taken by a simple instrumentation: a hammer-trigger and an accelerometer. The sonic velocity was measured horizontally in transmission mode, hitting the specimens with the hammer according to a grid sketched symmetrically on the two short sides of the walls and measuring with the accelerometer on the correspondent points on the opposite side. Surface measurements were also performed both horizontally and vertically (figure 11) on one of the larger sides of the specimens, by hitting with the hammer and recording with the accelerometer in different points of the grid sketched on same side.

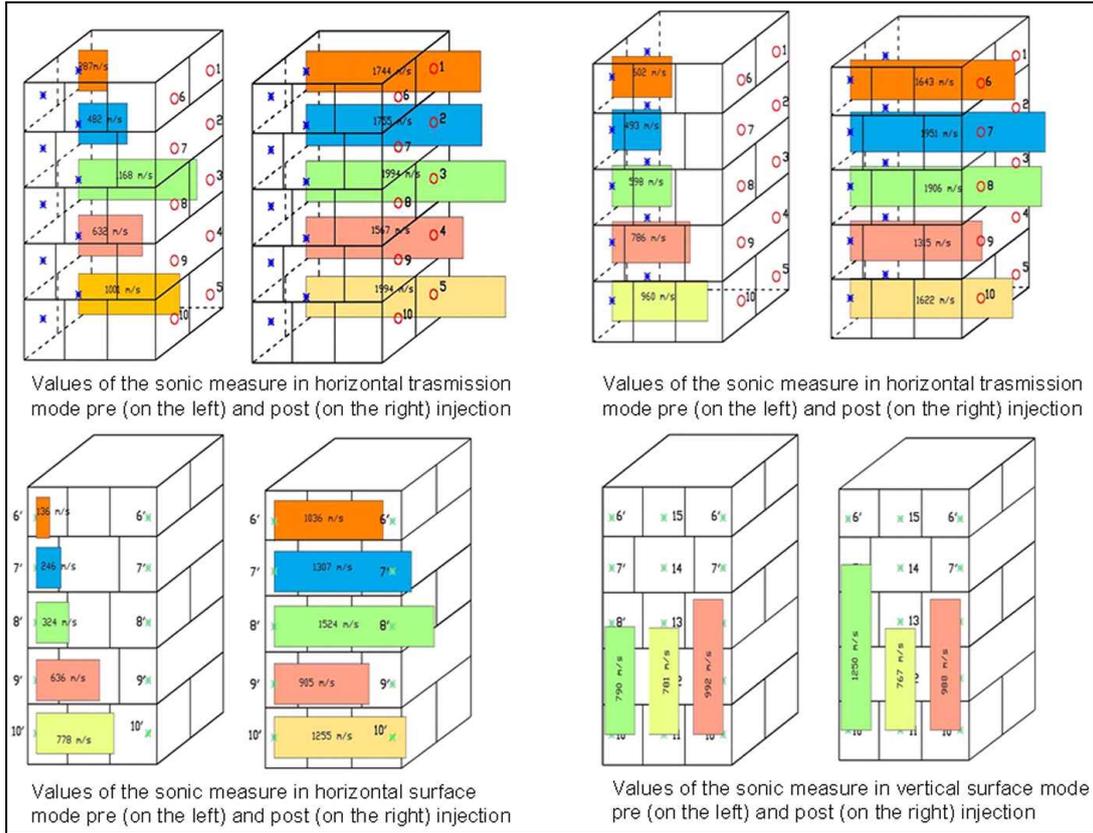
Figure 12. Values of sonic velocity pre and post injection acquired with different geometry on wall PN40.

Two campaigns of sonic measures have been carried out before and after the injections in order to determine the variation of the speed of the elastic waves due to the injection. As expected, a remarkable increase of sonic velocity was generally observed as a result of the injections (figures 12 and 13).

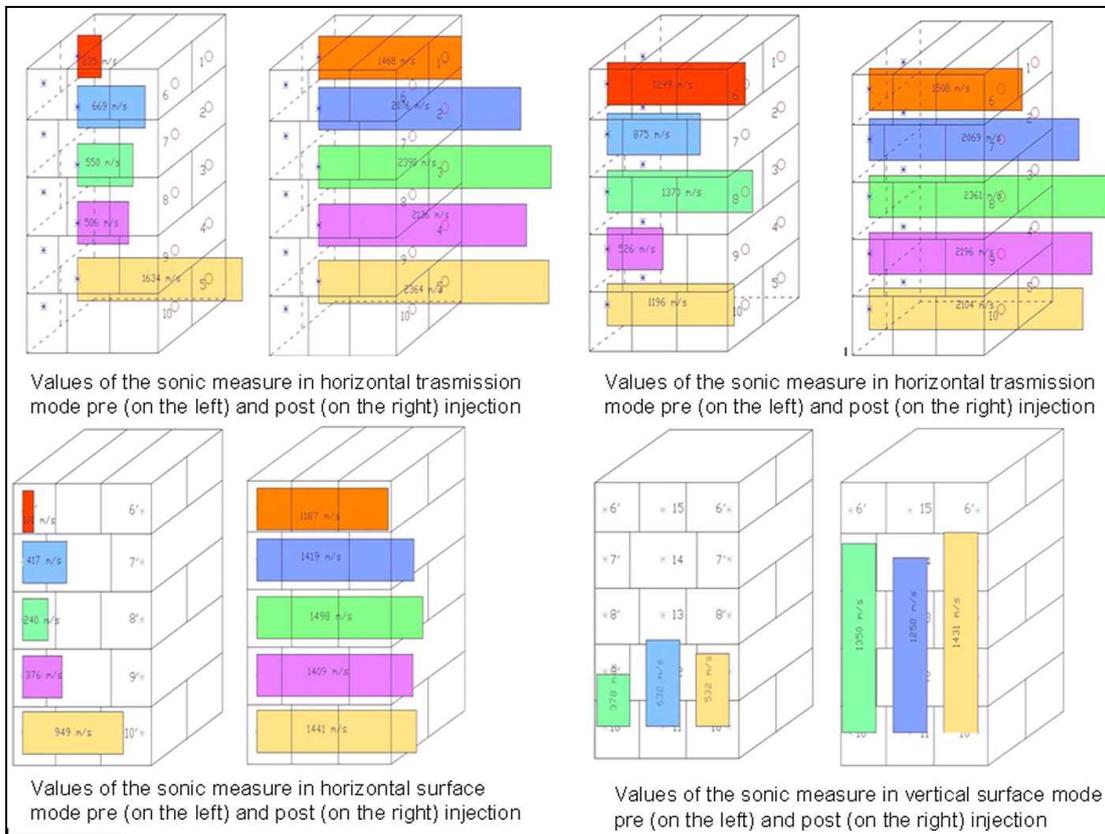
Figure 13. Values of sonic velocity pre and post injection acquired with different geometry on wall PN60.
