ACOUSTIC EMISSION DURING THE SCRATCH-TEST ON GALVANIZED STEEL

Keywords: Coatings, galvanized steel, acoustic emission, scratch test, microfracture.

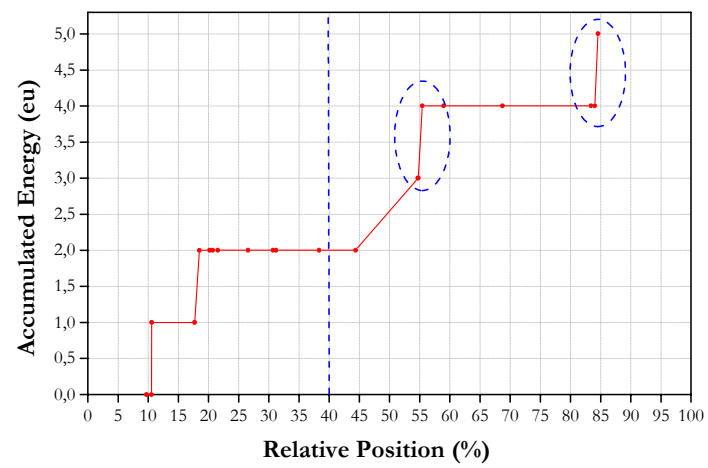
Figure 4 b (Middle): Accumulated acoustic against relative position in %. Sample H₁. Scratch 1.

When AE parameters were analyzed, we found a strong correlation between AE and microscopic results. Figures 4 (a-c) show respectively the parameters energy, cumulative energy and cumulative number of hits for the scratch 1 of sample (H_1). The remarkable steps in cumulative parameters and peaks in energy, in graphs where the independent variable is the % of total scratch length, are very close to the position of folds in micrographs (showed in Table 2), and would correspond to gamma/zetha and zetha/etha interface positions. Figures 5 (a-c) and 6 (a-c) show similar results in scratch tests performed respectively on samples M_1 (scratch 3) and L_1 (scratch 2). It was observed that AE activity increased when the coating thickness decreased. Moreover the steps in cumulative energy, which corresponded to development of significant folds (see Table 2), showed up at lower % positions along scratch, that is to say at lower depths inside coating, when thickness was lower. Thus, coating performance improved when going from lower to higher thickness in the studied range. Results of the present paper constitute a step forward to recommend the use of AE parameters as indicators of coating failure, in on line measurements, instead of the a posteriori microscopic determinations. Future work will be related with the evaluation and comparison of hot-dip galvanized and electrolytic galvanized samples, with different coating thickness and different corrosion degrees.

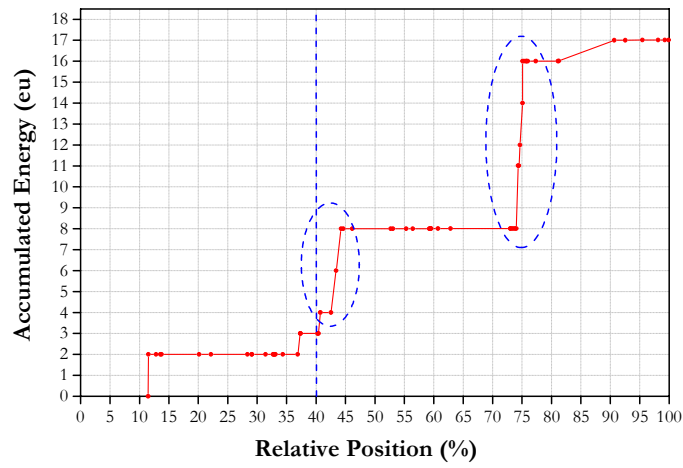
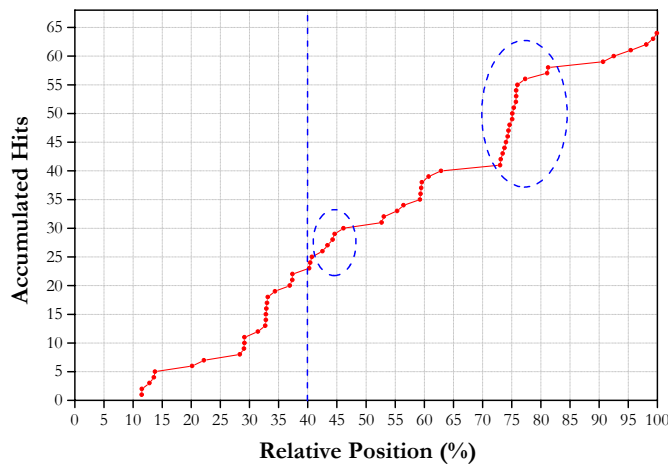
Figure 5 a (Up): Acoustic energy against relative position in %. Sample M_1 . Scratch 3.
 Figure 5 b (Middle): Accumulated acoustic against relative position in %. Sample M_1 . Scratch 3.
 Figure 5 b (Down): Accumulated number of hits against relative position in %. Sample M_1 . Scratch 3.

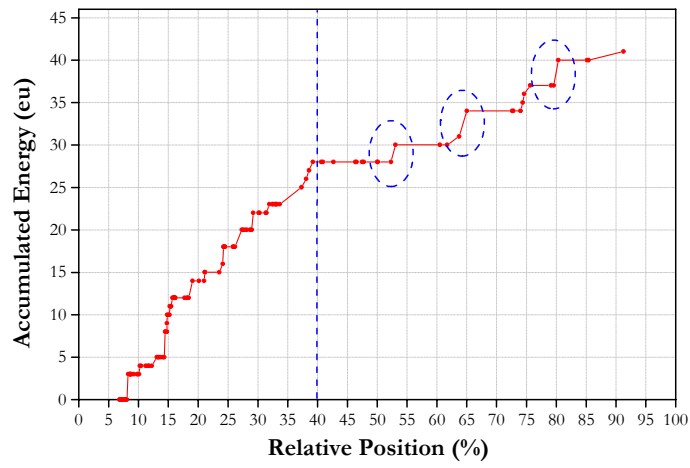
Figure 6 b (Middle): Accumulated acoustic against relative position in %. Sample L₁. Scratch 2.
