Application of Ultrasonic C-Scan Techniques for Tracing Defects in Laminated Composite Materials

NATIONAL TECHNICAL UNIVERSITY OF ATHENS

School of Naval Architecture and Marine Engineering, Shipbuilding Technology Laboratory

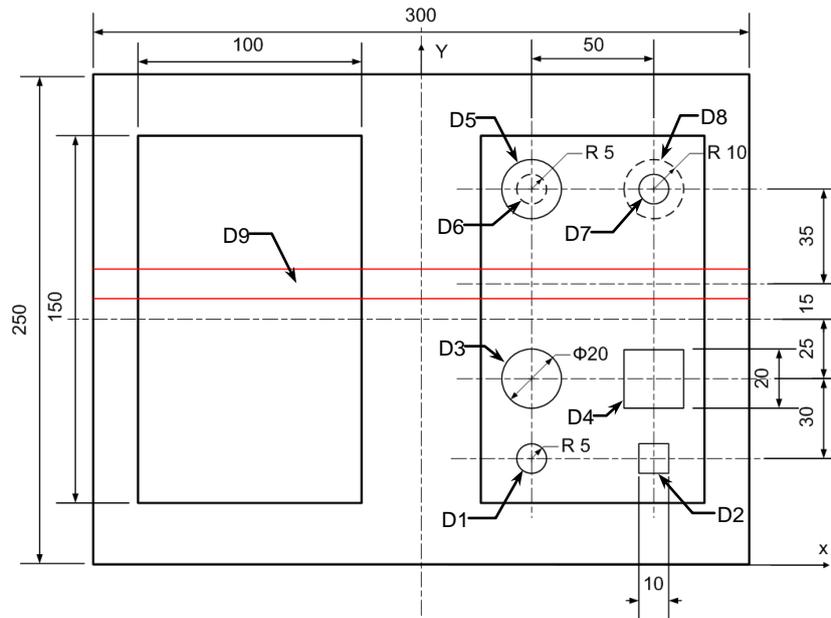
Figure 1 : Layout of specimens with artificial defects

The four test laminates had dimensions 300 x 250 mm, as it is shown in Figure 1. Two specimens were cut from each test laminate, each one having dimensions 100 x 150 mm. The first specimen (on the left in Figure 1) is a reference specimen without any polyamide artificial defects and the second (on the right in Figure 1) included all the embedded polyamide artificial defects. In GFRP laminates, the woven roving fiber reinforcements were layered with their warp direction along y axis, whereas in CFRP laminates, the unidirectional fiber reinforcements were layered with their warp direction along x axis.

In total eight separate polyamide artificial defects were embedded in each one of the defected specimens. These defects, designated D1 to D8 (see Figure 1), had the specific dimensions and were placed at the specific x-y positions shown in Figure 1. The distances between these defects were chosen so that their presence does not influence the detection of their neighbor ones. More specifically, the detailed characteristics of all these defects are as follows:

- D1: circular shape, radius = 5 mm, embedded between layers No. 4 and 5 (layers numbering starts from the mould side of the test laminate).
- D2: square shape, side = 10 mm, embedded between layers No. 4 and 5.
- D3: circular shape, radius = 10 mm, embedded between layers No. 4 and 5.
- D4: square shape, side = 20 mm, embedded between layers No. 4 and 5.
- D5: circular shape, radius = 10 mm, embedded between layers No. 3 and 4 (solid line in Figure 1).
- D6: circular shape, radius = 5 mm, embedded between layers No. 7 and 8 (dashed line in Figure 1).
- D7: circular shape, radius = 5 mm, embedded between layers No. 3 and 4 (solid line in Figure 1).
- D8: circular shape, radius = 10 mm, embedded between layers No. 7 and 8 (dashed line in Figure 1).

In addition to the above eight polyamide defects, a ninth one was manufactured (D9), consisting of a wrinkle of the sixth layer from the mould surface, along the full length of the test laminate (see red lines zone in Figure 1). The width of this wrinkle was varying from 10 to 15 mm. In the GFRP test laminates, this type of defect was manufactured by cutting the sixth layer in two pieces and overlapping them, since it was very difficult to create such a small wrinkle with a woven roving glass reinforcement. The objective of defect D9 was to investigate the capability of the method to detect and dimensionalize such types of defects, which are common in typical marine composite structures.

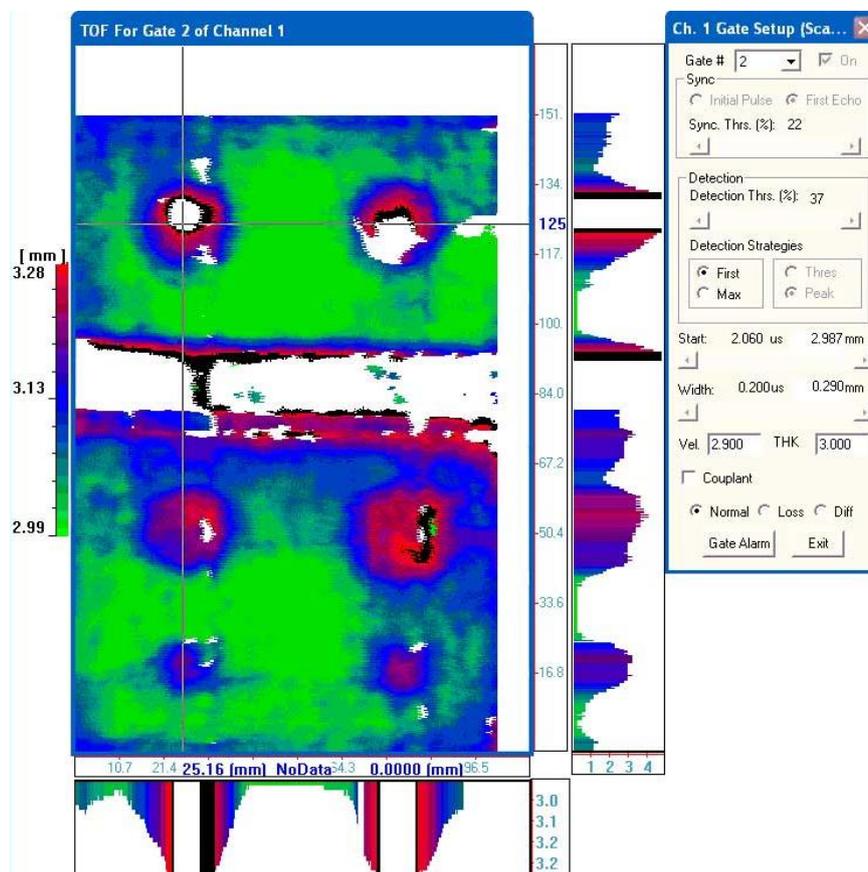
Figure 2 : TOF C-scan of CFRP-VI specimen focused at backwall

Figure 2 presents the Time Of Flight (TOF) C-scan of the CFRP specimen with defects. The gate was placed at backwall echo and the first-peak strategy was used in order to measure the thickness of the specimen. The thickness variation is presented in Figure 2 with different colors (see legend on the left). The gate width was properly adjusted in order to monitor the maximum thickness value of the wrinkle (see Table 1). Figure 2 shows that the majority of the specimen thickness is around the nominal value of 3 mm (green color), however there are areas where thickness is larger, like those around and on the artificial defects and at the wrinkle (blue and red color). The horizontal orthogonal white color zone indicates that the wrinkle area has thickness greater than 3.28 mm. The two circular white zones owe to the existence of the two different sized, overlapping defects (D5, D6 and D7, D8), which cause the absorption of a big amount of the acoustic energy and, therefore, no data points are reported there. In the B and B' scans shown in the horizontal and the vertical axis of the image, respectively, the thickness variation along the shown cross hair lines is presented. The aforementioned no data areas are monitored also in these scans.

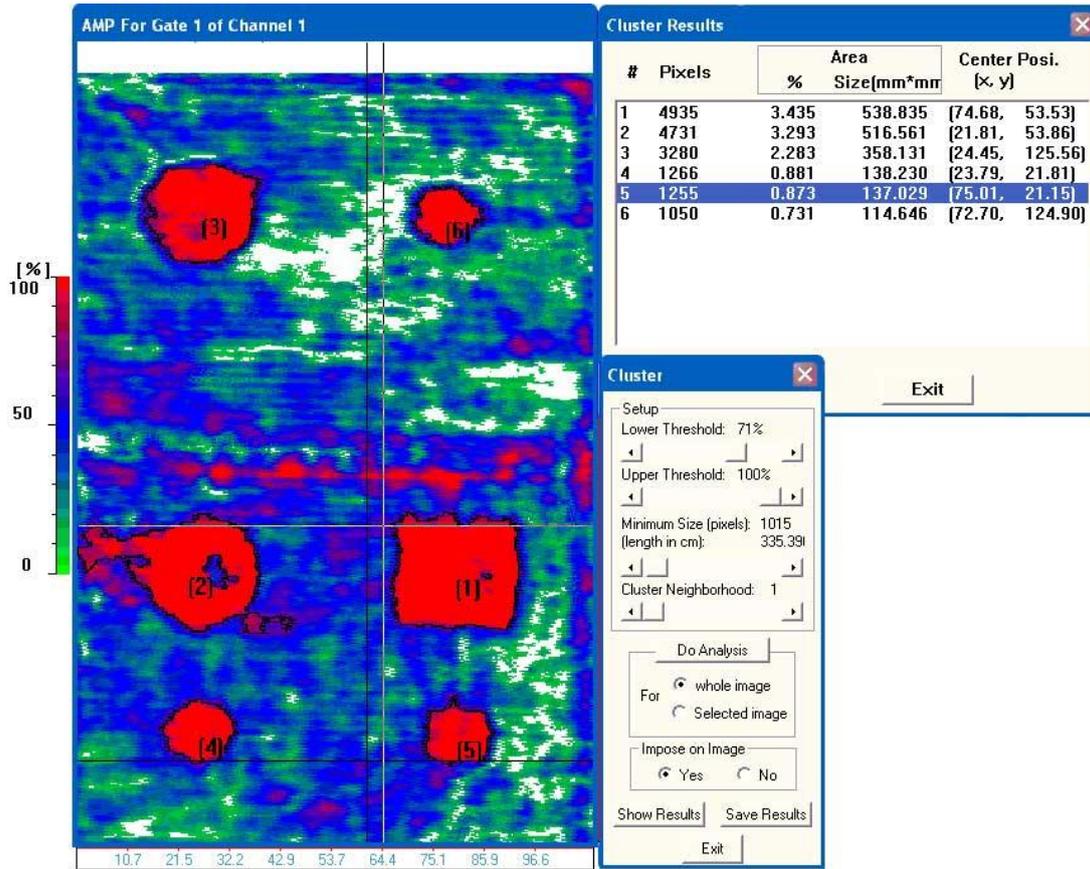
Figure 3: Amplitude C-scan of CFRP-VI specimen focused between the 3rd and the 5th layer.

In Figure 3 the amplitude C-scan of the CFRP specimen with defects is shown. The gate was properly adjusted in order to inspect the area from the top of the 3rd layer to the bottom of the 5th layer. The max-peak strategy has been applied in order to monitor all defects which have initially been placed between the 3rd and the

4th layer, that is all defects except D6 and D8. These six defects are clearly shown in Figure 3. The same figure shows also clearly the direction of the fibers, which is parallel to the short side of the specimen.

The last two columns of the “Cluster Results” window in Figure 3 present the monitored data for the coordinates of the center of each defect (defects numbering is shown in the figure), where x- and y- axes origin is at the lower left corner of the picture. The comparison of these data to the corresponding initial values shown in Figure 1 leads to the conclusion that the defects remain almost in the same position as they have been placed during the construction phase. Moreover, it is shown that the applied method scanned accurately the shape of each defect.

The “Cluster Results” window in Figure 3 presents also the ultrasonically monitored area of each defect (fourth column). By comparing these values to the original defect areas that can be calculated from Figure 1, we see that the ultrasonic method significantly

overestimates the area of all defects, from 14 up to 73%. These differences may probably owe to the fact that all layers above the artificial defects exhibit a small bending over the defects. As a result, echoes from the areas adjacent to the defects are amplified up to 70% of FSH and they are recognized as defect areas.

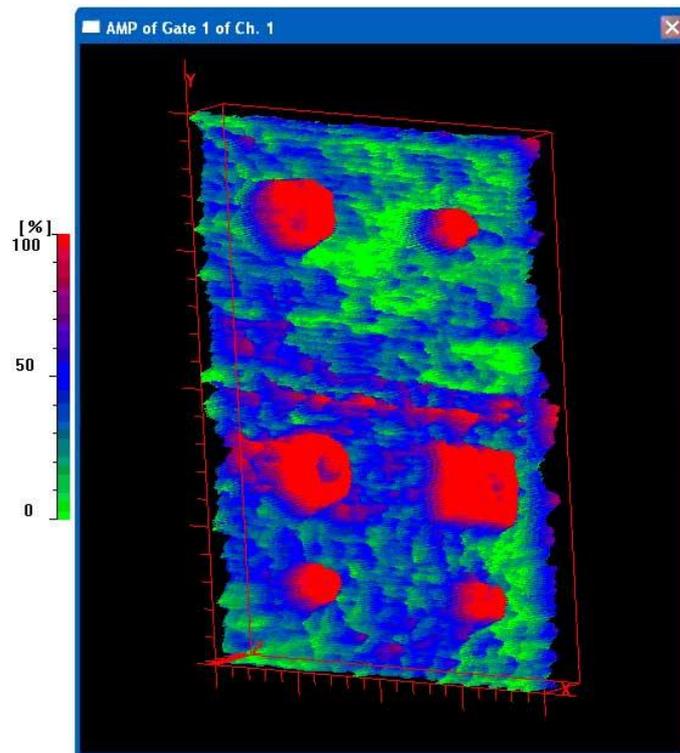
Figure 4: 3-D amplitude C-scan of CFRP-VI specimen focused between the 3rd and the 5th layer

In Figure 4, a 3-D amplitude C-scan of the CFRP specimen is given, focused from the 3rd down to the 5th layer. The six defects of the specimen D1, D2, D3, D4, D5 and D7 are clearly shown in this figure. They are colored in red, since these areas are highly reflective to the acoustic energy.

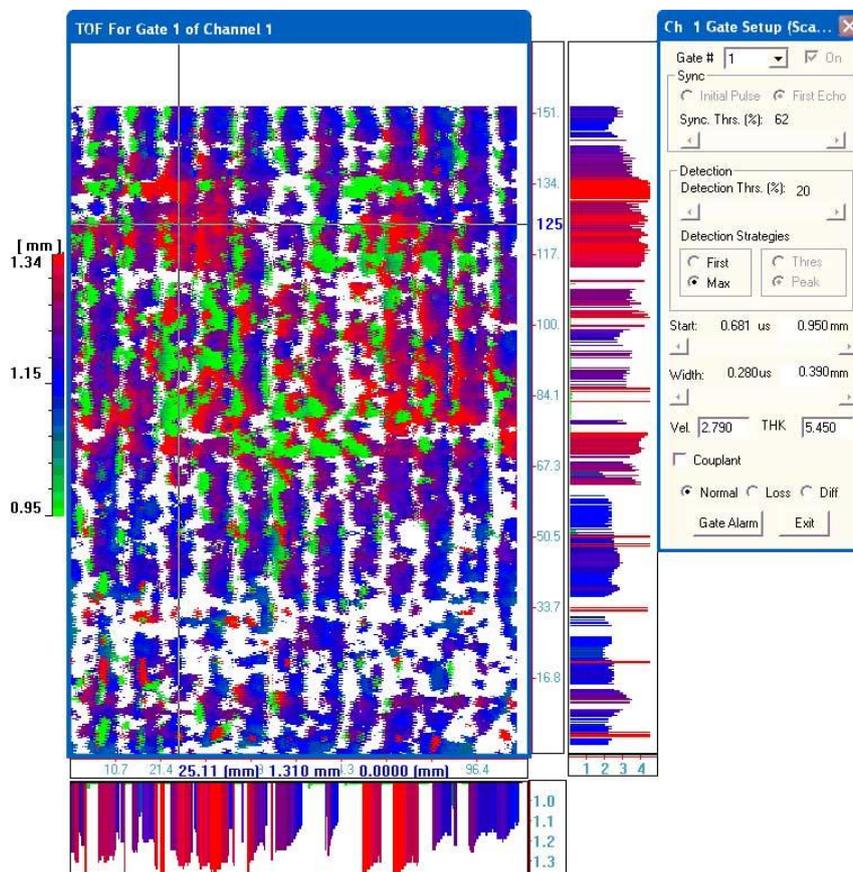
Figure 5. TOF C-scan of GFRP-VI specimen focused at the 3rd layer

Figure 5 shows the TOF C-scan of the GFRP specimen, focused at the 3rd layer in order to detect defects D5 and D7. The echoes coming from the glass fibers result in a more or less uniform color motive of the inspected surface. In this respect, Figure 5 clearly shows the general pattern of the glass yarns, constituting the woven roving reinforcement. The orientation of the fibers is clearly shown. The echoes coming from the defects have the same TOF and, therefore, are much more

concentrated and correspond to a single color (red areas in the figure). In order to better define these areas, we also take into account that their size must be considerably larger than the size of the repeated square crossings of the fibers in the warp and fill directions, whose dimension is approximately 4 mm.

However in the B and B' images in the horizontal and vertical axis of the image, respectively, it is shown that these red areas are not clearly defined, but they are mixed together with the echoes coming from the glass fibers. Therefore, these areas do not have a specific shape and well defined borders, as it is evident from Figure 5.

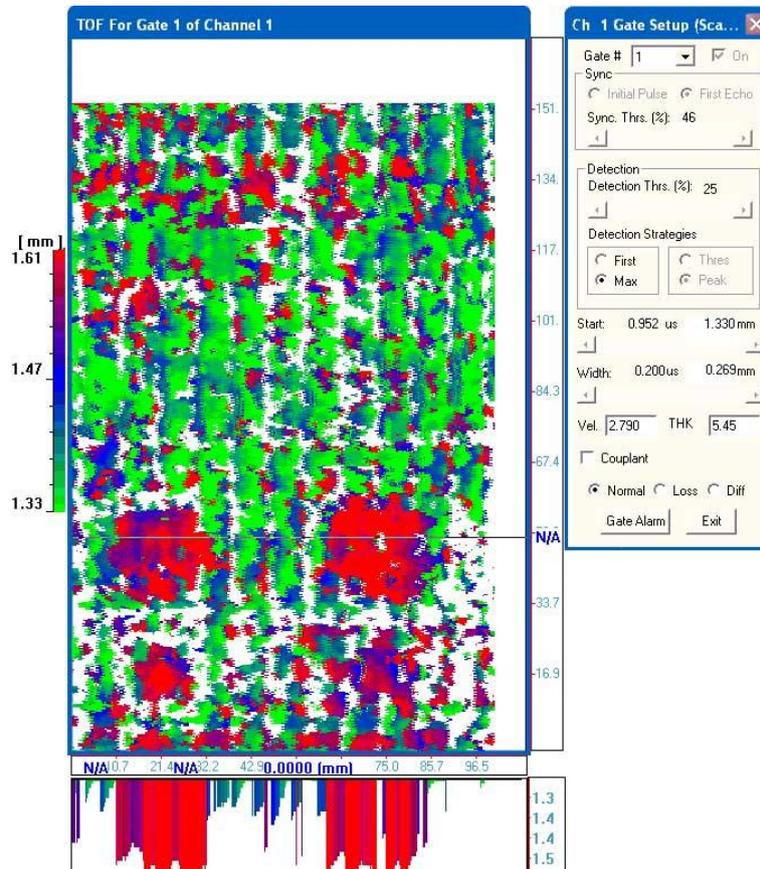
Figure 6. TOF C-scan of GFRP-VI specimen focused between the 4th and the 5th layer

Figure 6 shows the TOF C-scan of the GFRP specimen, focused at the area between the 4th and the 5th layer, in order to detect defects D1 to D4. The red colored areas, which correspond to the two aforementioned defects, are reported to a depth of approximately 1.6 mm, which is very close to the actual through thickness position of these defects. Although the existence of the defects is indicated in Figure 6, their geometry is once more not clearly defined, as was also the case in Figure 5.

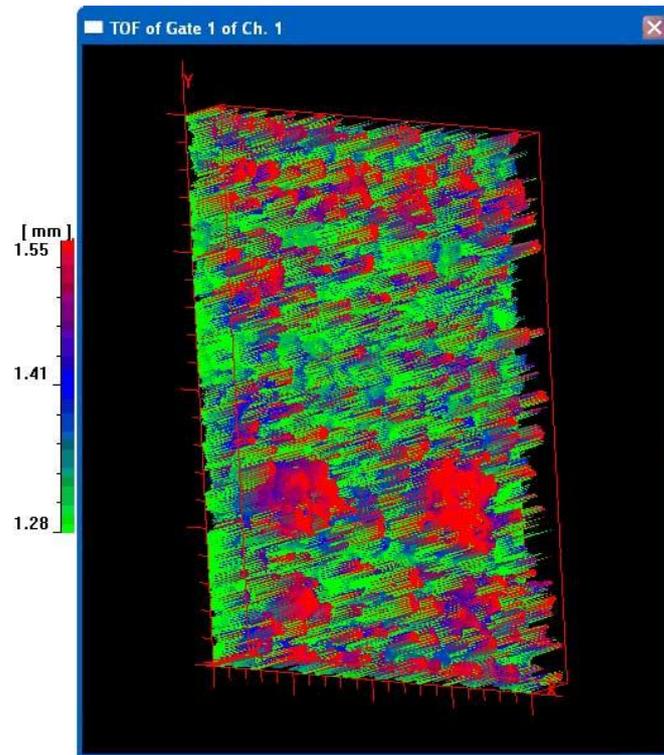
Fig 7. 3-D TOF C-scan of GFRP-VI specimen focused between the 4th and the 5th layer

In Figure 7, a 3-D TOF C-scan of the GFRP specimen is given, focused from the 4th down to the 5th layer. Contrary to the CFRP specimen case, the four defects D1 to D4 are not clearly defined in this figure. Echoes with high amplitude at the same TOF are monitored, but the shape of the resulting area is not geometrically specific.
