**Ultrasonic and Eddy current
Examination of Railway Rolling Stock**

Ioannis TSOMPANIDIS, ELESYL OE, Athens, Greece
(Tel:+30.210.6134689, Fax:+30.210.6134792, E-mail: itsompanidis@railwayndt.com)

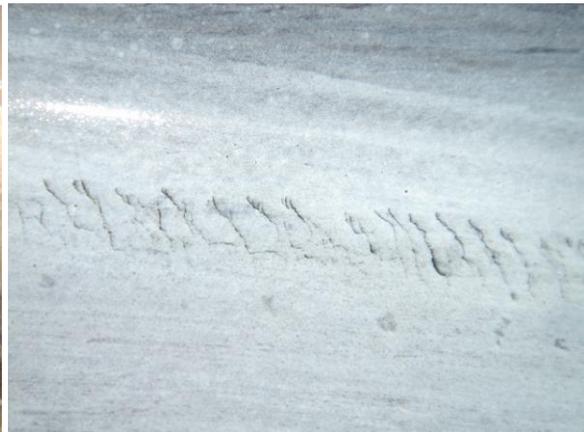
RCF in wheel tyre (2)

The most common defects in wheel tyres is RCF cracks, flats and internal cracks initiated from manufacturing defects with diameter less than 1 mm. For tyres inspection, ultrasonic, eddy current and magnetic particle testing utilized.

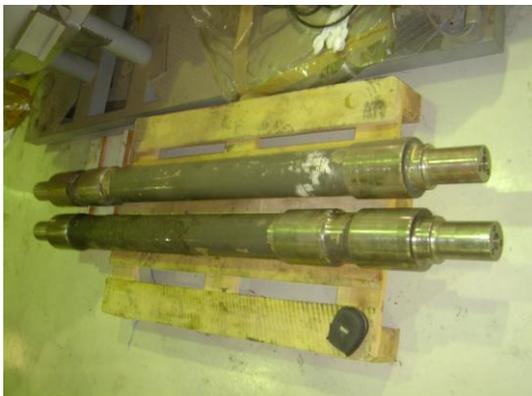
Calibration is made by the use a block contains EDM notches with depths of 0.2 mm, 0.5 mm, 1.0 mm and 2.0 mm.

Axles for calibration

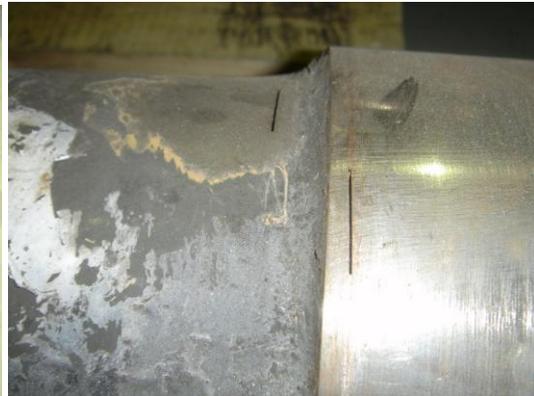
EDM notch for calibration in axle

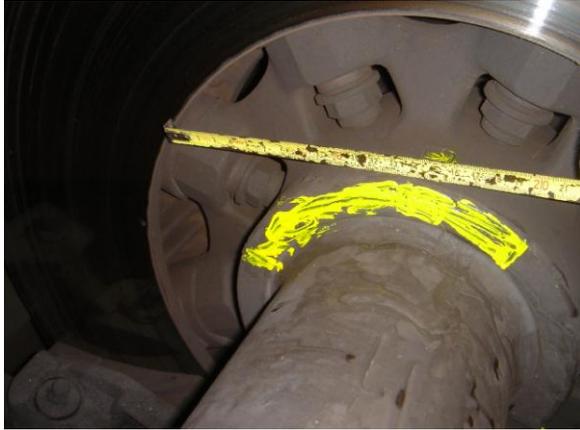
Axle with discontinuity indication (1)

Usually cracks can initiate in geometry changes, but during inspection with ultrasonic angle probes we observe internal defects not easily detectable by ultrasonic normal probes. From this areas can also initiated internal cracks. Also corrosion with depth of 0.3 mm observed in specific areas of wheels seats, with rarely indications in disk brake seats. Not any indication observed in "motion" seats.

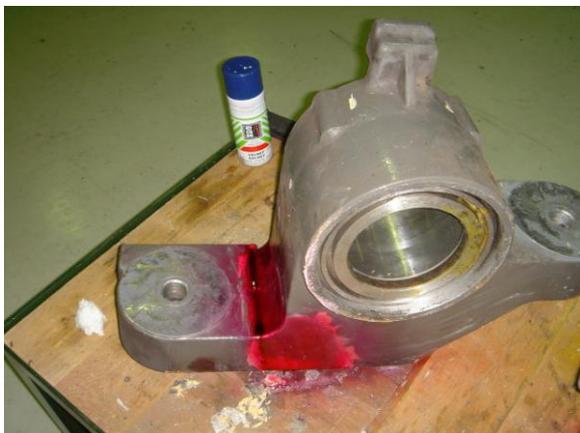
Axlebox crack verification (1)

All the areas giving signals above than of 0.5 mm EDM notch examined by liquid penetrant, after paint removal.
