## Subsea Automated Ultrasonic Inspection

**Leif Jeppesen, Jørgen Dam, Hans Ole Olsen**  
FORCE Technology  
Park Alle345, 2605 Broendby  
Denmark

### ABSTRACT

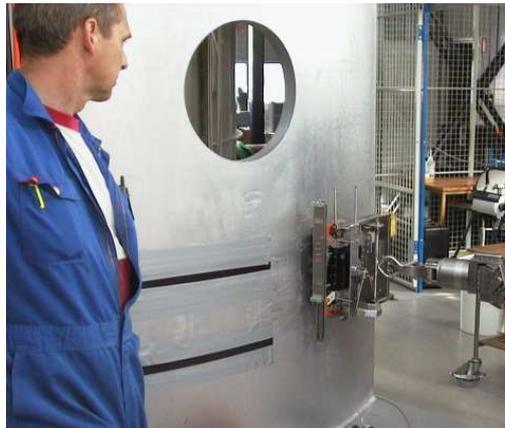
**Figure 2: Test of prototype frame for ROV handling. The test uses a manipulator similar to the ROV manipulator.**

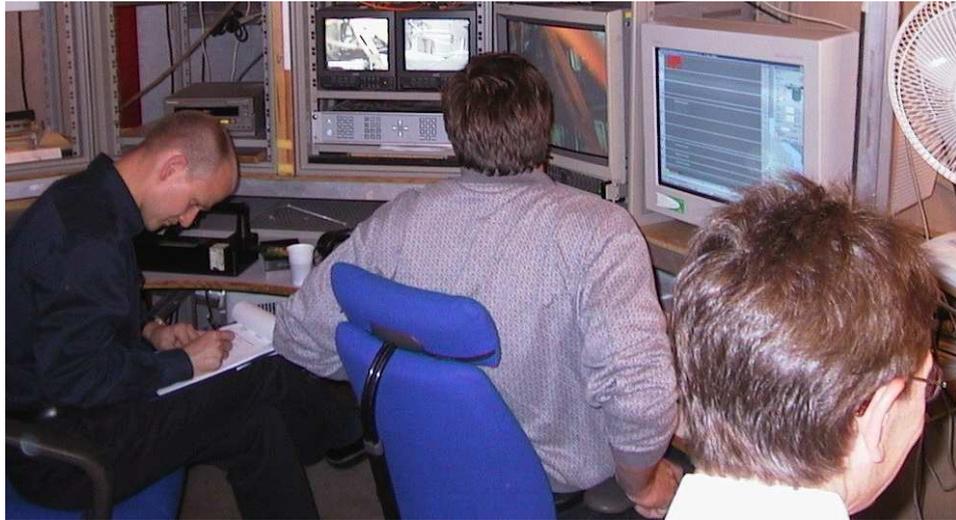
**Figure 3: Top side control room during the qualification. The qualification simulated real working conditions. Operation of scanner and ROV manipulator was done using cameras only.**

A successful demonstration of performance terminated the development program. The subsurface equipment was during the demonstration placed in the 170 m<sup>3</sup> test tank in the FORCE laboratories in Denmark. In order to simulate real field conditions the operating personnel was working from a control room installed in a container. Operation of scanner and ROV manipulators was done using cameras only.

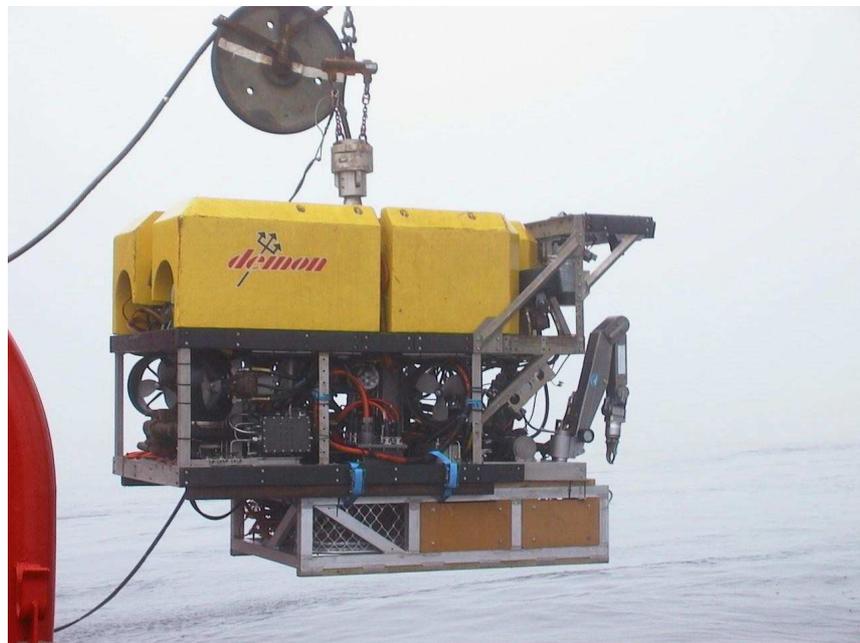
**Figure 4: Tool skid mounted under ROV**

During subsea inspection the ROV is positioned nearby the inspection area. Here the manipulators integrated in the ROV take the scanner and place it at the inspection area, where the scanner is released when a guide shows contact of the magnetic wheels. From that moment the FORCE team takes over control of the scanner movements while the ROV moves to a stand-by position less than 12 meters away for transmission of data and video surveillance of the inspection.

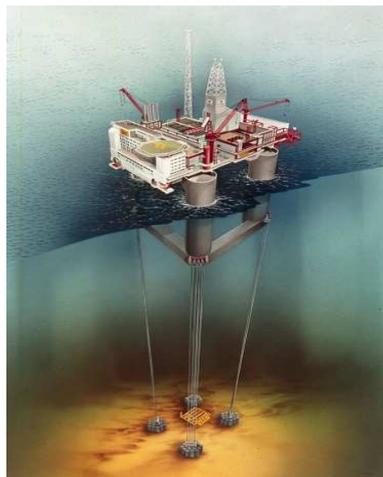
**Figure 5: Heidrun with tension legs to the bottom**

The tension legs of the Heidrun platform are 24" diameter pipes constructed by welding together 12 meters long sections with a wall thickness of 38 mm. These tension legs were examined very detailed during the production phase and all welds were inspected by automated ultrasonic methods. Now, about eight years after start of platform production these welds should be inspected again with the best possible subsea technology.

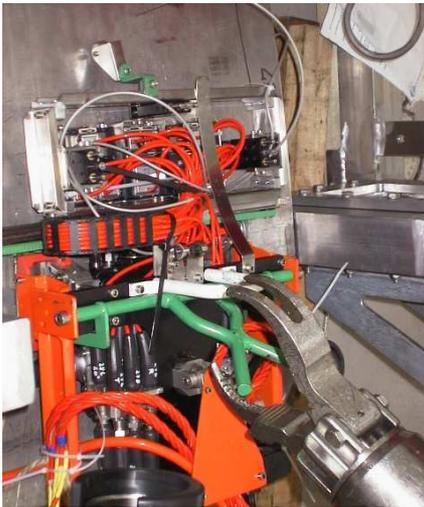
**Figure 6: Scanner AUS-4 for operation by ROV manipulators**
