IN-SITU METALLOGRAPHY FOR THE PLANT HEALTH ASSESSMENT STUDY AND FAILURE INVESTIGATION

Virendra K. Bafna and Paresh U. Haribhakti
TCR Engineering Services Pvt. Ltd.
Mumbai, India

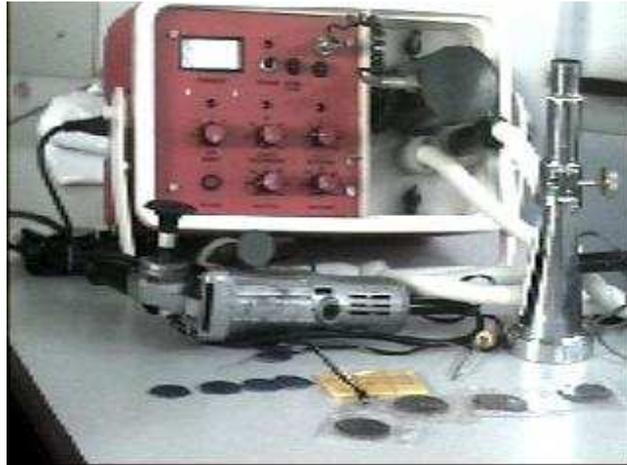
Photo. 1 shows the in situ metallography kit comprises of portable electrolytic ether/polisher with portable grinder and microscope.

Equipment and consumables used for in-situ metallography is shown in Photo. 1. The kit of in-situ metallography comprises of portable grinder, light grinder with variable speed controller, electrolytic etcher/polisher, microscope and variety of consumables. The consumables can be listed as self-adhesive polishing papers of different grit size, self-adhesive velvet cloth, solvents, water bottles, diamond paste, and suspended alumina, electrolytes and replica films. Sketch. 1 is the flow chart showing various steps involved in-situ Metallography.

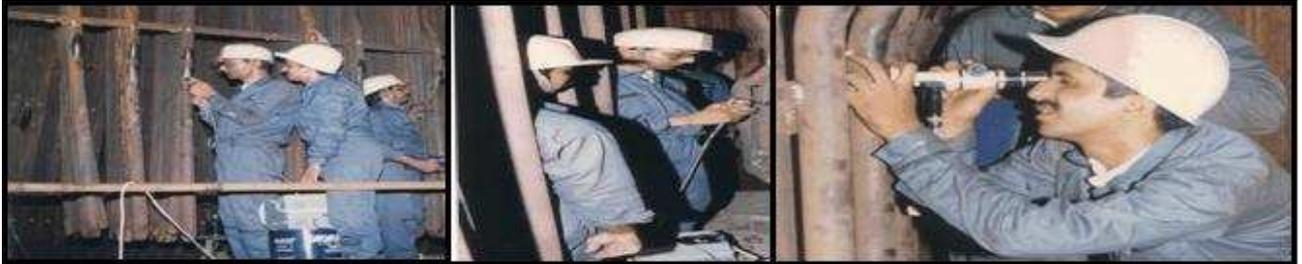
Photo: 2 The actual process of in-situ metallography under progress in side Boiler.

extraction replica, analysis of carbon precipitated at elevated temperature can be found out. The process of in situ metallography being done inside a boiler in the Photo:2, Where as sketch:2, is the schematic representation of process microstructure development by replication process.

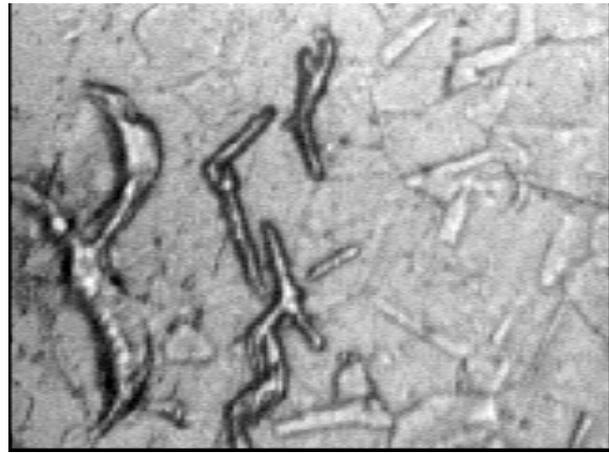
(200X)

Photo: 12 shows development of thermal fatigue crack with SS 316 at the steam inlet of paper digester.

Fatigue, involving repeated stresses, can lead to failure at high temperatures as it does at low temperatures. In components operating at high temperatures it often arises through temperature changes that can lead to cyclic thermal stresses. Eventually thermal fatigue cracking would take place in the areas where temperature fluctuation and variations are more. The nature of cracks are trans-granular in nature. Photo: 11 shows crack formation in chrome moly ferritic steel due to thermal fatigue of a tube at the entrance of outlet header of secondary superheater boiler operating at 540° C. Photo: 12 shows development of thermal fatigue crack with SS 316 at the steam inlet of paper digester.

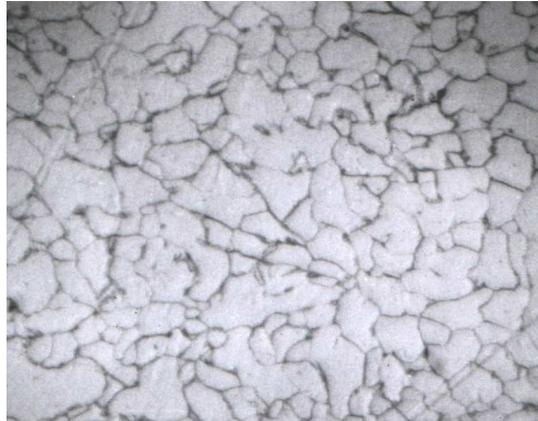
Photo:15

(100X)

Photo. -15 essentially ferritic structure showing removal of carbon from the surface of the steel.

oxidizing atmosphere at high temperature can be identified in microstructure which is shown in photo:15.
