Thermographic detection of defects in wood and wood-based materials

P. Meinschmidt

Wilhelm-Klauditz-Institut (WKI), Fraunhofer-Institute for wood research, Braunschweig,
E-mail: mei@wki.fhg.de

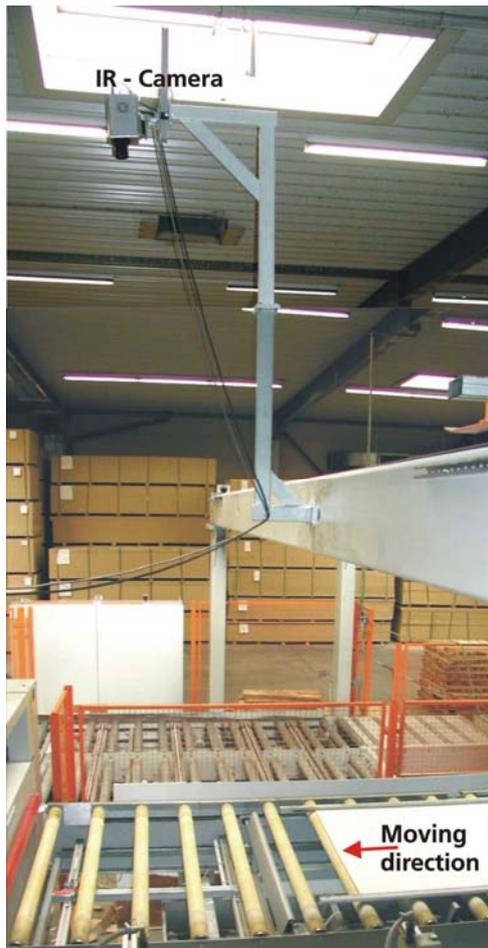
Fig. 3: Thermographic set-up just behind a paper laminating press. By moving the material along the infrared camera possible defects can be detected.

For measurements in industrial production lines -using the heat of the production process- the thermographic camera can be positioned on a steel frame above the conveyor belt (Fig. 3). Depending on the used camera lens, the distance has to be adjusted to observe the full width of the produced material.

The measurements can be carried out immediately behind the laminating press to use the production heat. Locally different temperatures like cold and hot spots observed on the surface, indicate defects either within the glued joint or in the carrier material.
