TERAHERTZ NDE FOR UNDER PAINT CORROSION DETECTION AND EVALUATION

Robert F. Anastasi¹ and Eric I. Madaras²

QNDE 2005, 32nd Annual Review of Progress in Quantitative Nondestructive Evaluation, Bowdoin College, Brunswick, Maine, July 21 – August 4, 2005

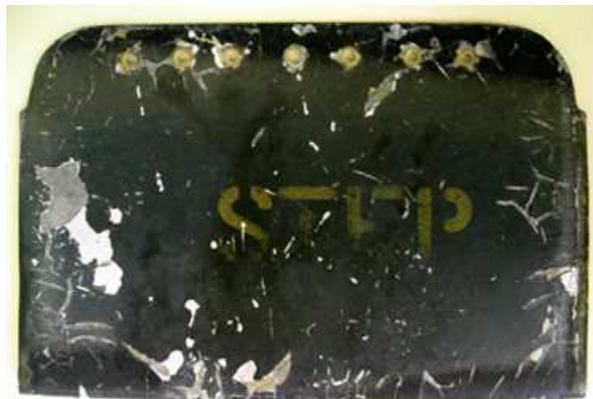
Figure 8. Chinook Fuselage Step Door is shown with flaked, chipped and cracked paint. It is approximately 20 cm by 14 cm

The Chinook fuselage step door, shown in figure 8, is approximately 20 cm by 14 cm and has areas of chipped, flaking and cracked paint. Two THz images are shown in figure 9. Figure 9a shows a maximum signal amplitude image. If the paint-thickness sample results are used as a reference then the areas of thick and thin paint can be identified by signal amplitude correlation, thus, the darker areas in the image maybe caused by thicker paint or potentially corrosion. Figure 9b, is a frequency image of mean amplitude between 0.62 and 0.68 THz, generated at a 10° angle. Using the backscatter results from the surface roughness samples, the brighter colors correspond to rougher areas and maybe potential areas of corrosion.
