Damage Detection in Wind Turbine Blades using two Different Acoustic Techniques

ANNE JÜNGERT

Materialprüfungsanstalt Stuttgart, University of Stuttgart
Pfaffenwaldring 4, D-70550 Stuttgart, Germany
anne.juengert@mpa.uni-stuttgart.de

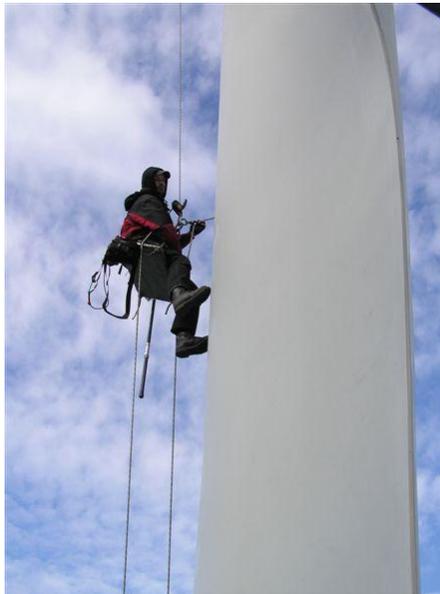
Figure 1: Inspection of a wind turbine blade. The inspector ropes from the rotor and inspects the leading and the trailing edge.

In Germany wind energy plants are treated as buildings and the structural safety has to be evaluated at regular intervals. Besides the tower and the gear, the turbine blades are, due to the constant wind contact, highly stressed parts and have to be inspected regularly by experts. However, the current inspection techniques are only very rough and limited to visual inspections and manual tapping tests. Both techniques require a highly experienced expert and are not able to detect internal damages at an early stage. Figure 1 shows an industrial climber roping from the rotor of a wind turbine to inspect critical areas of the blades. Besides the use of basket cranes this is a common way to get access to the blades.
