NONDESTRUCTIVE EVALUATION OF AROMATIC POLYIMIDE INSULATED AIRCRAFT AND SPACECRAFT WIRING

E. J. Tucholski, Physics Department, U. S. Naval Academy, Annapolis, MD, USA

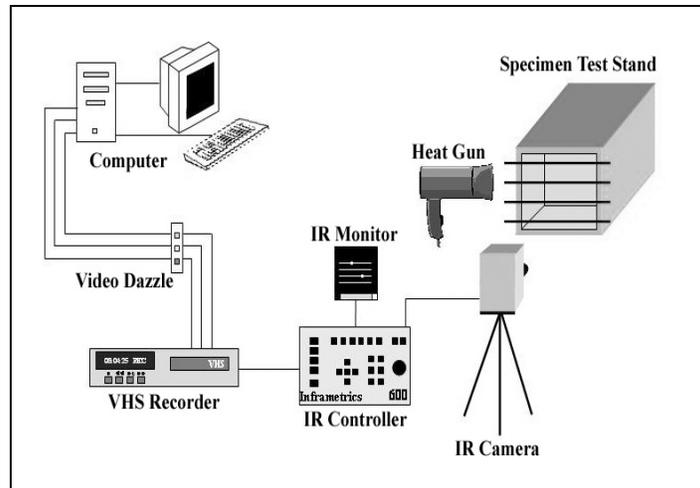
In the current research, a standard handheld heat gun was utilized to distribute heat over various lengths of single wires, multiple wires and wire bundles. The infrared systems used during this phase of the experimentation were an Inframetrics® Model 600 and a newer higher resolution Raytheon Amber AE173 InSb Galileo® system. The testing was conducted on wires approximately 30 cm long which were affixed across the opening of an insulated styrofoam box with an open face of 23 by 30 cm. A schematic of the infrared thermography system used is shown in Figure 1.

Figure 1. Schematic of the infrared thermography system.

The infrared camera was placed at a standoff distance of approximately 0.6 m. The wires were then heated with hot air from a heat gun possessing a wide nozzle attachment to distribute an even heat flux across the surface of the wires while passing the hot air across the face of the box along the length of the wire samples. The advantage of this procedure was to ensure that all of the wires could be heated concurrently. At a minimum temperature sensitivity span of approximately 10 °C, the baseline image with no heat applied yielded an image of light gray wires against a dark gray background. However, upon a single sweep of the heat gun, set at 320 °C, the radiant intensity of the wires was raised dramatically. At this same sensitivity, the heat being transferred through the wire insulation makes the wire appear as a white line against a gray background. Additionally, defects in the wire insulation have significantly different absorbtivity and emissivity resulting in temperatures well above the bulk of the wire. This allows the defects to stand out prominently in the display.

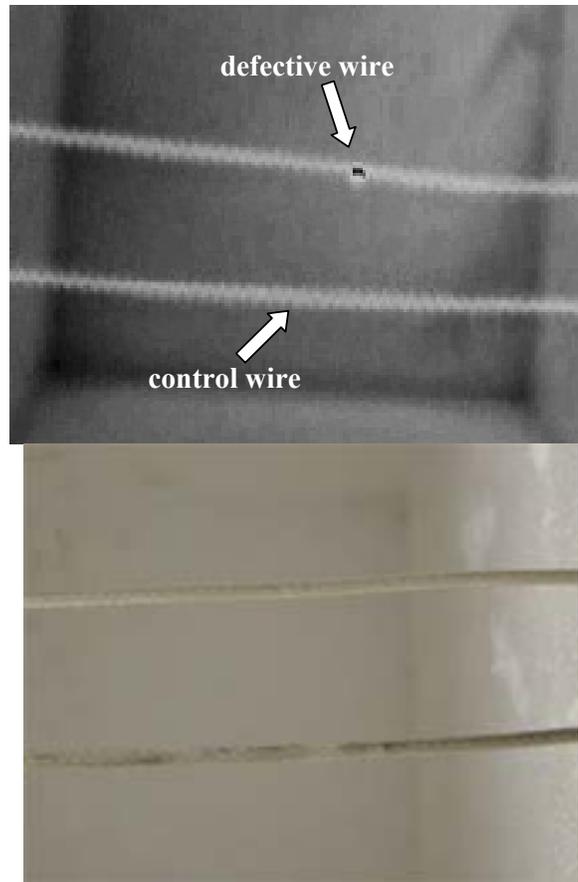
Figure 2. Single wire test: Infrared thermography (left). Photograph of same wires (right)

Initially, to determine the effectiveness of the infrared thermography technique an 18 AWG wire with a minor fray was taped to the open face of the test box. Approximately 25 mm below, a second undamaged control 18 AWG wire was affixed to the box, as shown in Figure 2. While heating with a hot gun, both wires became easily visible when viewed with the infrared camera system (Inframetrics® 600). Most importantly, the region in the vicinity of the fray turned a different color (or different shade of gray) representing a higher temperature making it much more visible than when inspected visually. The control wire, having no such defects, remained uniform in temperature. A black and white photograph on the right of Figure 2 shows the same two wires from a slightly different camera angle. This photograph does not reveal the damage as easily as the infrared thermograph. The discoloration on the lower control wire is not seen on the infrared image. The zigzag pattern on the infrared image shows the braided insulation clearly.

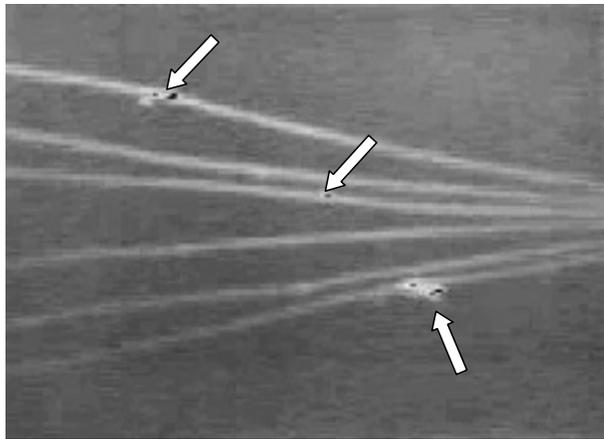
A six wire test was performed to determine the relative sensitivity of this test to wires in close proximity containing various defects. In this test, five 18 AWG wires differing only in the magnitude, type, and location of defect were taped horizontally across the test box. A sixth wire was added as an experimental control. In Figure 3, the top wire was chafed with a knife, the second wire from the top was stripped of its outermost layer of insulation, the third wire suffered a subtle cut, the fourth wire was undamaged, the fifth wire had been crimped and suffered from resulting bend damage, and the sixth wire was significantly frayed.

Figure 3. Infrared thermography: multiple wire test

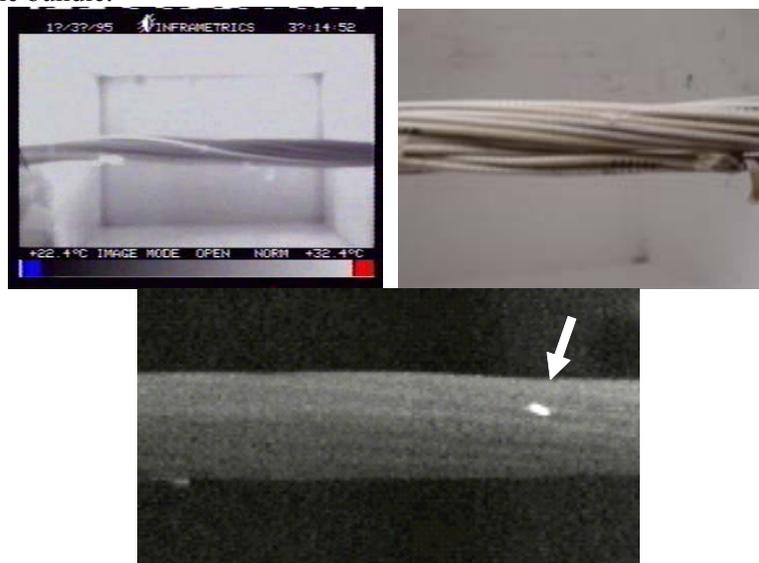
A 0.3 m segment of a wire bundle containing 18 AWG wires was removed from a larger aviation bundle specimen. Two separate wires of the 32 wire bundle were deliberately inflicted with flaws. A superficial nick was placed on the insulation of one wire, while a fray of the outer insulation was imposed upon a second wire. The frayed insulation was readily apparent using both camera systems and also when the bundle was inspected visually. As shown in Figure 4 (left and center), the damaged wire is fairly small but causes the entire wire to stand out in the infrared thermograph. The more sensitive Galileo system was able to detect this defect at ambient temperatures without the benefit of a hot gun. The slight nick was also observed by both IR systems. In Figure 4 (right), a brilliant white orb radiates from the vicinity of the superficial nick using the Galileo system, whereas the other defect-free regions of the wire retain a grayer hue under heating. The horizontal striation in this figure results from the infrared imaging of the outer wires in the bundle.

Figure 4. Wire bundle test: Infrared thermography of fray of outer insulation (left), photograph of fray of outer insulation (center), Infrared thermography of superficial nick (right)

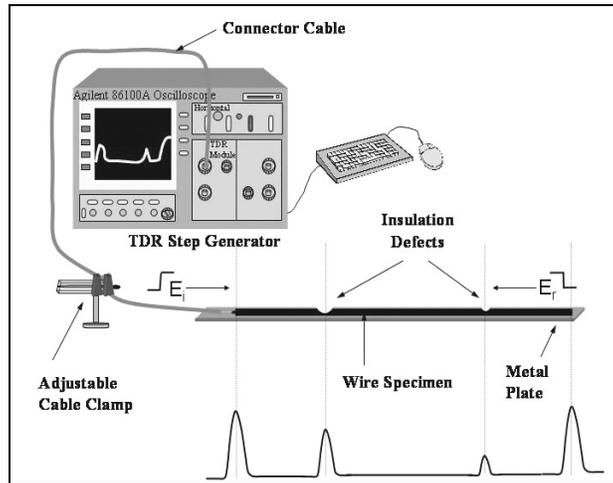
Figure 5. Schematic of time domain reflectivity (TDR) system

As shown in Figure 5, an electrical pulse is launched by the step generator at one end of the wire or cable and reflected from the opposite end. The time of propagation of the pulse from the propagation end and back from the opposite end is determined by the length of the wire or cable and the speed of the signal traveling through the wire. If a flaw exists at an intermediate location, such as a break in the conductor or a significant change in dielectric "loading" of the insulation coating, which would cause a perturbation in electrical impedance, a reflection comes back to the oscilloscope before it should. Its arrival time tells the distance to the flaw and the magnitude of the returning pulse is related to the size of the flaw. When connecting the test wire, the inner conductor of the coaxial connector cable is attached to the conductor of the wire under test and the outer conductor is attached to the metal plate test stand to create a capacitive cell.

In Figure 5, the connection to the test wire, the defects in the insulation and the end of the wire were described schematically as positive changes in impedance. In fact, the change in impedance is very likely to be negative if the defect in the wire lowers its overall capacitance. As an example, Figure 6 shows the results of a metal shard imbedded in the Kapton® insulation of a

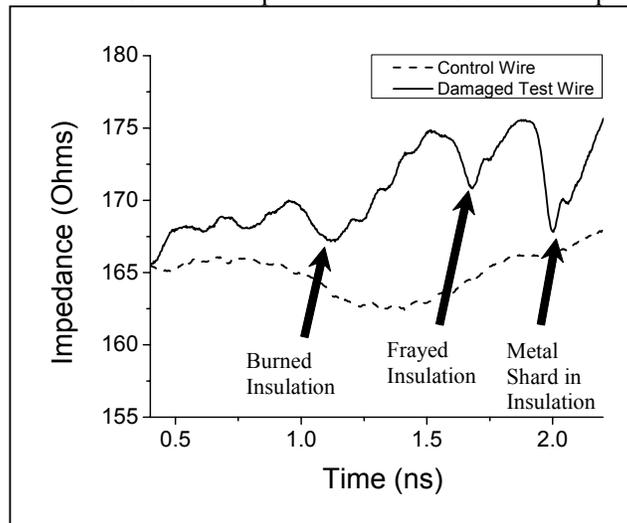
Figure 6. TDR results of metal object in wire insulation

braided conductor wire. The wire specimen is a 25 cm section of 18 AWG wire. The metal does not penetrate through to the conductor, but its presence is easily detected on the time domain reflectometer as a reduction in impedance.

Other damage to the insulation can be detected due to the difference between the relative dielectric constant of air and the insulation. Nicks, scrapes, cuts, chafes and frays are then detectable by a trained operator using this technique. Figure 6 also demonstrates a noticeable change in the impedance in an area where the insulation was stuck with a pin multiple times until frayed. Also visible is a decrease in impedance where the wire insulation was burned with a soldering iron over an area of about one cm in length along the wire insulation surface.

On the other hand, the defects in Figure 6 are worst case attempts to find the most subtle damage to the wire. Obtaining a baseline on new wire and watching for changes over time can reveal significant information on the health of the wire. Additionally, when the damage to the wire insulation is such that the conductor is very close to or almost touching a metal ground, the time domain reflectometer will show a dramatic change in impedance. The same is true when embedded metal shards touch a ground. In both cases, the speed of the signal moving through the wire is known allowing the exact location of the problem area to be determined. This is exceptionally useful for locations within the aircraft where wiring is inaccessible to visual inspection or an infrared camera.

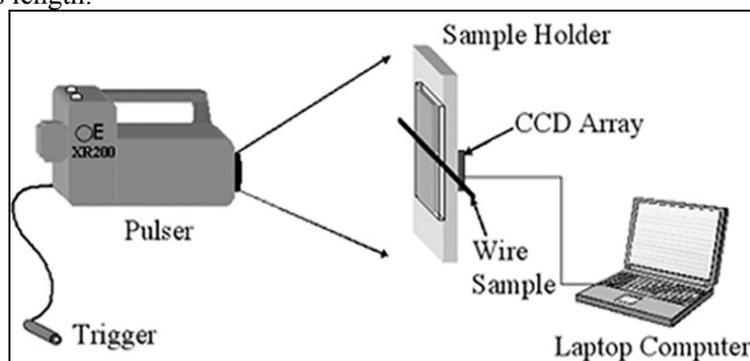
Once a more global technique, such as infrared imaging of heat generation or time domain reflectometry, indicated that a flaw exists in a run of wire or cable, a portable pulsed x-ray system was used to obtain a radiographic image of the portion of the wire or cable. The generator used was a small battery operated Golden Engineering pulsed x-ray source. Either a Polaroid film cassette or a Schick CCD flat panel, solid state array sensor (active area: 36 mm by 26 mm) coupled to a laptop computer was used for data acquisition and image display as illustrated in Figure 7. Use of the CCD array method, however, enabled instantaneous imaging feedback and eliminated the costs and processing time associated with film development. The pulsed x-ray source had a fixed nominal energy of 150 keV, yet other pulsed x-ray sources are available ranging from 100 keV up to 2 MeV. High-speed flash x-radiography can be performed using x-ray pulses having duration of less than 100 ns. The spectrum from molybdenum or tungsten targets consists of a short wavelength component having substantial penetration and additionally a longer wavelength component, which permits enhancement of the image contrast. The pulsed x-rays were controlled by means of a remote electrical switch. The Golden Engineering x-ray source is a pointed anode with an array of cathode wires arranged both circumferentially and longitudinally along its length.

Figure 7. Schematic of pulsed x-radiography system (CCD detection)

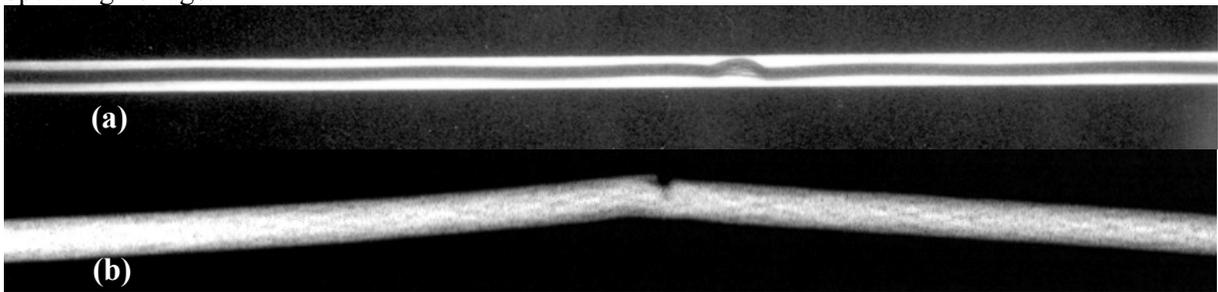
Figure 8. Wires damaged by severe bending: (a) x-ray film detection; (b) x-ray CCD detection

A comparison of the results obtained by using the x-ray film detection and the x-ray CCD detection modes is illustrated in the radiographs of Figure 8. Pulse x-rays were used to inspect two 18 AWG aircraft wires that each suffered from cracked and embrittled insulation. The damage to the Figure 8a wire was incurred while being bent and snapped after having been submerged in liquid nitrogen, while the cracking in the Figure 8b wire was the consequence of severe, repetitive bending. The radiograph in Figure 8a was recorded on film by means of 9 pulses from the pulser and the specimen was set back 150 mm from the x-ray collimator cap. The twist in the copper wire is evidence that the conductor has undergone a significant deformation in the vicinity of the embrittlement. The pulse x-rays also provide critical information on the position of the conductor within the insulation. For instance, on the top side of the contortion there is considerably less insulation than on the bottom side. The radiograph in Figure 8b was taken via the pulse x-ray CCD array detection system and digitally recorded. A total of ten x-ray pulses were fired at the specimen, which was positioned 250 mm back from the x-ray collimator cap. The penetrating power of the pulse x-rays permits a high resolution depiction of the individual strands of copper wire. Furthermore, the breach in the exterior insulation is also clearly discernible. The film detection method provides substantially more detail regarding the thickness and external state of the insulation, whereas the CCD detection method evidently provides more insight into the internal conditions of the wire conductor.

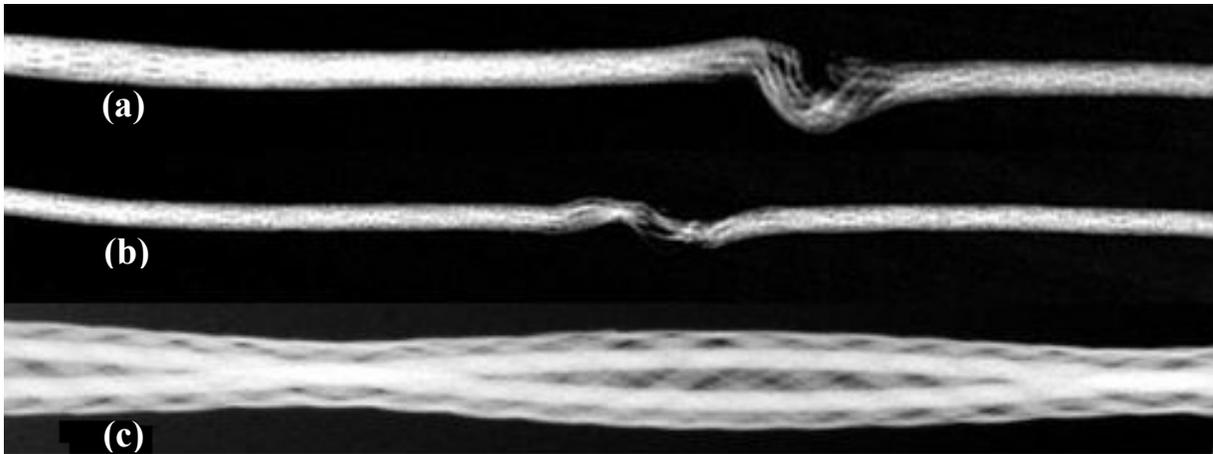
Figure 9. Pulse x-ray radiographs: (a) Burnt Wire; (b) Crimped Wire;
(c) Undamaged Metallic Braided Wire

All of the specimens shown in Figure 9 were irradiated with 10 pulse x-rays and each of the specimens was set back 250 mm from the pulser. The pulse x-ray radiograph in Figure 9a is of a wire that had experienced extensive charring damage. The segment of wire featuring the dramatic kink corresponds directly with the extent of the scorched area. The brightness of the wire rapidly fades in this burnt section and is consistent with an observable decrease in the amount of insulation present in this portion of the wire. Moreover, upon closer examination of the radiograph, only a few spindly threads of conductor are visible suggesting a possible degradation, or even loss, of copper wire in the damaged region. In Figure 9b, a wire that had been crimped was analyzed with pulse x-rays. Again, it is possible to demarcate the portion of the wire that has been impaired. Likewise, the individual strands of copper are also obvious; hence, a significant discontinuity in the conductor is clearly discernible in the contorted region that was crimped. Finally, a prominent decrease in light intensity in the crimped region is indicative of a loss of insulation and potentially wiring. An undamaged metallic braided wire was studied using the pulse x-ray system as well, as depicted in Figure 9c. Not surprisingly, the two insulated copper conductors buried beneath the metallic braiding are easily identifiable. The imaging system also uncovers the presence of the actual interwoven metallic braiding pattern.
