## **THERMAL NDT & E OF COMPOSITE AIRCRAFT REPAIRS**

**Abstract:** The objective of this study was to investigate different defects and material systems (notch or delamination under carbon and boron composite patching bonded with FM73 adhesive film to the surface of Al 2024-T3) using several thermal non-destructive testing and evaluation techniques. Active thermographic approaches, using, firstly, a simple heat excitation source with an infrared camera, secondly, an integrated pulsed thermographic system, thirdly, pulsed phase thermography and lastly, thermal modelling, were used in the inspection of the composite aircraft repaired panels. In all situations the subsurface defects, were positioned intentionally. After the detection of the defects, representative images obtained from the thermographic investigation underwent quantitative analysis with the intention of obtaining information about the defects in space and in time.

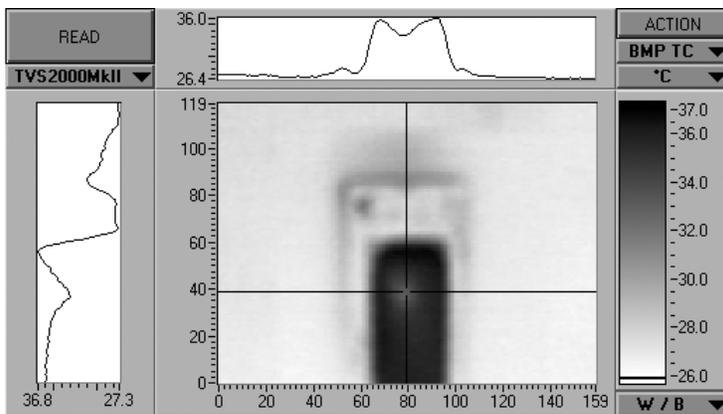
The results after investigating sample A using the first experimental approach (simple heat excitation source) are presented in the following figure (figure 1). The situation in this sample was that a defect – delamination (Teflon) was formed deliberately on the boron composite patch. The Teflon part (dimensions of 25 X 25 mm) was positioned between the 3rd and 4th ply of the composite patch. The approach was able to detect the artificially created delamination on the boron composite patch.

Figure 1: Thermal image & line profiles of sample A using a simple heat excitation source

Furthermore, from the line profiles it was possible to calculate the size of the defect in the examined sample employing the Full Width Half Maximum (FWHM) approach (in both cases). In the first case, the result was 5.37% and in the second case it was 5.68%. This could be compared with the 5.95%, which is the real surface patch percent area. Figure 3 shows the obtained result after investigating again sample A by the use of the experimental set-up 3 (PPT). An early recorded thermogram (top-left) is used to segment the plate from the image (bottom-left) and to count the total number of pixels. The maximum contrast thermogram (top-right) and the maximum contrast phasegram (bottom-right) are then used to segment the defect by thresholding. In the first case, the defect was calculated to occupy 5.86%, whilst in the second case 5.93% of the patch area. Again, this is to be measured up to with the real surface patch percent area of 5.95%.

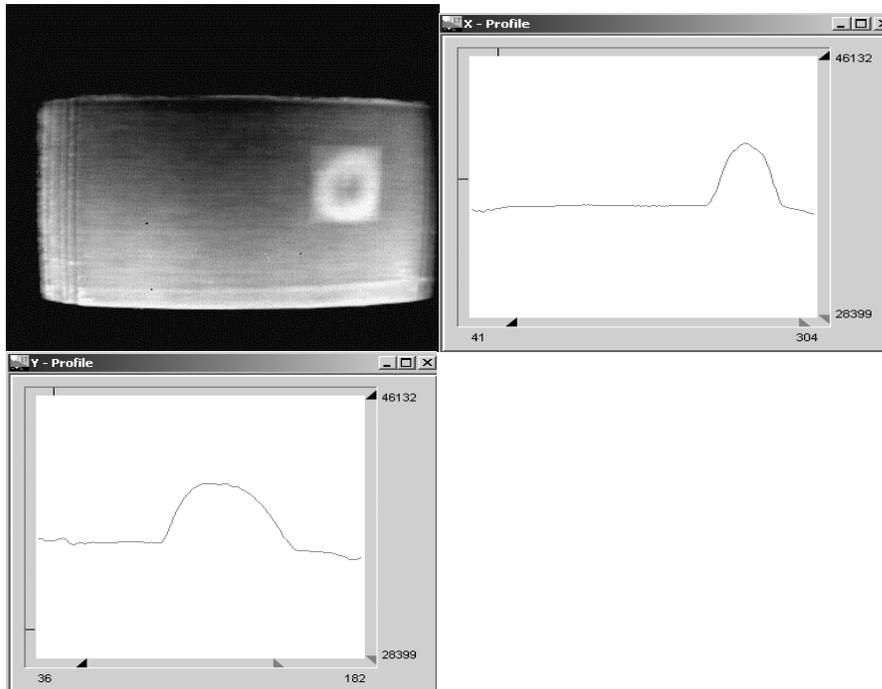
Similarly, using the second experimental approach (PT) the following thermal image (representative image) and line profiles were obtained (figure 2).

Figure 2: Thermal image & line profiles of sample A using pulsed thermography

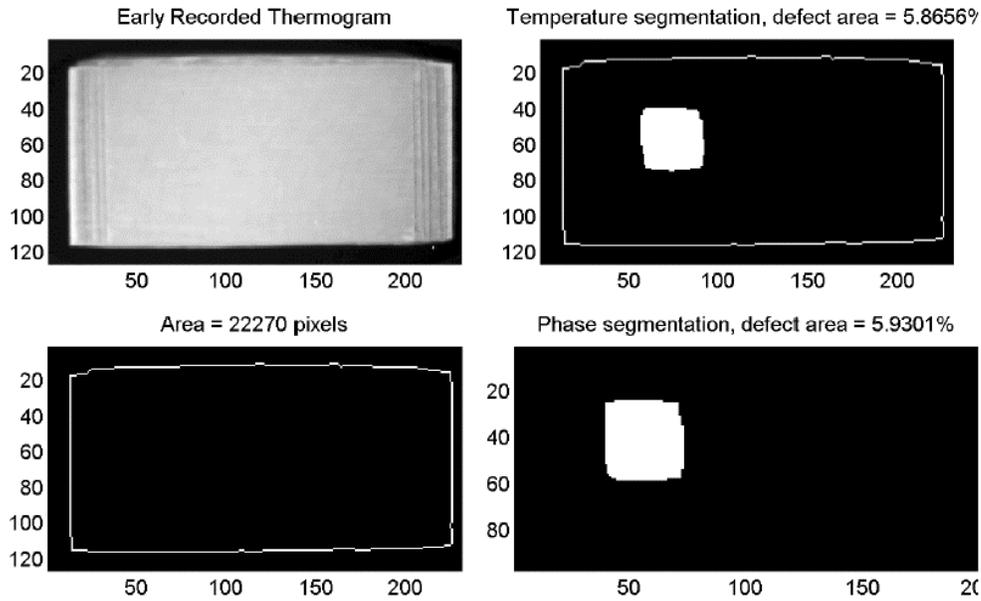
Figure 3: Thermographic investigation of sample A using PPT

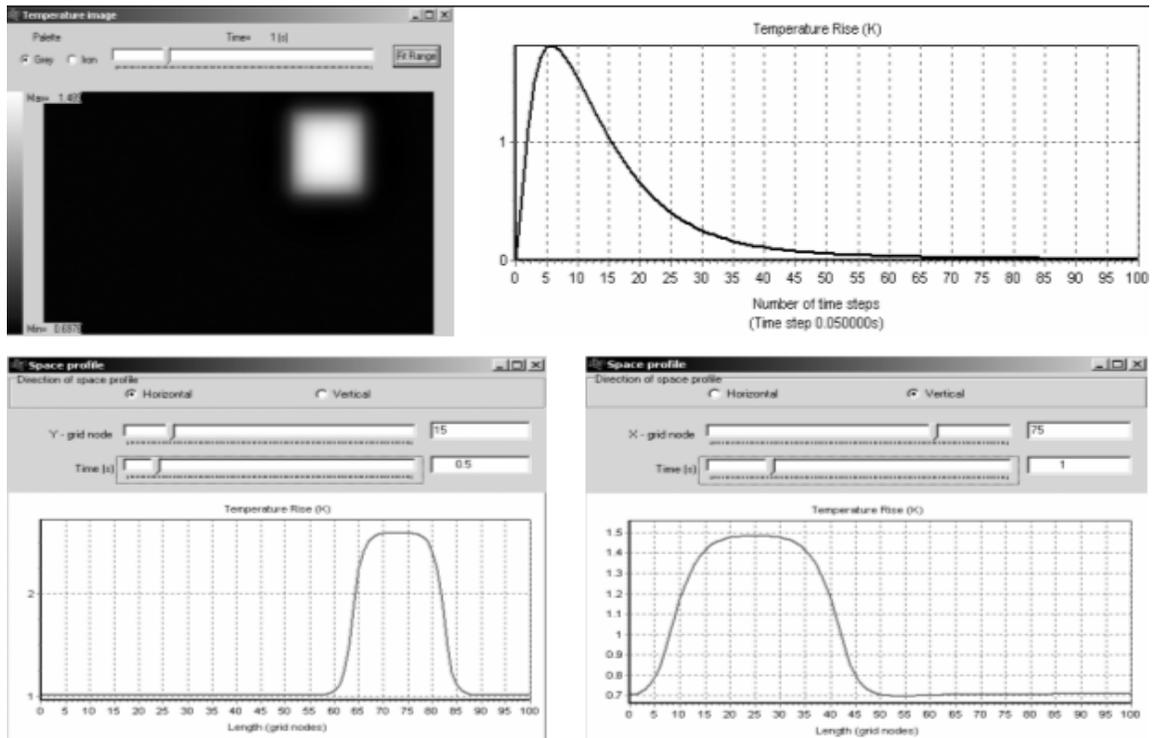
A representative thermal image, spatial profiles and the thermal contrast curve of sample A from the thermal modelling run are presented in figure 4. The results give a good indication of how the boron composite material responds to thermal excitation. It shows the behaviour of a delaminated composite material after it was heated with a thermal heating source uniformly in order to detect a sub-surface defect by means of transient thermography.

Figure 4: Representative thermal image, spatial profiles and the thermal contrast curve of sample A from the thermal modelling run

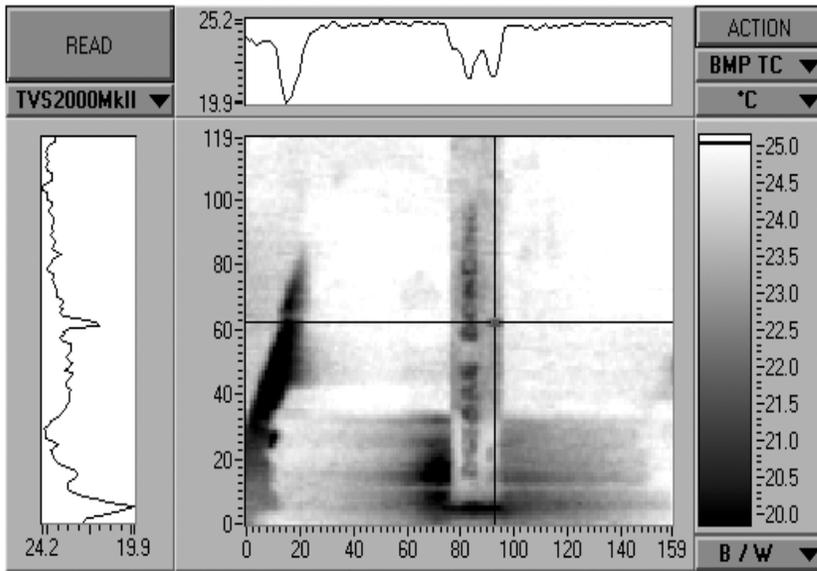
The following figure, figure 5, presents the obtained results after investigating sample P1, using the simple heat excitation source (experimental approach 1). The dimensions of the notch on the surface of the aluminium panel were 10 mm (length) and 1 mm (width).

Figure 5: Thermal image & line profiles of sample P1 using a simple heat excitation source

Then, from the line profiles it was possible to calculate the size of the defect – notch in the examined sample employing the Full Width Half Maximum (FWHM) approach (in both cases). In both situations, the result was 0.18% instead of 0.09% (actual defect percentage).

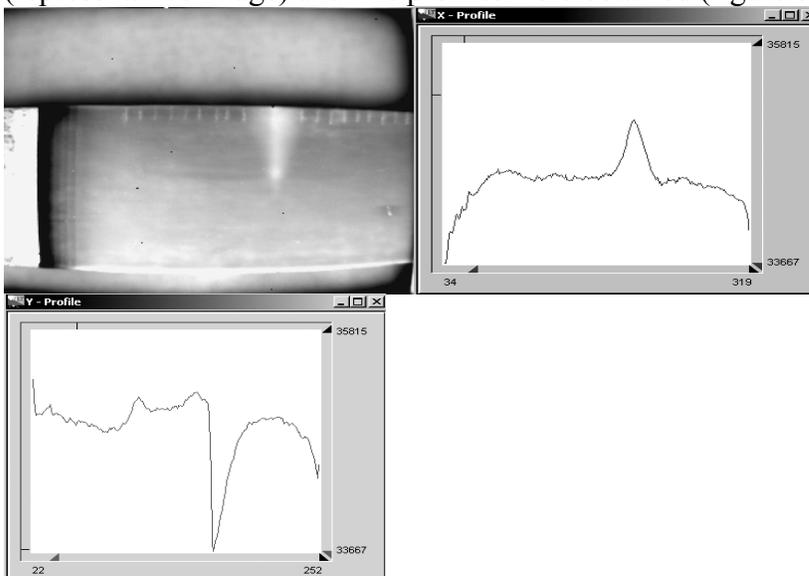
Similarly, using the second experimental approach (PT) the following thermal image (representative image) and line profiles were obtained (figure 6).

Figure 6: Thermal image & line profiles of sample P1 using PT

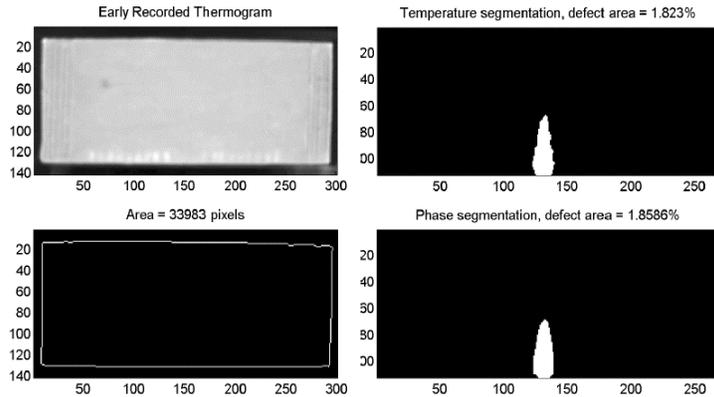
Figure 7 presents the defect segmentation for sample P1. Both thermogram and phasegram thresholding oversize the defect dimensions (~1.8% instead of 0.09%) according to the sample specifications.

Figure 7: Thermographic investigation of sample P1 using PPT

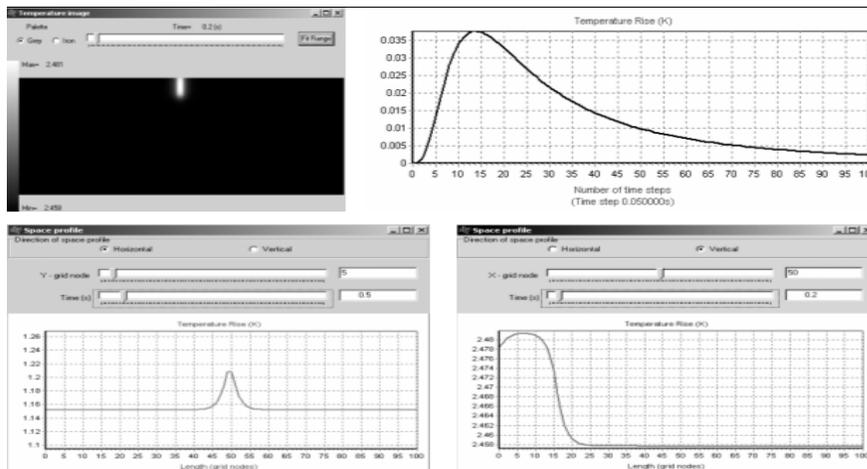
Results (thermal image, spatial profiles and the thermal contrast curve) from the thermal modelling run (sample P1) are also presented in Figure 8. The results give a good indication of how the carbon composite material responds to thermal excitation and how easily a relatively near surface defect can be detected.

Figure 8: Representative thermal image, spatial profiles and the thermal contrast curve of sample P1 from the thermal modelling run.
