## **Evaluation of Impact Damages in RTM Stitched Composites by Using Ultrasonic Multiple Imaging Techniques**

**Songping LIU, Feifei LIU, Enming GUO and Legend LI**

**The Center of NDT&E, Beijing Aeronautical Manufacturing Technology Research Institute; Beijing 100024, China**

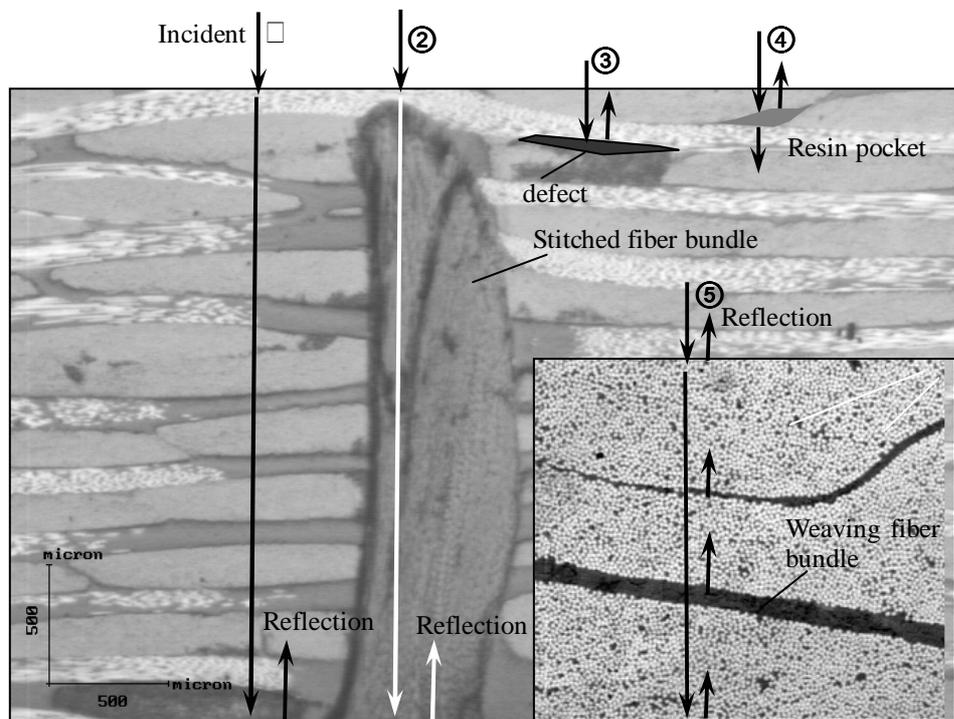
Figure1. Illustration of ultrasound propagation in RTM stitched composites

Figure 1 gives the microstructure of a RTM stitched composite laminate in cross-section. The structural details, such as the characteristics of lay-up, stitching and weaving in laminate body, can be seen well in it. When probe ultrasonic wave impinges on RTM composites, their evident structural specificities will give a complex ultrasonic propagation and reflection: 1) in RTM composite laminate as a whole; 2) along different fiber directions; 3) at resin pocket; 4) at weaving bundle and 5) defect, as illustrated in

figure 1. It is dependent on employed wavelength <sup>[4]</sup>.

RTM stitched composite laminate is treated as uniform multi-layer acoustic media by ultrasound when its wavelength is much larger than their characteristic structural units. No ultrasonic reflection will result from structural details, as illustrated by □ in figure 1. However, in short wavelength limitation the interface between neighbor layers will give rise of reflection when ultrasonic wave pass through RTM laminate body <sup>[4]</sup>.

In generally, an absolutely reflection will occur when probe ultrasound impinges on a defect, for example, impact damage, as illustrated by □.

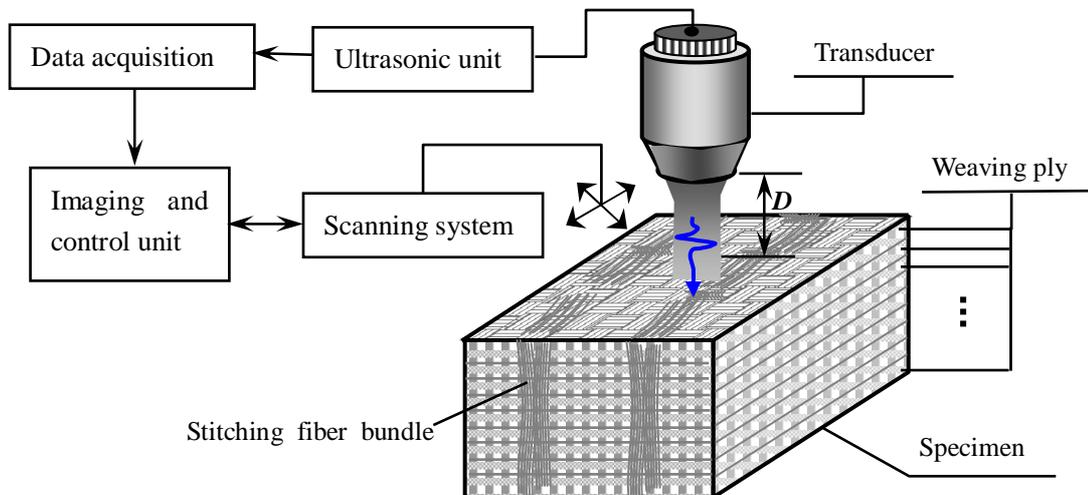
Figure 2. Experimental setup of ultrasonic scanning system

Figure 2 is the experimental setup of the ultrasonic scanning system, which is designed by Beijing Aeronautical Manufacturing Technology Research Institute (BAMTRI). A high resolution ultrasonic transducer is designed for evaluation of impact damage in RTM stitched composite materials. Its frequency is 5MHz. Focal spot is about  $\Phi 0.5$  mm. Focal distance is about 55 mm. Focal waist is approximately 8 mm. The Resolution of the ultrasonic unit –including the transducer and FCC-B ultrasonic inspection instrument for composites, which are made by BAMTRI, China, can reach 0.13 mm –the thickness of a

single ply in composite laminates. That means that impacted damage, even located in sub-surface of composites, can be discriminated by the ultrasonic unit.

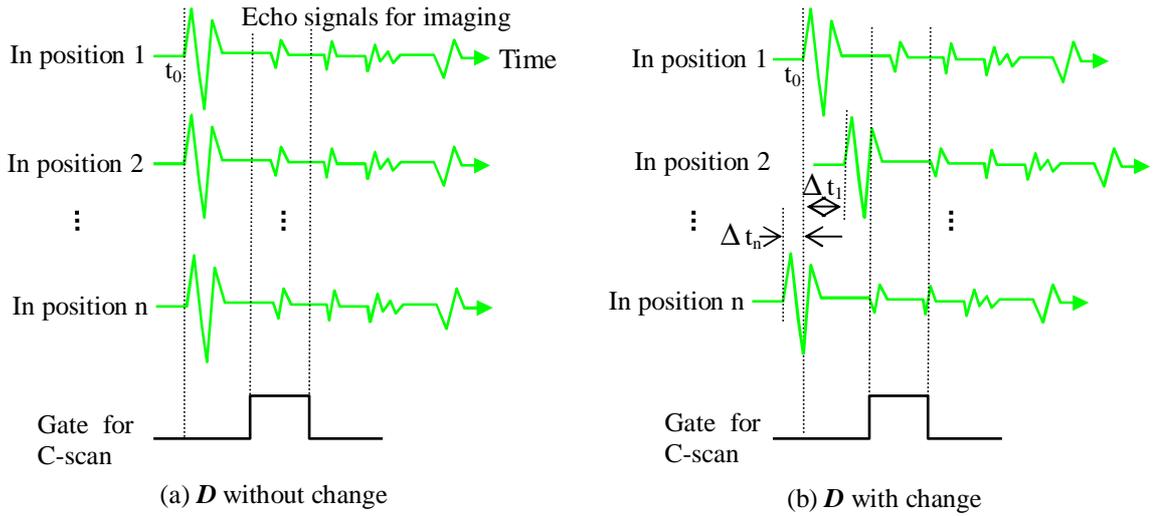
Figure 3. Conventional ultrasonic data acquisition

The signal acquisition with special software-electronic gates for this application is also designed by BAMTRI. Usually, commercial ultrasonic signal acquisition systems with pulse-echoes mode, whether all signals from transducer are recorded, or the gate-selected ultrasonic signals are sampled, are operated according to an assumption that the distance  $D$  between transducer and the surface of specimen to be tested is constant, shown as in figure 2. Then, it can assure to get a correct ultrasonic C-scan image, as shown in figure 3(a). All the signals are supposed to have same original position  $t_0$  in time scale during scanning. But the real situation is that  $D$  may change in time-scale axis during scanning because of accidented surface of the specimen to be tested (see figure 4). Then the signal echoes maybe have a movement in time-scale axis, as shown in figure 3 (b), but the gate already was set before scanning, for example, according to the echo signal from transducer in position 1. When transducer is scanned to next position 2, a movement  $\Delta t_i$  ( $i=1, 2, n$ ) of echo signal in time scale will occurs compared with the echo signal in the original position 1. It is much possible for the signal echoes to move out of the gate, or other echoes, for examples, echoes from surface or bottom of specimen, move into the selected-gate because of the change of  $D$  in different positions of specimen, shown as in figures 3(b). Therefore, a special soft-electronic gate technique is designed in the ultrasonic signal data acquisition system. The original position of the signal gate, used to switch A/D, is formed, based on the echo from surface of specimen to be tested in electronic circuit, shown as in figure 4. When a change of the distance  $D$  between transducer and surface of specimen takes place, the signal gate will vary with it in time-scale axis, i.e. tracing the signals from the positions of specimen with the same thickness.

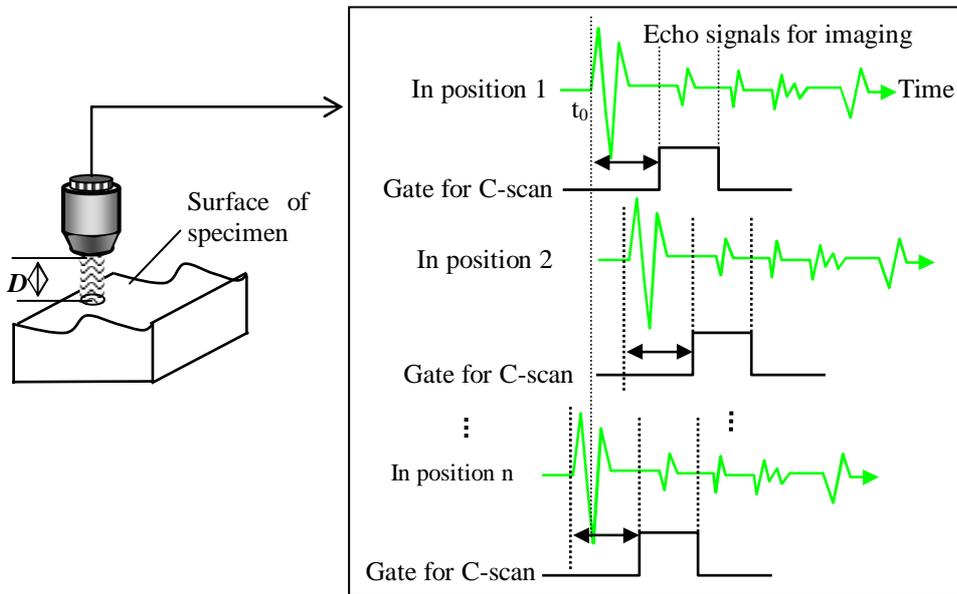
Figure 4. Soft-electronic gate for ultrasonic signal acquisition free of  $D$  change

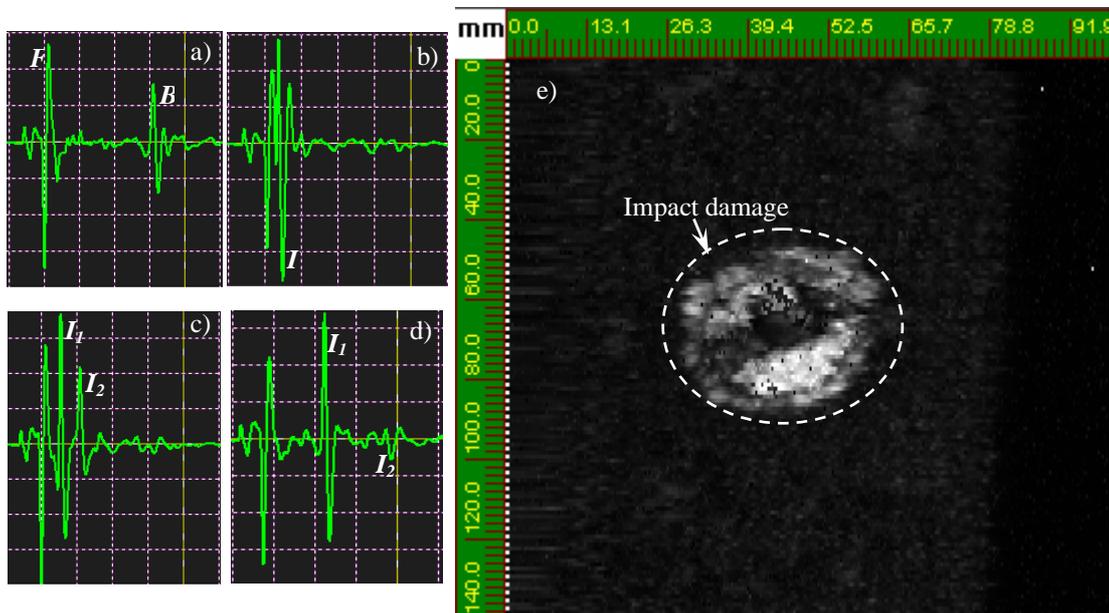
Figure 5. Echo signals and C-scan imaging of RTM stitched composites specimen No.#2. a) Echo signals from good zone, b) – d) Echo signals from impact damage zone, c) C-scan

Figure 5 gives a series of ultrasonic echo signals (A-scans) and C-scan image of RTM stitched composite laminate specimen No. #2. Thickness of the specimen is 6 mm. Impact energy is 4.5J. Figure 5(a) is the echo signal from the zone without impact damage. The echo pulses  $F$  and  $B$  –resulting from ultrasound reflections at specimen surface and bottom, respectively, are seen clearly. The tiny echo pulses between  $F$  and  $B$  are resulted from ultrasonic reflections in the specimen body. Figure 5(b)-(d) are the echo signal patterns from different positions in the impact damaged zone. The damage may be caused nearby the surface of the specimen, for example, the echo pulse  $I$  in figure 5(b) is from ultrasonic reflection at the damage nearby surface of specimen. The distribution of damage has a topology in specimen depth because the echo pulse  $I$  and  $I_1$  ( $I_2$ ) in figure 5(b, c, d) from ultrasonic reflections at different positions of damaged zone have remarkable distinctness in

time of flight (TOF). The echo pulses in figure 5(b, c, d) show a very interesting damage characteristics. For examples, no repeat reflection of  $I$  and echo pulse  $B$  are seen in figure 5(a). That means a serious porosity may be caused at this position. But in figure 5(c, d) the repeat reflection  $I_2$  of  $I_1$  is clearly. That means a delamination may be caused at these positions of the impact damaged zone. Some reflections resulted from the structural details in the RTM specimen body may be found in figure 5(a, b, c, d) although they are very weak.

The ultrasonic reflections in figure 5(a, b, c, d) provide very effective mechanism for C-scan imaging of impact damage. So, the damaged zone is visualized very well in figure 5(e), as the white area showed by the white arrowhead. The grey scales correspond to ultrasonic reflections in the damaged zone. In generally, one may get information about the degree of damage according to the C-scan image.

The contrast distributions corresponding to the RTM stitched composite structural details can also be seen between  $F$  and  $B$  although they are very weak. This is agreed with the echo pulses in figure 5.

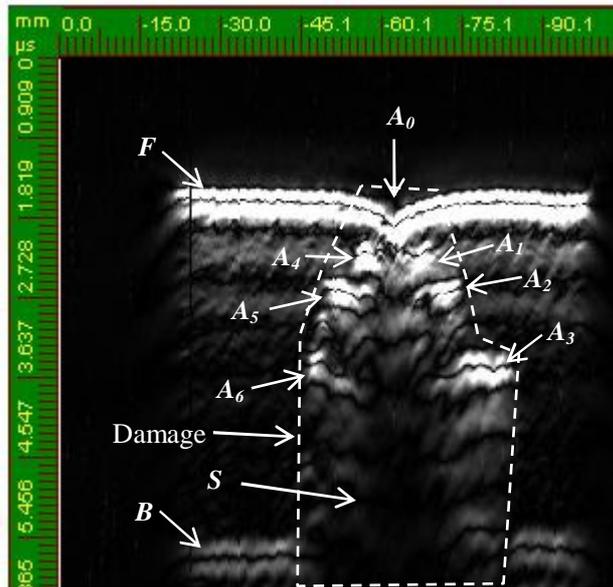
Figure 6. B-scan imaging of RTM stitched composites specimen No.#3

A B-scan image of specimen No.#3 is presented in figure 6. Thickness of the RTM stitched composite laminate specimen is 6 mm. Figure 6 is one of a series of the B-scans. The scanning line corresponding to the B-scan is passed through the central impact damaged zone. The surface and bottom of the specimen are seen clearly, as the white lines  $F$  and  $B$  marked by the arrowheads in figure 6. The topology of impact damages is visualized detailedly in figure 6. (1) The damages in specimen impact zone are seen clearly, as the light spots showed by  $A_1, A_2, A_3, A_4, A_5$  and  $A_6$ . These damages locate in different depth of the specimen. The damaged characteristics is also supported by the echo pulse patterns in figure 5(b, c, d). (2) The B-scan image show particularity of the impact damages in RTM composites: They have a significant extending in RTM stitched composite laminate body, as the damages showed by  $A_1, A_2, A_3, A_4, A_5$  and  $A_6$  in figure 6. (3) The impact point on the specimen surface is also seen well, as the white concave showed by  $A_0$ . (4) The dark area showed by  $S$  in figure 6 is the ultrasonic shadow of the impact damaged zone. This is why there is dark spot in the damaged zone in figure 5(e).
