## Optical Fiber Sensor based Impact Detection System for Aircraft Structures

**Key words:** Optical fiber sensor, In-Service Inspection, Composite, Aerospace, Special session Airbus-Japan

*Airframe structures, especially composite structures, are prone to damage by tool drops, bird strikes, hailstones, etc. The authors have developed an optical fiber based impact damage detection system for composite airframe structure. The Japan Airbus SHM Technology for Aircraft Composites (JASTAC) has been instrumental in guiding this development activity. This paper summarizes the achievements over the years on the development of Impact Detection System (IDDS), with the emphasis on the joint achievements between Airbus and Kawasaki Heavy Industries.*

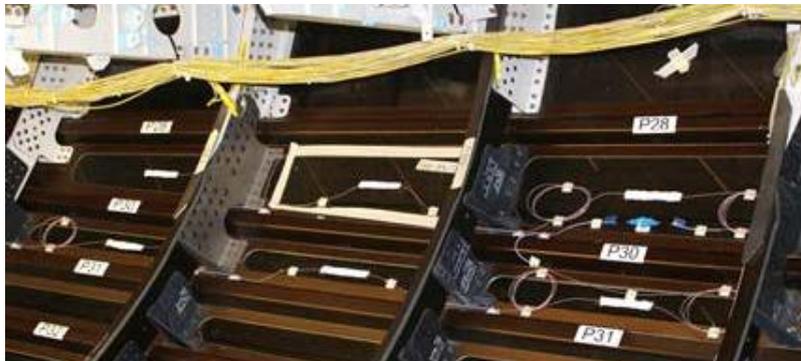
Figure 4 shows the two sensor installation locations. Three sensor lines (built of multiple FBG sensors and connecting optical fiber cables) were installed in two locations near the door of the fuselage structure. A sensor line was installed in Location 1, which is below the passenger door and is of a typical aircraft fuselage configuration. Two more sensor lines were installed in Location 2, which is below the bulk cargo door and surrounded by large metal reinforcements.

(a) Location 1

(b) Location 2

Figure 4: Sensor installation locations

From the visual and optical response inspections, no damage or degradation were found in the sensing line in Location 1. In Location 2, two fiber breaks were found, which were apparently due to handling and not due to the fatigue loading. The sensing lines in Location 2 were repaired to bypass the two fiber breaks.
