Array Eddy Current for Fatigue Crack Detection of Aircraft Skin Structures

Eric Pelletier, Marc Grenier, Ahmad Chahbaz and Tommy Bourgelas

*Olympus NDT Canada, NDT Technology Development, 505, boul. du Parc-Technologique
Québec (Québec), Canada, G1P 4S9*

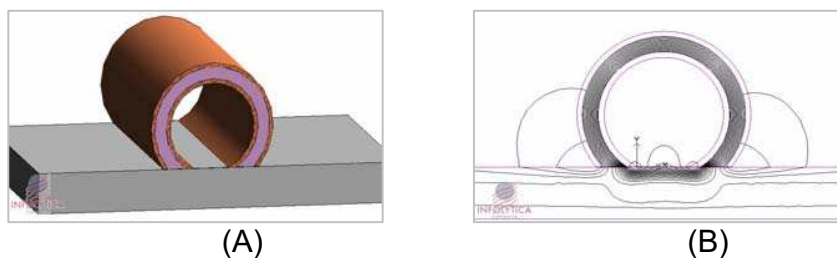
Figure 1: Transmitter coil modeling results

Figure 1 (A) shows the general appearance of the probe transmitter and figure 1 (B) shows the magnetic field distribution produced by the coil. Measurements were made to quantify the produced magnetic field. Such probe configuration provides a powerful transmitter allowing a large magnetic field generation in the inspected material.

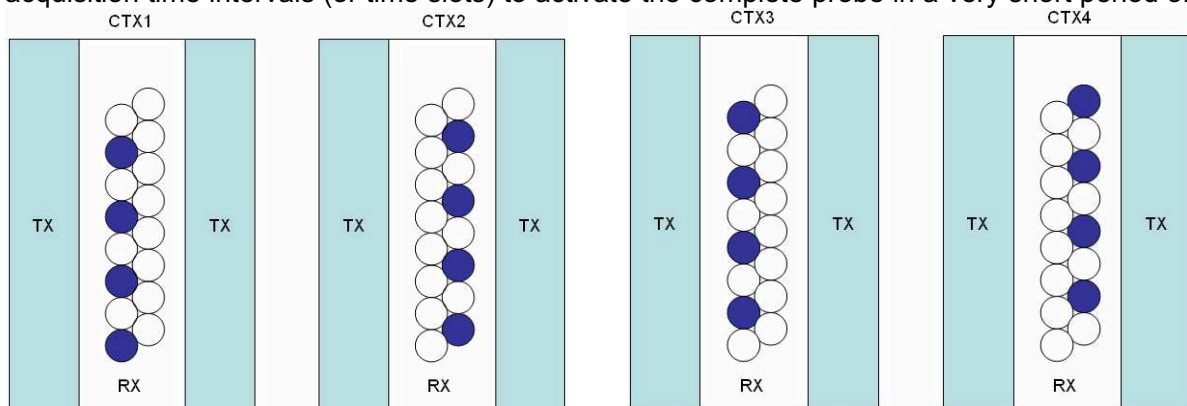
Figure 2: Receiving coil multiplexing

The following figure illustrates the configuration of the designed eddy current array probe receiver. The probe is used with an ECA unit (OmniScan), which has an internal multiplexer that activates four pick-up coils at the time. The receiving configuration is composed of 16 coils. Four coils are activated in four acquisition time intervals (or time slots) to activate the complete probe in a very short period of time.

This multiplexing technique provides a large coverage in a single inspection pass while maintaining high scanning resolution. Also, it reduces the need for complex robotics to move the probe; a simple manual scan is often enough when using ECA. R/D Tech (Olympus NDT Canada) was the first NDT instrument manufacturer to use this revolutionary multiplexing technique.

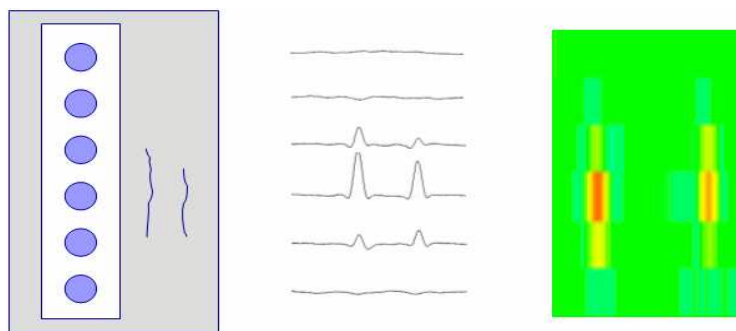
Figure 3: ECA probe C-scan representation

This section describes the signals that are produced when the eddy current probe passes over a defect. Figure 3 shows how a C-scan image can be built when an ECA probe passes over a defect. In this case, the coil located just over the flaw produces a strong signal. The further the coil is from the defect, the weaker is the produced the signal. The C-scan view is color coded to represent the amplitude of the close and far coil signals.

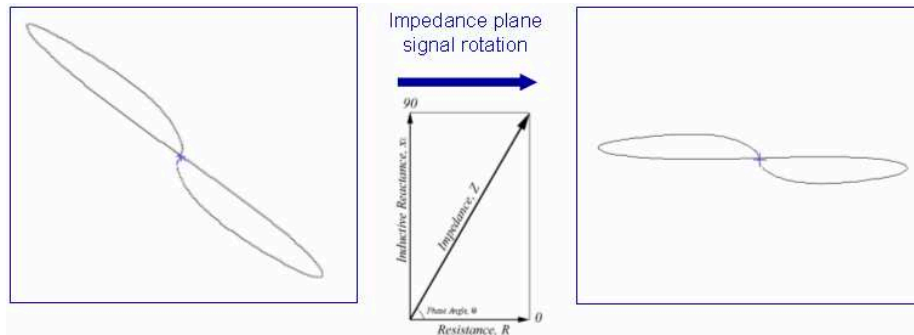
Figure 4: Fastener signal processing

The same principle is used in the inspection of a fastener. When the probe passes over a fastener free of defects, we obtain a signal in the impedance plane as shown on the left of Figure 4. In order to facilitate the interpretation, the signal is rotated until it reaches a horizontal position.

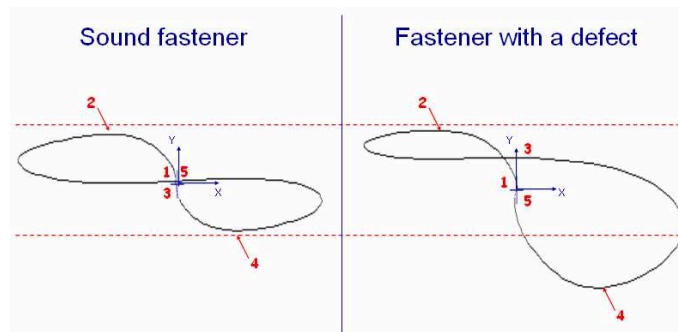
Figure 5: Defect detection signal interpretation

This rotation makes it easy to set an alarm threshold on the Y-axis, which is usually the component affected by a defective fastener (see Figure 5).

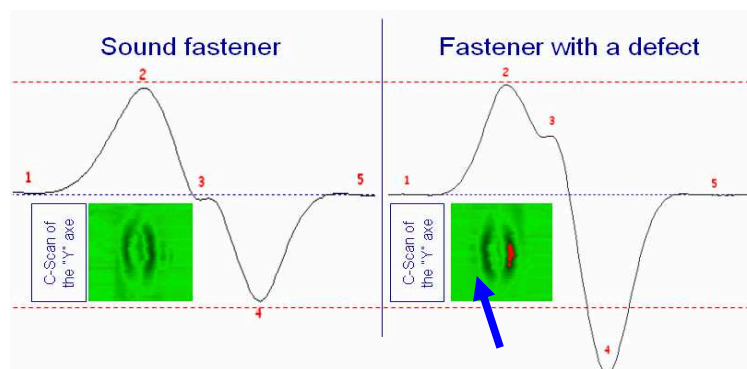
Figure 6: Y-axis strip chart and C-scan signal representation

When the probe passes over a fastener with a crack, the signal crosses the alarm threshold and the C-scan of the Y-axis clearly shows the defect. Figure 6 presents the strip chart and C-scan representation of that Y-axis (the X-axis is not used at this moment).

Each line forming the C-scan represents the measured signal of each receiving coil. It is possible to obtain a smoother C-scan if we use an interpolation processing between each received line.

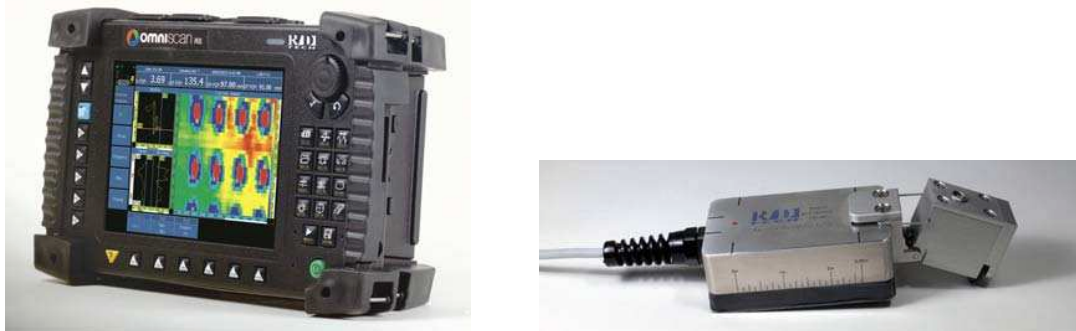
Figure 7: Experimental equipment

The experimental equipment needed for this demonstration is shown in Figure 7. This is a setup built around the user-friendly equipment produced by R/D Tech. The equipment includes the ECA OmniScan unit and software, an ECA probe prototype, and a small position encoder.

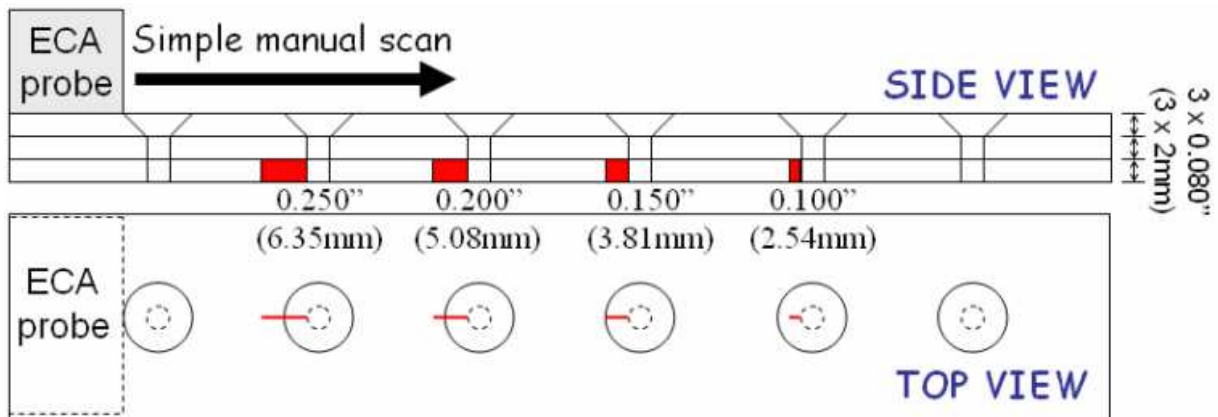
Figure 8: Experimentation 1 configuration

The first simulated specimen is aluminum machined three-layer thick lap-joint structure. The cracks are located in the third layer of the structure (each layer is 2 mm thick). It is important to mention that such sample configuration represents a considerable thick structure for the eddy current technique. As a matter of fact, the crack is located under 4 mm of aluminum plates.

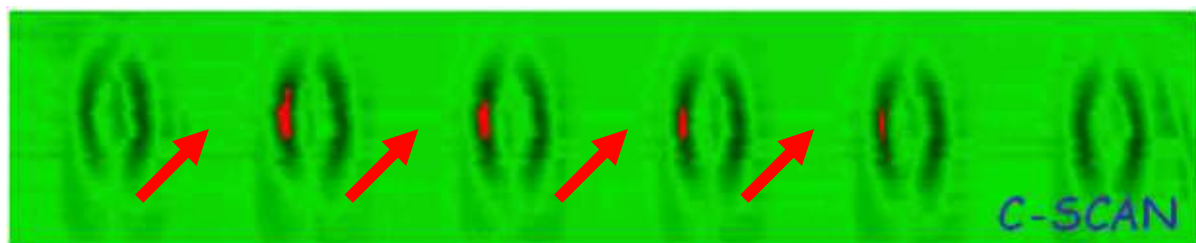
Figure 9: Experimentation 1 C-scan results, frequency of 1 kHz

Scanning with the designed ECA probe, figure 9 shows that we were able to cracks down to 0.100" (2.5-mm) located in the third layer of the simulated lap-joint structure. Another important point is that the ECA probe had very low sensitivity to lift-off.

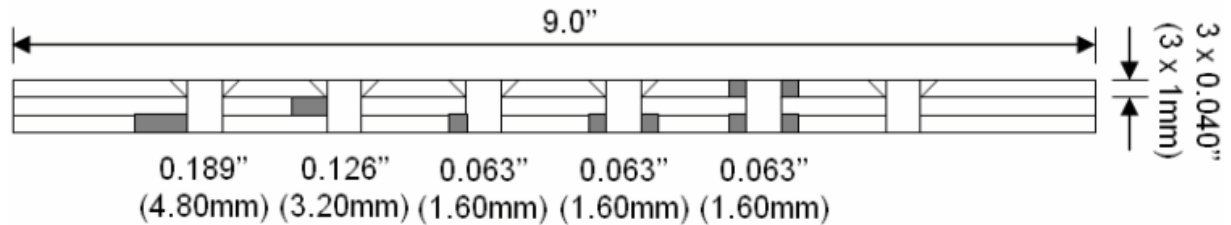
Figure 10: Experimentation 2 configuration

The second application is a machined, three-layer thick lap-joint sample like the first one, but the defects were located in different layers of the structure. Each layer is 1 mm thick.

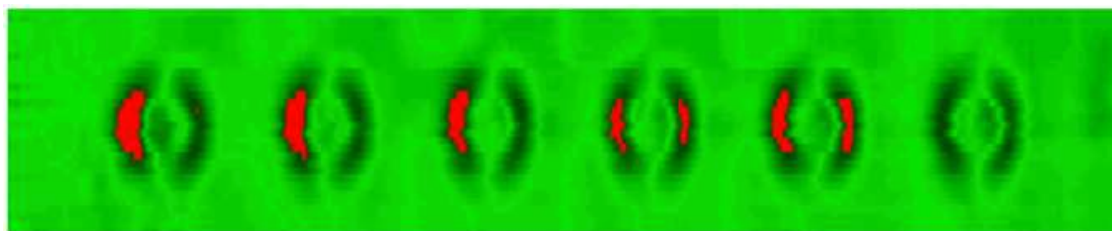
Figure 11: Experimentation 2 results, frequency of 2 kHz

This above results (figure 11) demonstrates that we have been able to detect cracks in the third layer as small as 0.063" (1.6-mm). This setup also allows the detection of defects located in different layers of the structure without any false calls.

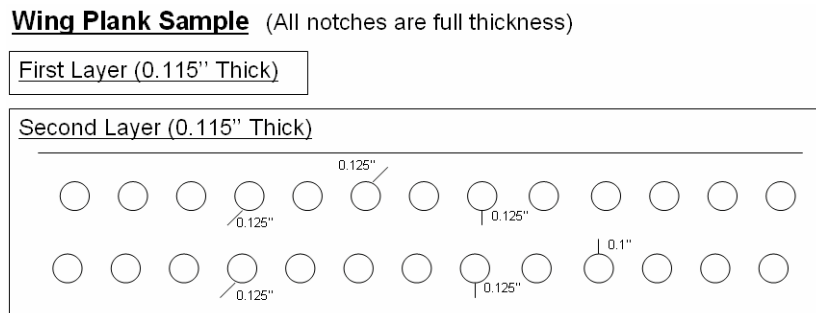
Figure 12: Experimentation 3 configuration

Figure 12 shows the sample configuration with the different location of the cracks.

Normally, the fastest way to inspect the plate would be to move the ECA probe along the fastener line. However, since the designed probe has a better sensitivity to the type of cracks oriented along the scanning axis, scanning along the fastener is not really recommended for defects with orientation between 5 and 7 o'clock such the above sample. With such defects, a perpendicular scan or an oriented 45 degrees scan of the fastener line would provide much better results. The following section shows the results obtained for different scan orientations.

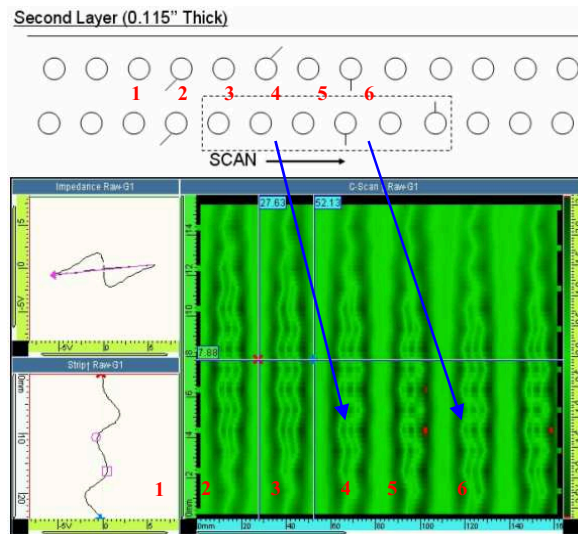
Figure 13: Parallel scan, very weak detection (because of crack orientation)

With the probe moving parallel to the fastener line, it is very difficult to adjust the C-scan color palette to obtain good detection of the cracks. Figure 13 shows two small indications that correlate with the plate defects. However, the signal amplitude that we get from those defects is relatively small and could easily be confused with a good fastener. With this type of parallel scan, the minimum detectable flaw would vary between 0.160"-0.180".

- A parallel scan can provide very fast scan but the detection level is expected to be more around 0.160" to 0.180".
- Optimum response is obtained when the probe is scanned in the same orientation as the defect. In this case, a crack as small as 0.125 in. can be detected. To cover all direction at this level of sensitivity, a total of four scans are required.

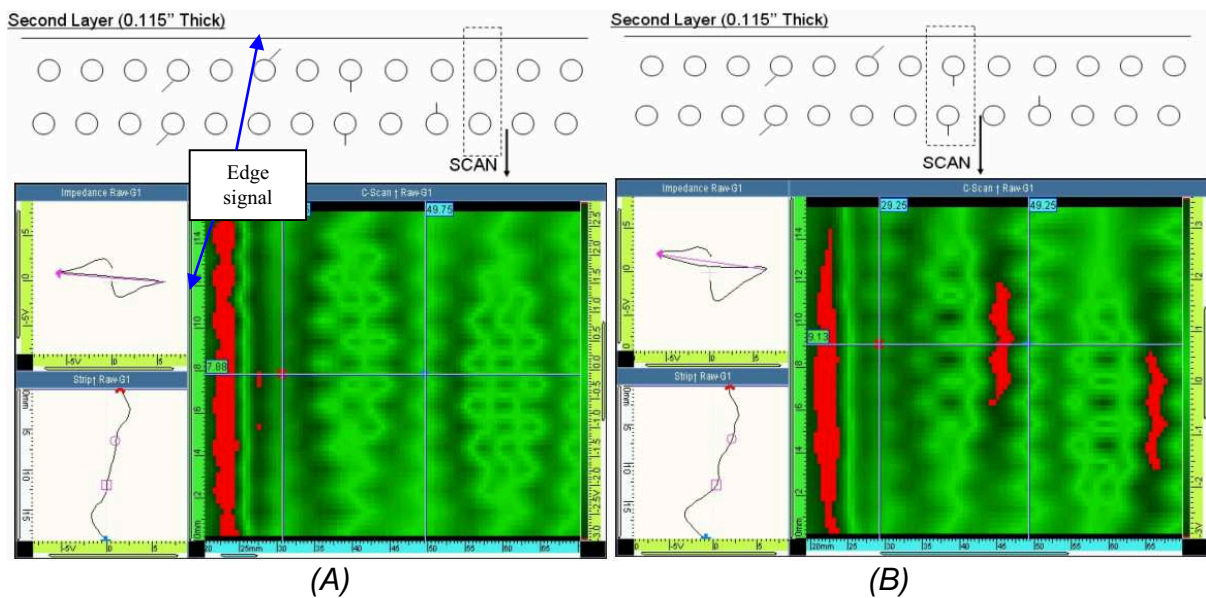
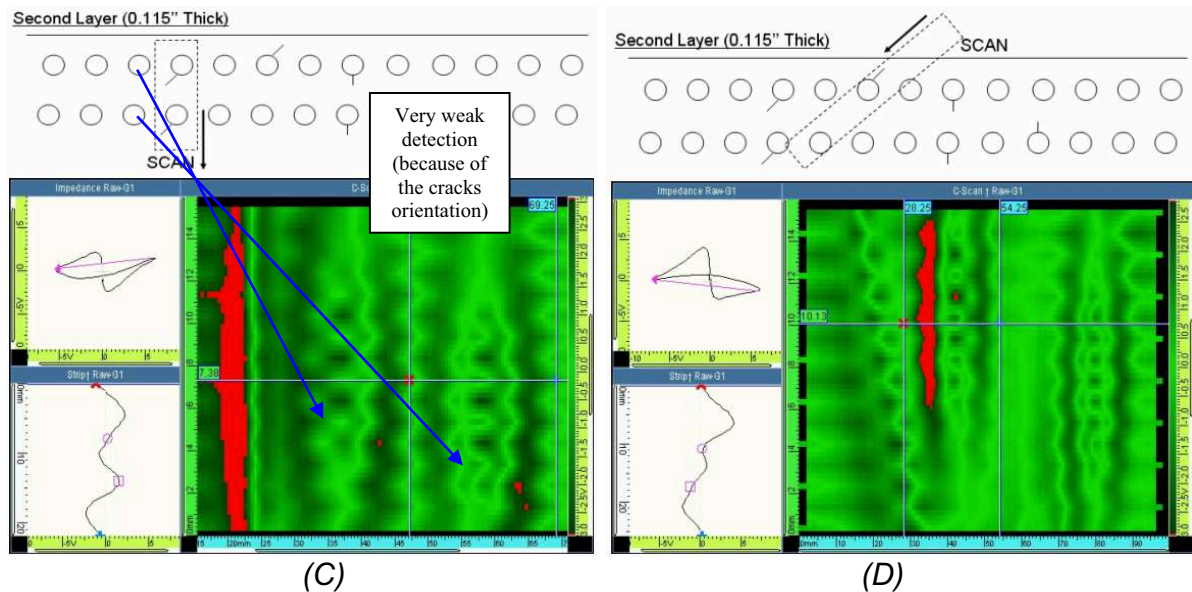
Figure 14: Experimentation 3 Results: frequency of 1.5 kHz – A) Response of good fastener - B) Response for defective fastener with crack at 6 o'clock – C) Response for crack located at 8 o'clock – D) Response for crack located at 8 o'clock (good scan orientation)

When the scan is made perpendicular, the signal response to a crack located around 6 o'clock becomes much stronger. Figure 13 (A) and 13 (B) shows the results from two scans, one made on good fasteners and one made on fasteners with cracks. When the crack is located at 8 o'clock like in the Figure 13 (C), the defective fasteners are more difficult to detect. They can still be detected but the difference with a good fastener response is very small.

Figure 13 (D) shows the scan result for a 45-degree orientation. This type of scan is clearly optimized for defect around 7 and 8 o'clock. The first fastener gives a big signal represented as a deviation in the positive plane of the impedance plane and as an important color change in the C-scan.

To conclude with this third experimentation, the new ECA probe design was able to detect all the fatigue cracks located in the second layer of the simulated lap-joint samples. However, this probe has some limitations:
