Non Destructive Testing of Laser Welded Lap Seams by Eddy Current Technique

Antje ZÖSCH, Martin SEIDEL, imq Ingenieurbetrieb für Materialprüfung Qualitätssicherung und Schweißtechnik, Crimmitschau, Germany

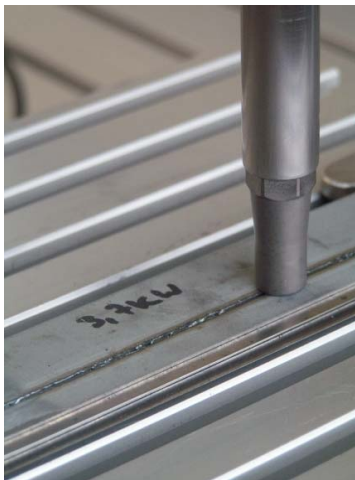
Fig. 1: Eddy current probe on laser welding seam

Eddy current measurements have been carried out by the help of an ELOTEST B320 by Rohmann GmbH, Germany. The eddy current probes was made as reflection (“transformer”) style devices (PLR Linke&Rühe GmbH, Germany). Reflection probes utilize a driver coil and a sensor coil. The primary advantages of reflection probes are good signal-to-noise ratio and a wide band of operating frequency. The probes have been used as absolute probes, which can detect both gradual and sharp changes. Physical size and shape of the eddy current probes were adapted for testing short lap widths.

During measurements samples were moved laterally by the help of a linear unit using a linear stepping motor with repeatability of ± 0.02 mm. Eddy current probe was assembled into a resilient mount which ensured a constant gap between probe and surface of 0.2 mm.

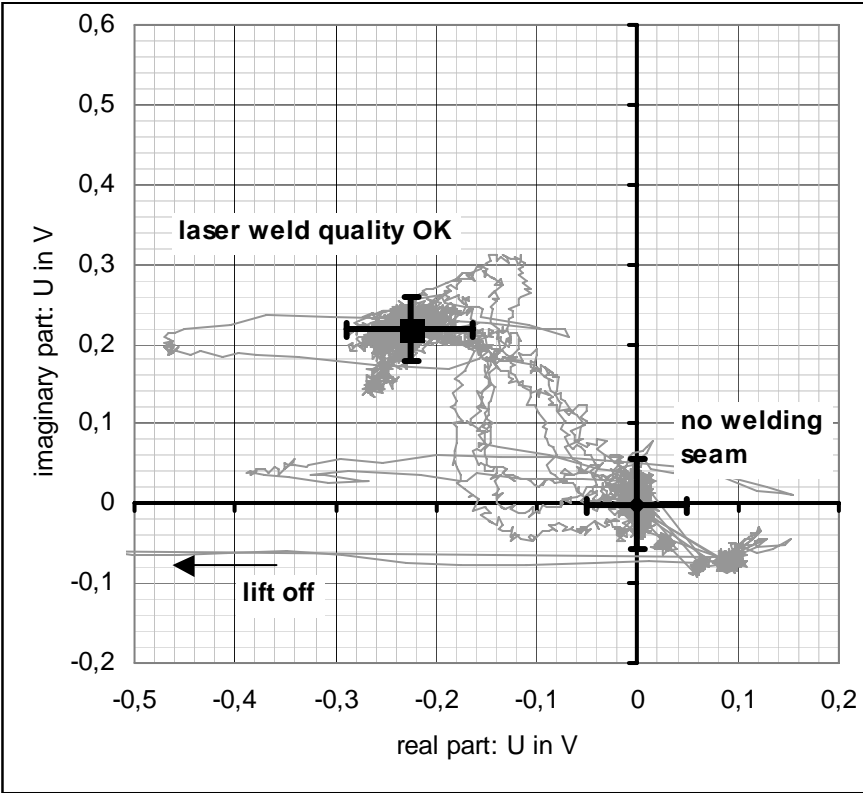
Fig. 2: Impedance plane: characteristic area for “laser weld quality OK”

The example shows evaluation of two plate lap seams of TRIP 700 (thickness 1.5 mm) and H260 PD Z 100 (thickness 1.6 mm) produced with laser power of 4 kW and process velocity of 40 mms^{-1} , respectively. Reference samples were produced and investigated. After data pre-processing in the impedance diagram characteristic areas for the states "weld quality OK", "surface pores", "no connection between joining plates" and "no welding seam" were defined by averaging eddy current data of corresponding weld parts (Fig. 2-4). It can be shown that there are differences between these states.

Changes of the signals into the lift off direction indicate the existence of partially melted weld spatter (Fig. 2). Eddy current probe is shifted and the lift off effect occurs. The

effect can be identified because it is characterized by large changes in x-direction and small changes in y-direction.

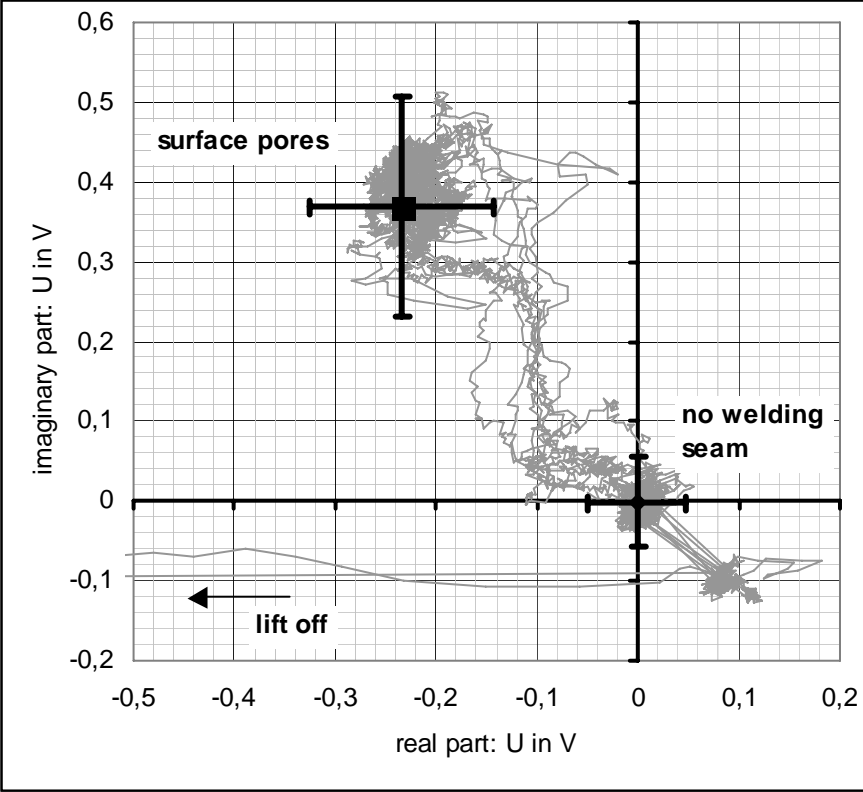
Fig. 3: Impedance plane: characteristic area for surface pores

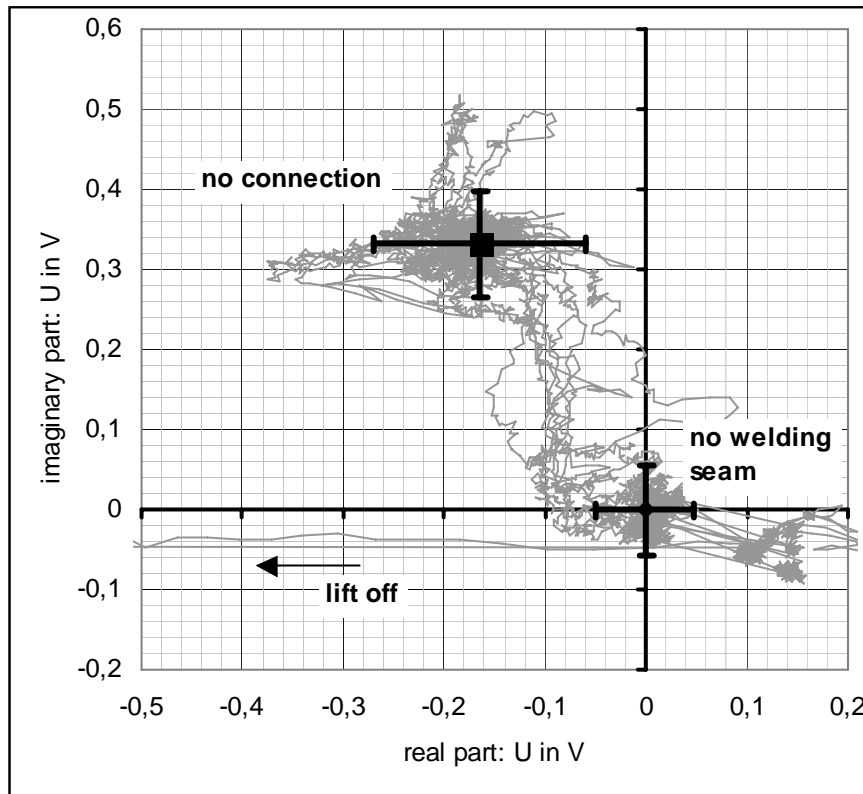
Fig. 4: Impedance plane: characteristic area for “no connection”

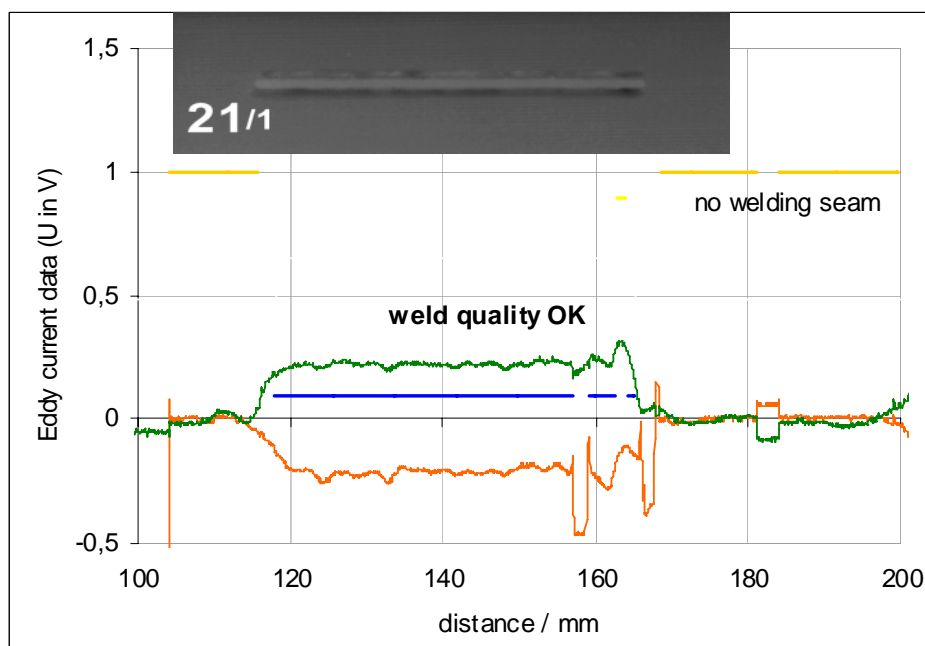
Fig. 5: Eddy current data versus distance, results of evaluation for a laser welding seam with satisfying weld quality.

Laser welded lap seams of the same material produced with different gap sizes between joining plates have been investigated. Eddy current data have been pre-processed and assigned to the characteristic areas of reference samples in the impedance plane diagram.

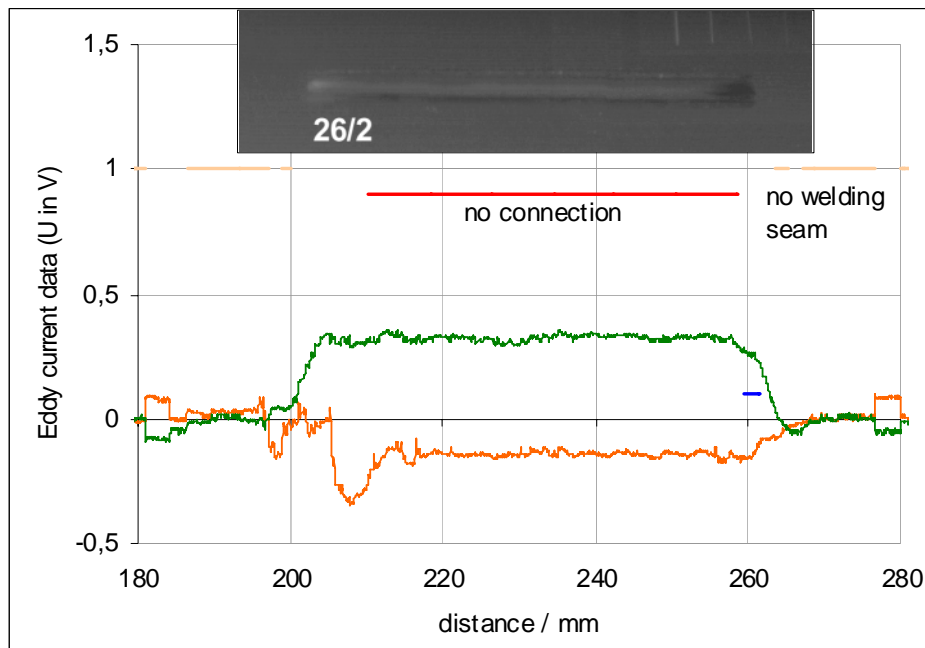
Fig. 8: Eddy current data versus distance, results of evaluation for a laser welding seam where joining plates have no connection over the whole length of seam.

X-ray images show dark contrast indicating surface pores and low contrast indicating parts with no connection between joining plates. Eddy current data can be assigned to the area of surface pores and lack of connection in the impedance plane diagram of references. The lines in the diagram illustrate the results of eddy current evaluation. Surface pores and lack of connection were found.
