NONDESTRUCTIVE TESTING OF POLYCRYSTALLINE SILICON SUBSTRATES BY MILLIMETER WAVES

Y. Ju, Y. Ohno, H. Soyama and M. Saka

Department of Mechanical Engineering, Tohoku University, Sendai, Japan

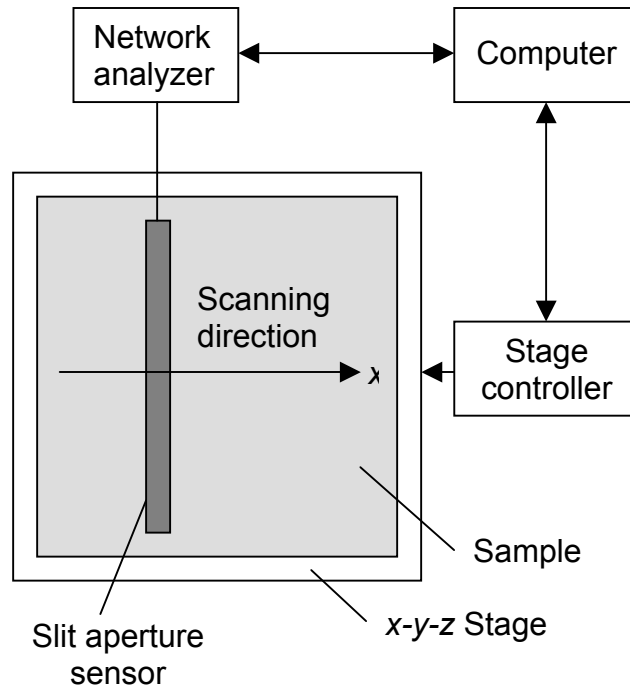
Fig. 1 Configuration of the millimeter wave measurement system

Experimental Procedure: The configuration of the millimeter wave measurement system is shown in Fig. 1. The photograph of the measurement system is shown in Fig. 2. A network analyzer was used to generate a continuous wave signal fed to the sensor and to measure the amplitude of the reflection coefficient at the sensor aperture. The operating frequency was 110 GHz and the standoff distance was $600 \text{ }\mu\text{m}$. A computer was used to synchronize the stage translation in the x - and y -directions and to create a one-dimensional graph using the measurement results. In order to apply the technique to on-line testing, a high speed testing was carried out by introducing the slit aperture sensor. The sensor has a slit aperture with the dimensions of $50 \times 1 \text{ mm}$. In the experiment, the sensor scanned the sample along the x -direction, which is perpendicular to the longest side of its aperture. Therefore, a high spatial resolution was obtained in the scanning direction. To obtain high testing speed, the sensor was controlled to scan the sample continuously with a speed of 35 mm/s . Therefore, for testing an area of $50 \times 35 \text{ mm}^2$, only 1 second is needed.

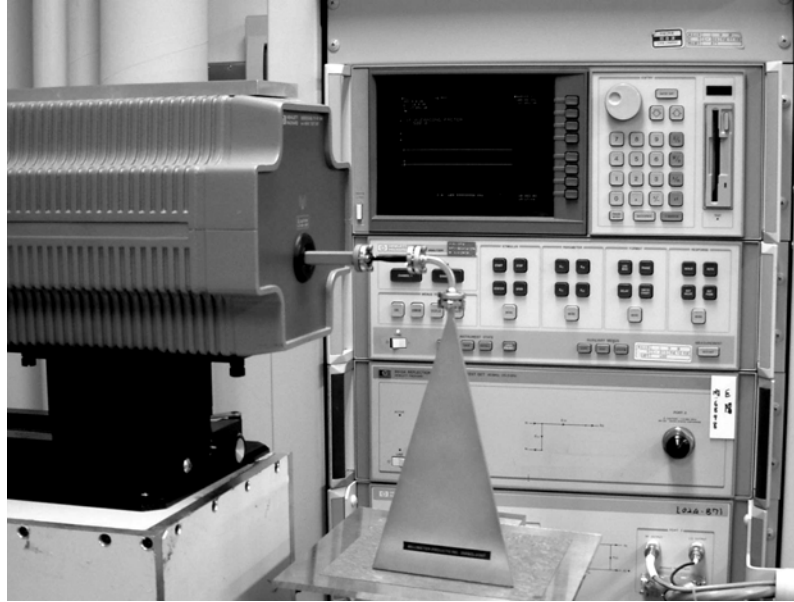
Fig. 2 Photograph of the millimeter wave measurement system
