## IMPROVEMENT OF THE APPLICABILITY OF SHEAROGRAPHY UNDER AIRCRAFT PRODUCTION AND MAINTENANCE CONDITIONS

The presentation will describe the developments within the EC-funded project INCA with the following examples: The development of a mobile shearography-system for aircraft in-service inspection. Integration of a CMOS-sensor. Results of examinations on real aircraft structures.

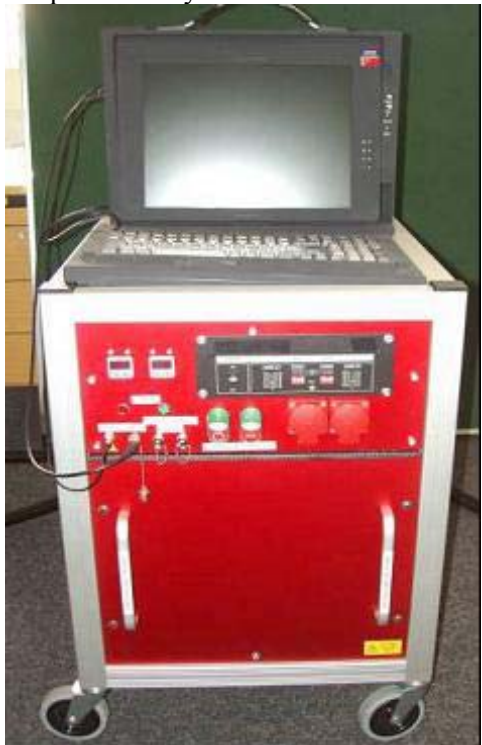
Fig. 1: Mobile rack with PC

**Results:** The development of the shearography demonstrator in the scope of the EC funded INCA project was finished recently. The demonstrator (Fig. 1+2) consist of three main components: Mobile rack, PC, and the cabinet.

The mobile rack includes all necessary electronic devices for energy supply of the laser, which are located in the cabinet. An other component placed in the mobile rack is the vacuum control unit. It provides two independent circuits with vacuum power. Each vacuum-circuit ends in three suction pipes at the cabinet. The power of the vacuum pump is designed to hold a stable connection between the cabinet and the testing object with only three suction pipes (one circuit). Every circuit is monitored by pressure indicators (fig. 1 upper left side of the front panel) and in the case of a drop in pressure it will be indicated by an optical and acoustical signal. In spite of these securities it is recommended to use an additional security (e.g. belt) but it's not inevitable necessary.

A stand alone PC includes the fringe-analysis-software for image processing. The PC is connected with the CCD-camera and record resulting images in nearly real time. The software provides some filter and demodulation features for building up reportable images.

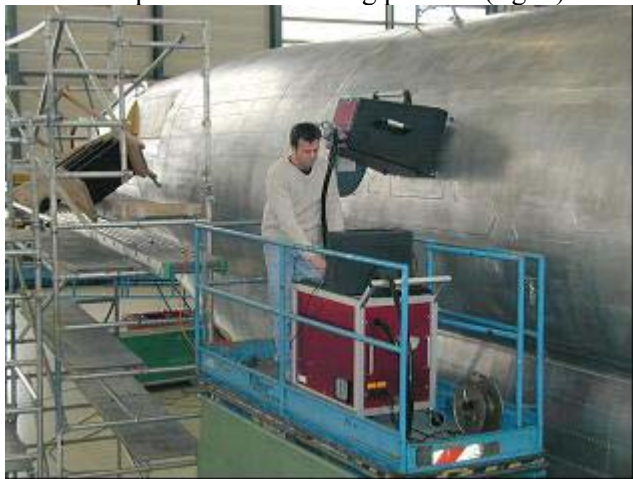
Fig.3: First performed tests on a aircraft fuselage with aluminium honeycomb structure

The first tests on real aircraft structures were performed on a fuselage of Breguet Atlantic 1150, a reconnaissance marine aircraft of the German forces. During a routinely US-inspection for debondings in aluminium honeycomb structure, the new shearography inspection system was evaluate under maintenance conditions very successfully:

The equipment is able to operate on a narrow working place (see fig. 3).

Due to the stable connection of the cabinet and testing part relative movement could be prevented. The test results of these measurements are not influenced by any movement disturbances.

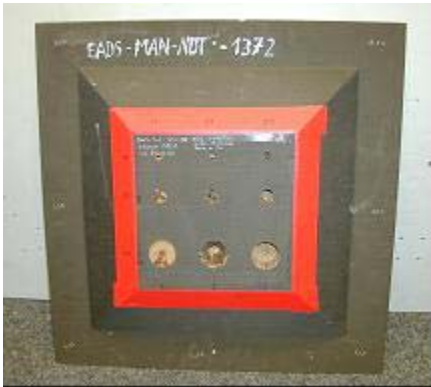
Fig. 7: Performed test on a CFRP-Honeycomb-Composite-Structure

Fig. 6: Results of performed test on fuselage out of CFRP monolithic structure  
Next tests were carried out on test samples of CFRP-H/C-structure (fig. 7a). In this test samples debondings of the H/C core are simulated by holes of various depths. It is shown that the holes which are penetrating the complete honeycomb core pointed out very clearly (fig. 7b). The other holes are difficult to recognize. Additionally many defect indications distribute on the entire testing area are shown. After a X-ray examination (fig. 7c) it was determined that there is an accumulation of resin within the H/C cores.

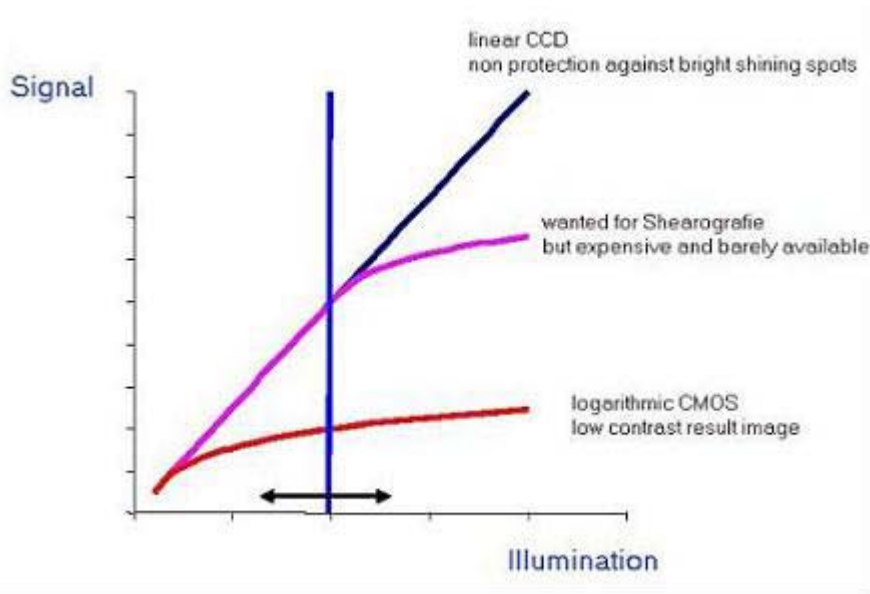
A CMOS-sensor has the advantage, that its nominal line (ratio of light density to voltage output) is logarithmic (CCD is linear). Due to the nominal lines the CMOS-sensor is able to process more intensity variations than a CCD-chip (over six decades). However the dynamic in grey scale and hence the contrast of an image of a CMOS-sensor is worse than a CCD-sensor, because the CMOS-sensor has to depict a much bigger range of intensity on the provided range of value.
