NON-DESTRUCTIVE TESTING IN PREDICTING OF PROCESSING FURNACE REMAINING LIFE

Key words: process furnace; predicting of remaining life; non-destructive testing (NDT); metallographical examinations; MP-TUBELIFE probabilistic assessment software package.

NDT for Safety

November 07–09, 2007, Prague, Czech Republic

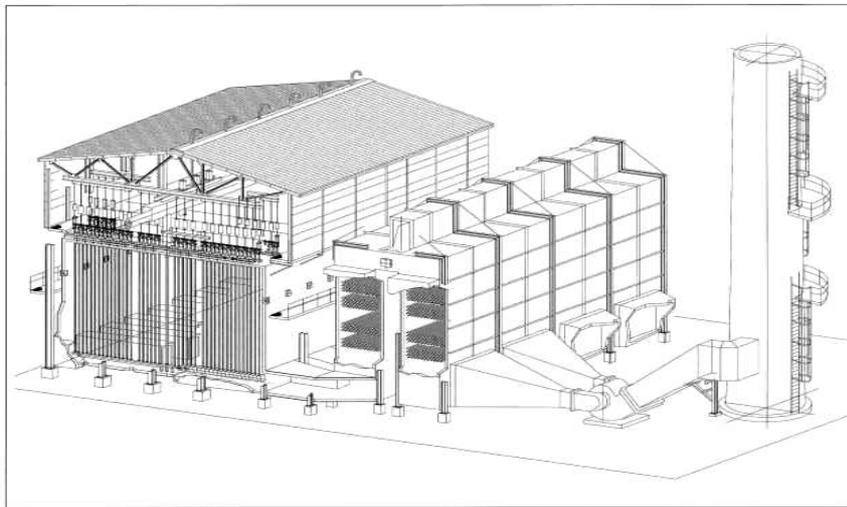
Figure1: Scheme of fertilizer factories primary reformer unit [10]

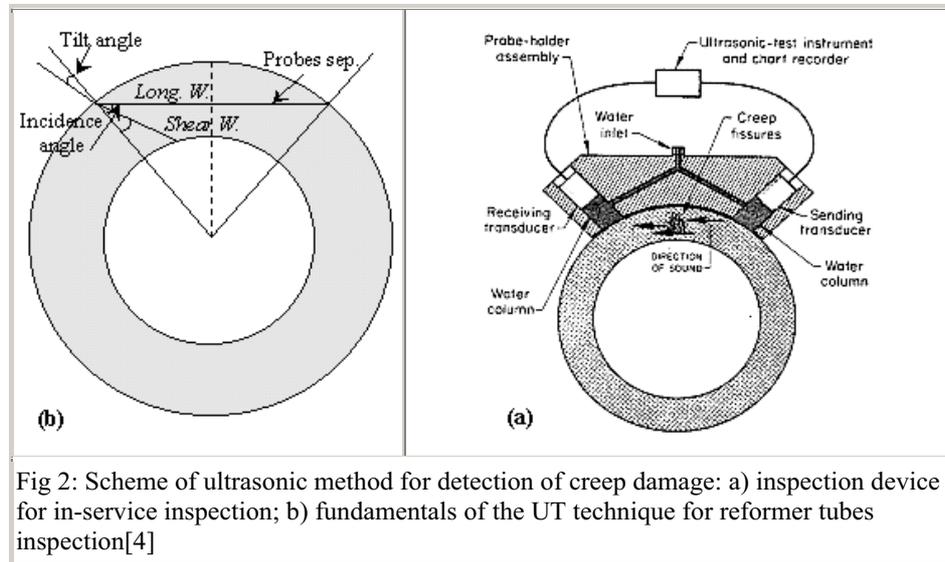
- **Eddy current** (responds to chromium migration due to overheating and conductivity changes)
- **Ultrasonic** (responds to attenuation and scattering rupture, accelerated by service conditions). If the relationships between ultrasonic parameters and material are known, it will be possible to determine the state of the material by measuring the ultrasonic variables. When the material exhibits creep damage, due to the presence of cavities, the attenuation changes from its standard value; studying these changes the damage can be characterised (transmission ultrasonic attenuation technique). Due to the surface state of reformer tubes, non-contact techniques should be applied. Since no water spilling (or any other liquid) is allowed into the furnace, the design is based in a local immersion technique, using compression wave probes. The method consists on a pair of probes arranged in pitch and catch fixture. The transmitter sends a pulse, which travels following a chord in the tube and is picked up by the receiver (see figure 2, (a)). When the UT beam goes through the water and crosses the steel, the probe angle is diffracted (see figure 2, (b)). Even, mode conversion is produced (unless in the case of normal incidence), generating shear and longitudinal waves

The shear wave front has some limitations to be transmitted in this type of materials that the best probe arrangement (based on the distance between emitter and receiver probes and in the tilt angle) consists of doing the longitudinal wave cross the tubes along the middle thickness structure. Separately, in paper will be emphasized using CT (combination technique) of diametrical growth and eddy current techniques due to their advantages of integrated works with automatic climbing device.

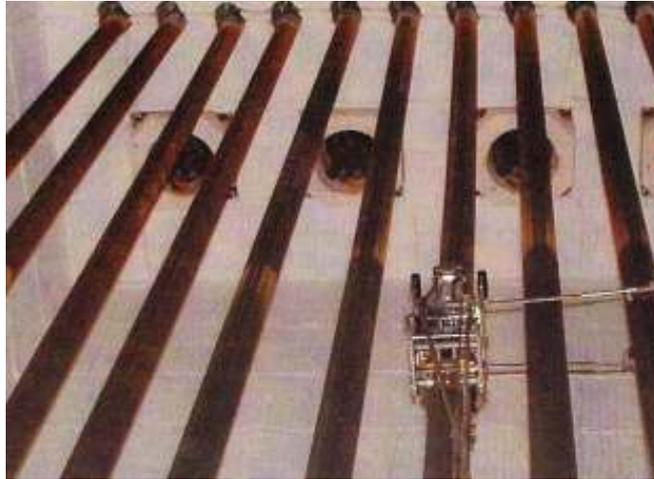
The inspection is performed with a pneumatic tube crawler with speed of 0,3m/sec. This translates into an estimated 250 tubes inspected per normal work shift (Figure3). Increment of tube diameter is an indicator of creep relaxation presence. Then, as the laser scanner is inspecting and moving vertically, two perpendicular tube diameters are measured along the tube.

Figure 3: MP-automatic climbing device for eddy current crack depth and laser outside diameter (OD) measuring (profilometry) during in-service inspection of reformer tubes [11]

Creep crack depth measured by eddy current technique is rated in percentage of sound wall lost to the crack (i.e. 30%, 40 %, 50% etc.). The crack normally begin approximately one third from the wall-thickness inside diameter, growing first toward the ID and then the OD. Combination both results provide optimum information on the tube condition and remaining life expectancy.

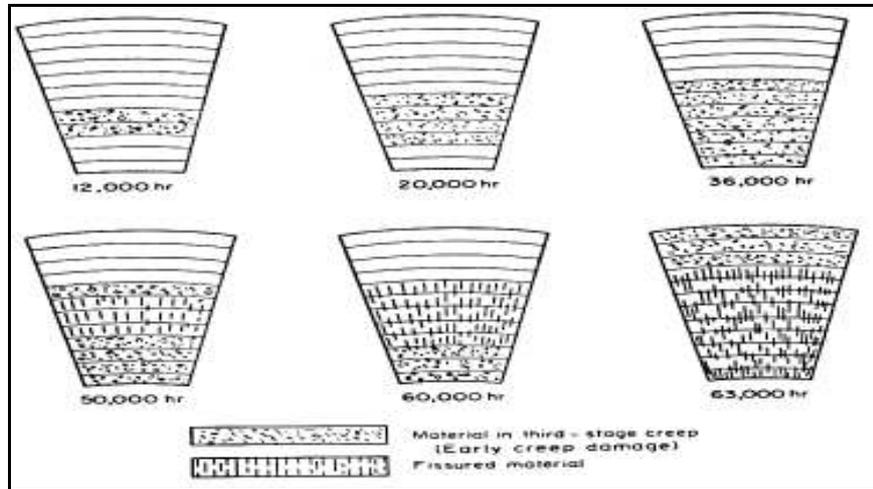
On Figure 4; progress of failure of furnace tubes regarding on thermal creep degradation and oxidation on high temperatures is presented. Depending on work hours, the presences of different degradations stages (i.e. third stage creep damages or fissured material) are noticed.

Figure 4: Presentation of progressive failures flow of furnace tubes [5]

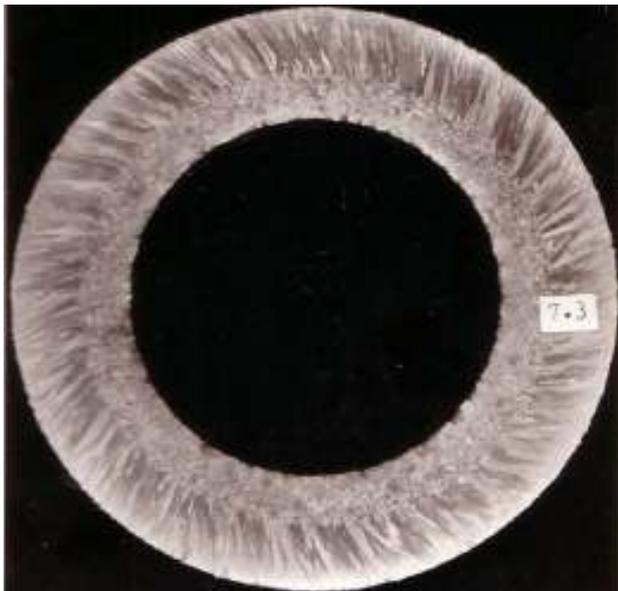
Macrostructure is developed by etching in Adler's reagent. Structure is characteristic for centrifugally cast process, i.e. The 2/3 of outer side of tube thickness consists of columnar grains. The following 1/3 of thickness has equiaxed grains (Figure 5; Figure 6).

Figure 5: Macrostructure of centrifugally cast tube,

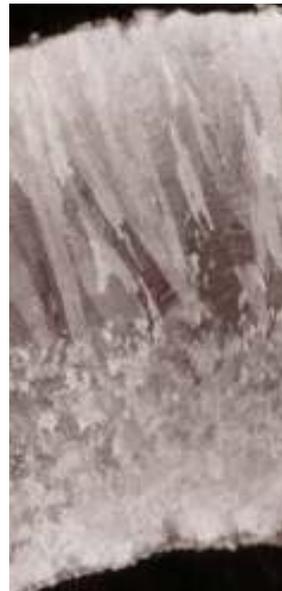
1: 1 Figure 6: Macrostructure, 5:1

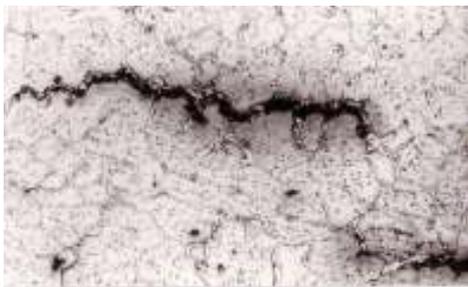
After 50.000 work hours of tubes on temperature in range of 1100-1150 K , the structures with macro-fissures (figures 7, 8) and dispersed Cr-carbides with inter-metallic phase (σ -phase) (figures 9,10) are shown [11].

Fig. 7; Microstructure of cracked tube, 100:1

Metallographic analysis of damages tubes was performed on one example with eddy current registered cracks. The evaluated damages are metallographic confirmed (Figures 7, 8, 9, 10). The microstructure of reformer tubes (ASTM A297 HK40) is developed by “Glyceregia” etching (HNO₃ + HCl + glycerol).

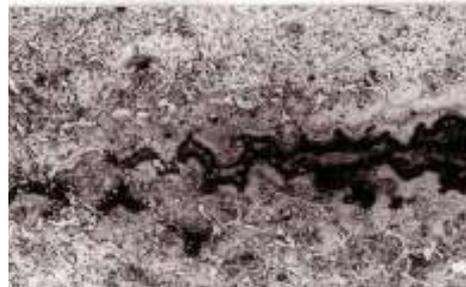
Fig. 8; Macro-fissure, 250:1

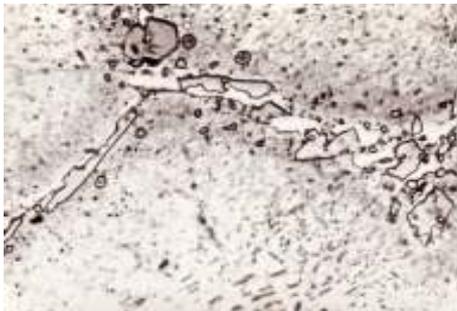
Fig. 9; Microstructure of sigmatization;500:1

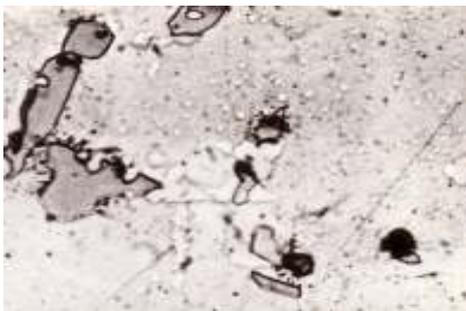
Fig.10; σ -phase with dispersed Cr-carbides,1000:1

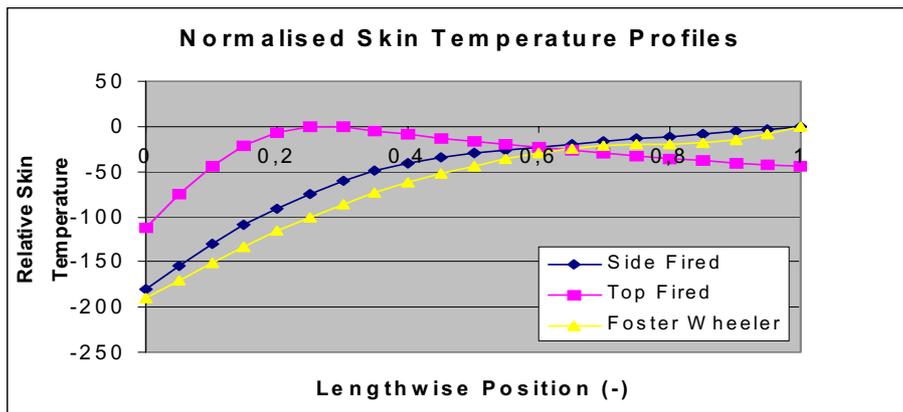
Figure 11; Processing data related on skin tubes temperature[13].

- revised stress analysis
- revised creep models
- account of transient operation (loss of steam)
- Flux and skin temperature profiles for top-fired, side-fired and Foster Wheeler design configurations (example see figures 11,12)
- Due account taken of inspection findings
- Guidance and software for data collation.

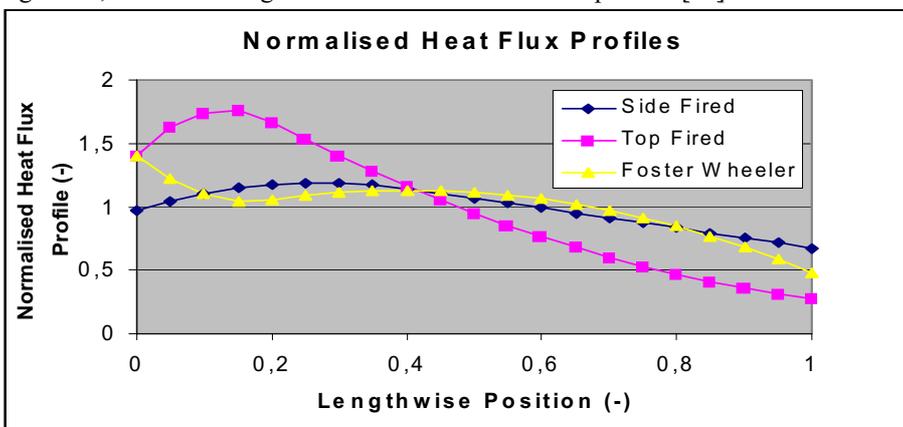
Figure 12; Processing data related on tubes heat flux [13].

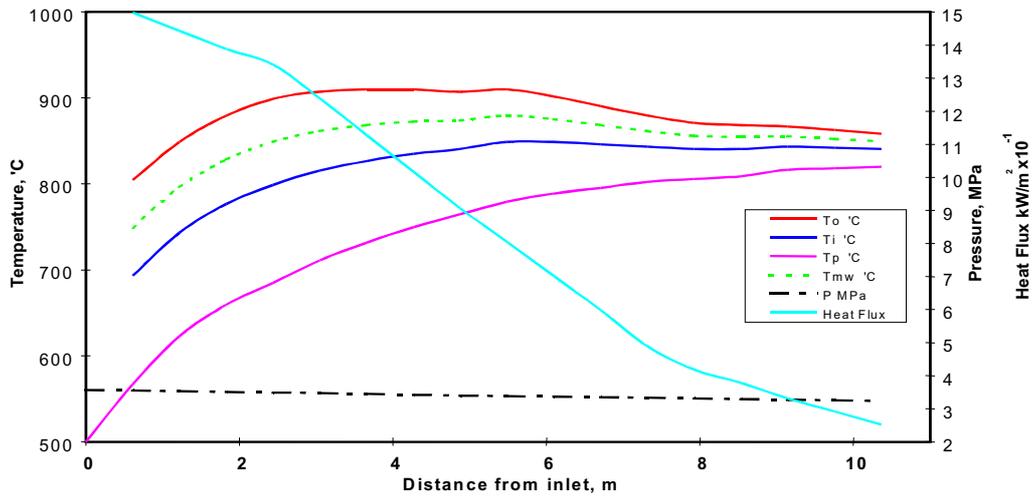
Figure 13; Unit configuration (flux & temperatures & pressure) profiles data

Where, on which tube, is failure going to occur first?, including all processing data, using TUBELIFE, predicting tubes failure is possible with low level of risk (Figure 13,14).

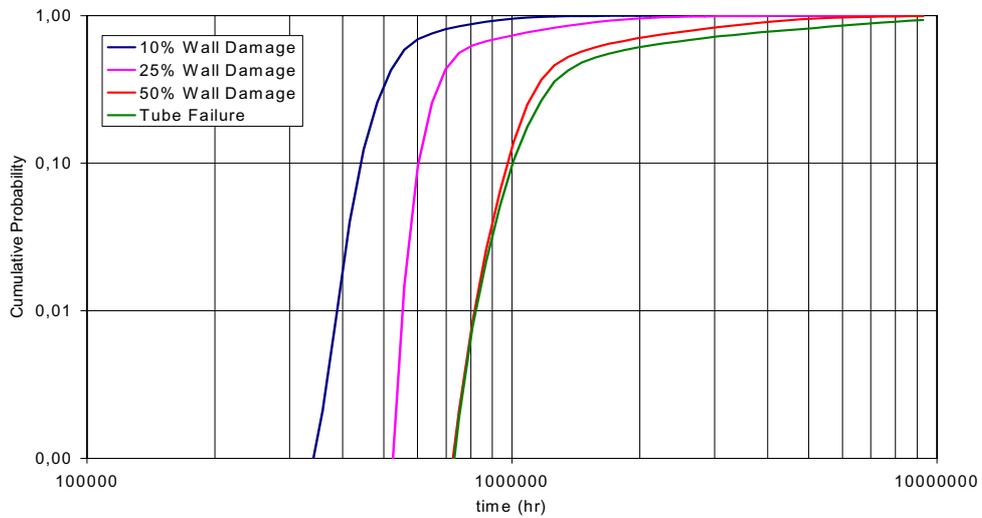
Figure 14: Final report on TUBELIFE assessment by probabilistic methodology

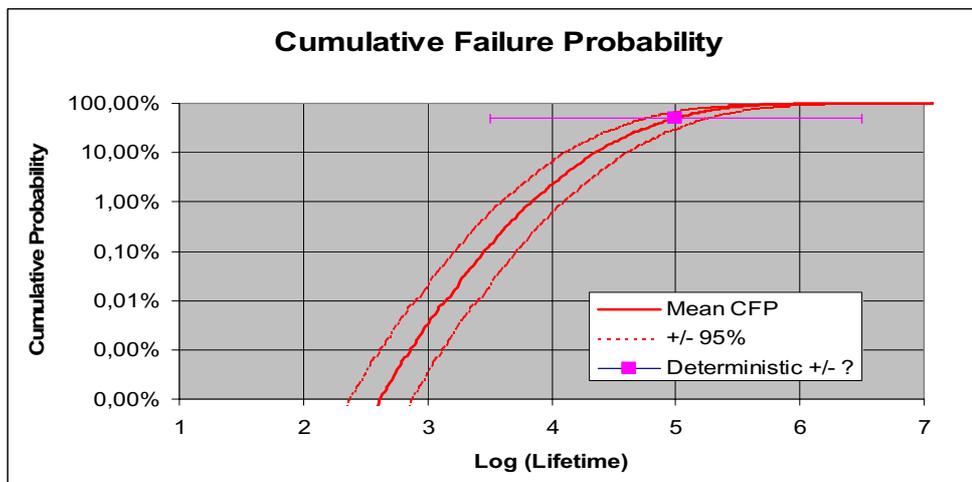
Figure 15; Final report on TUBELIFE cumulative failure probability predicting by probabilistic methodology comparing with deterministic approach [13].

Finally, comparing two present approaches of predicting reformer life, it is necessary show the characteristics of both, with cumulative failure probability final sample report (figure15).

Probabilistic approach:

- Considers all failure scenarios
- Considers all tubes in the cell/row
- Considers variability of :
 - material
 - operational parameters (flux and temperatures)
- Considers evolution of damage and tube failure.

Deterministic approach:

- Considers one failure scenario
- Single life estimate for all tubes in cell
- Assume a minimal confidence level
- “simplified” approach
- “less” input data
- “simple” to implement
- Which tube?
